**THE SILVER MAPLE
ON
UNIVERSITY BOULEVARD
VANCOUVER**

**A
STRATEGY
FOR
REVIEW AND
REPLACEMENT**

**M. R. Gardner
August 20, 1995**

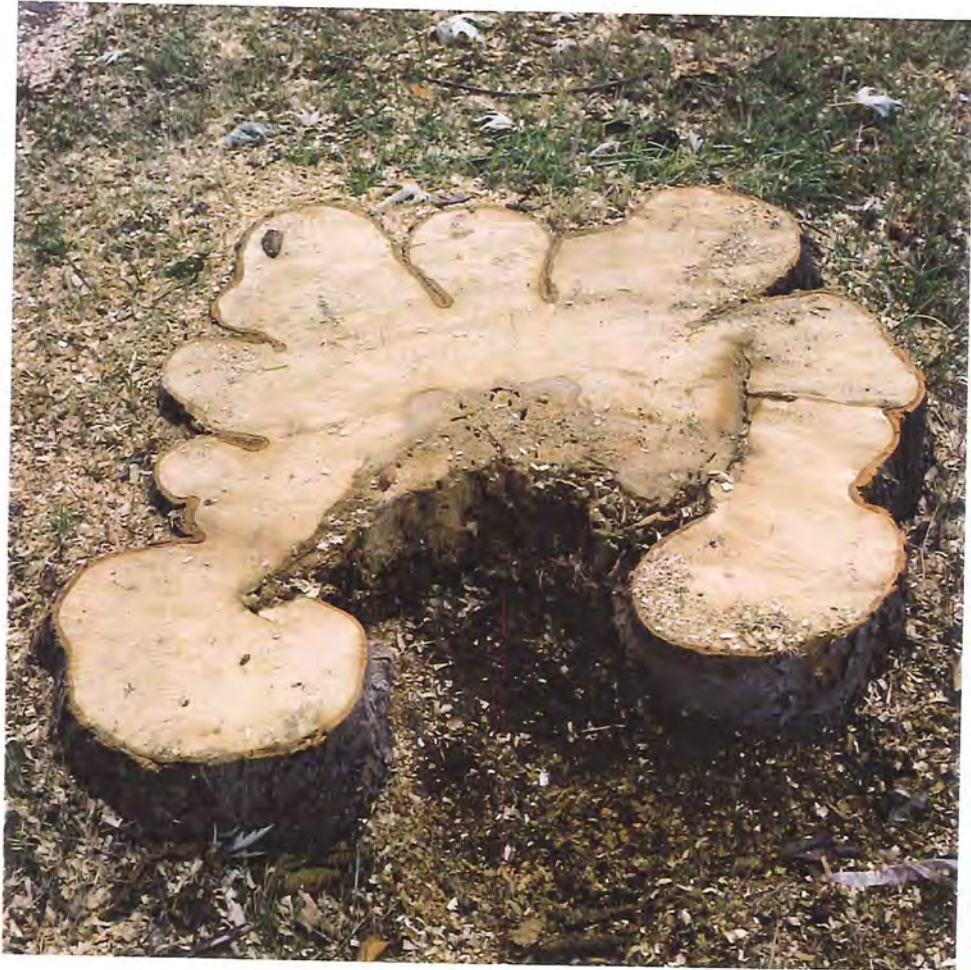
Stem wounds and carpenter ant activity has significantly reduced the heartwood and live stem wood of this tree following lower bole wounding some years ago.

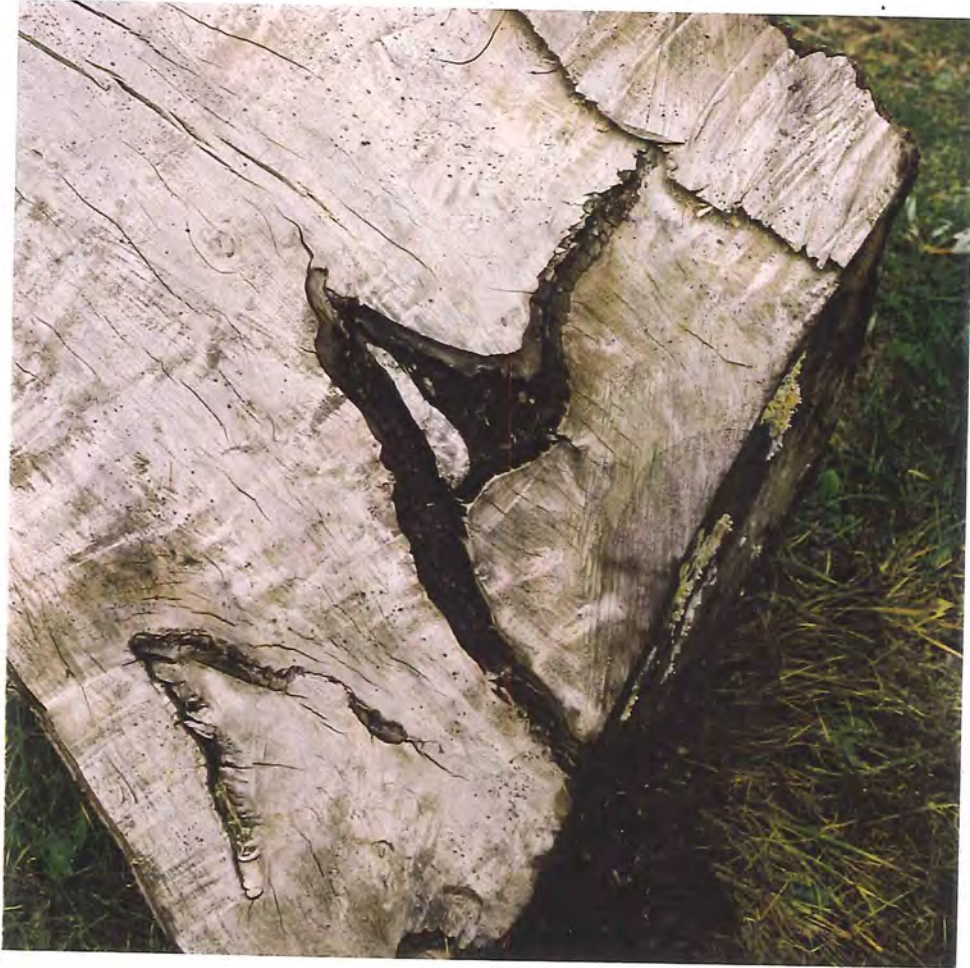
Bark inclusion has occurred in a number of limbs which significantly reduces the mechanical strength and attachment of some branches.

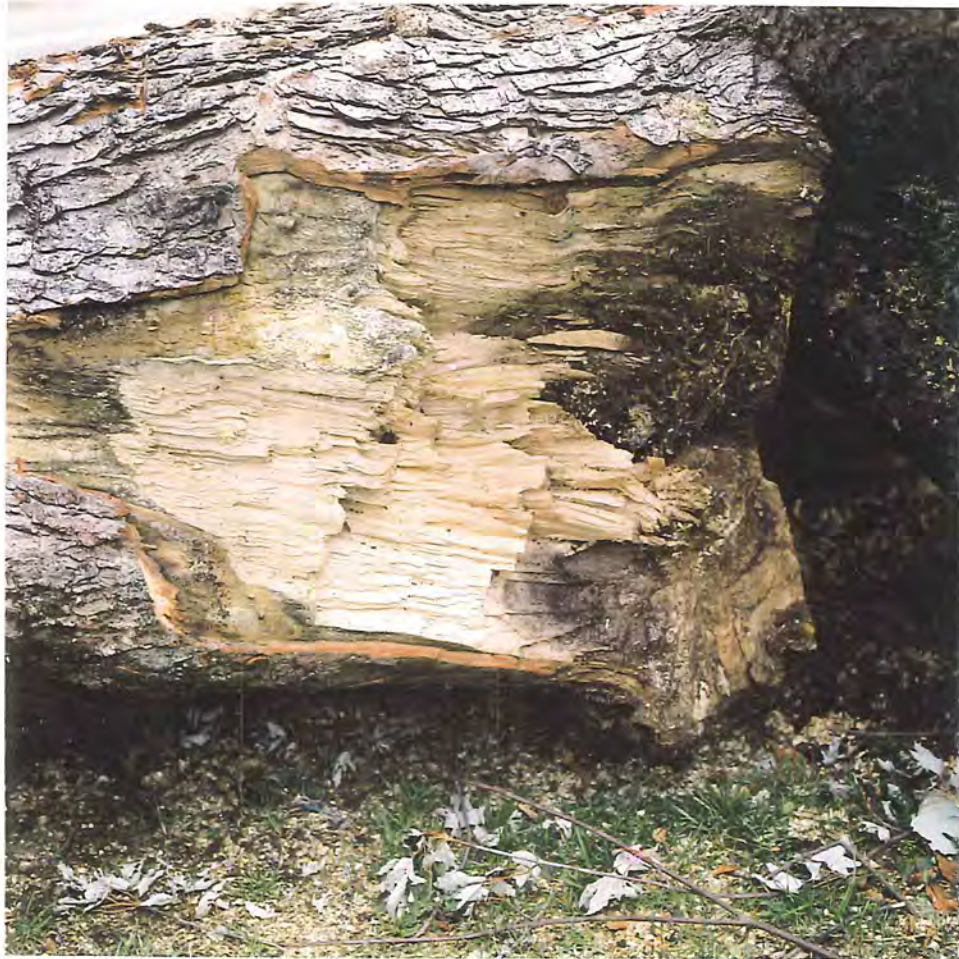
This part of the tree trunk, now lying on its side, was the original attachment point of a large limb. The dark right side is an area of included bark with no mechanical strength decreasing the attachment of the associated large branch. This branch recently broke off falling across the pedestrian pathway narrowly missing the adjacent traffic light control system.

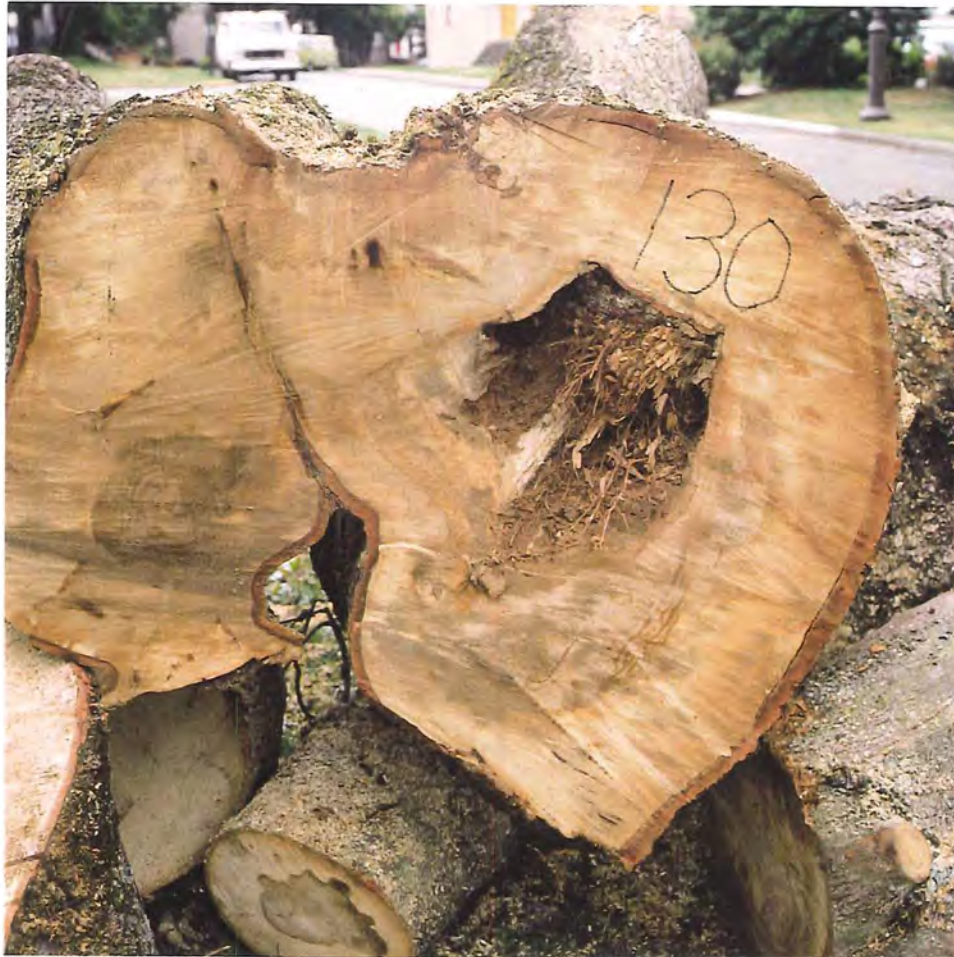
Internal decay of the stem part of the tree on the left will not in of itself contribute directly to the tree failure. The cleft and bark inclusion to the right of centre is a more arboriculturally significant indication of a potential failure point.

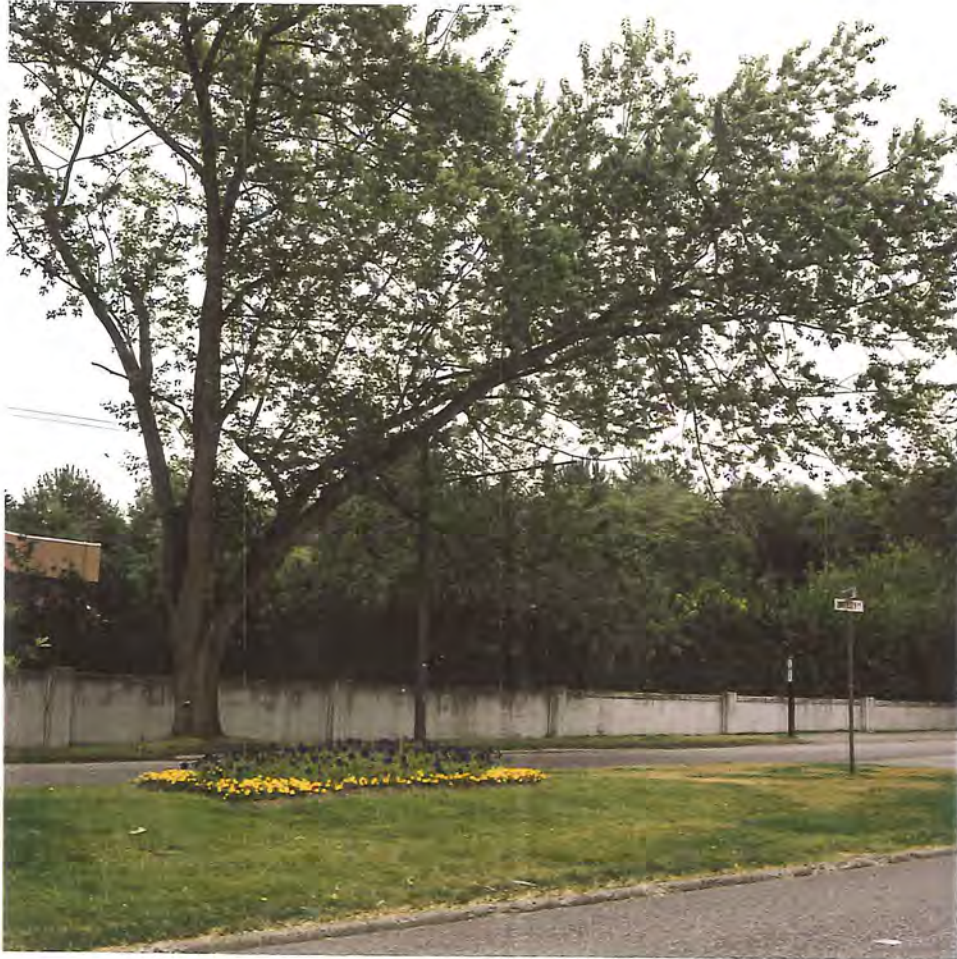
Very considerable strain is put on crotches by ever elongating scaffold branches leaning out over the roadway. Few viable pruning points exist to reduce the weight on this limb by drop crotch pruning.

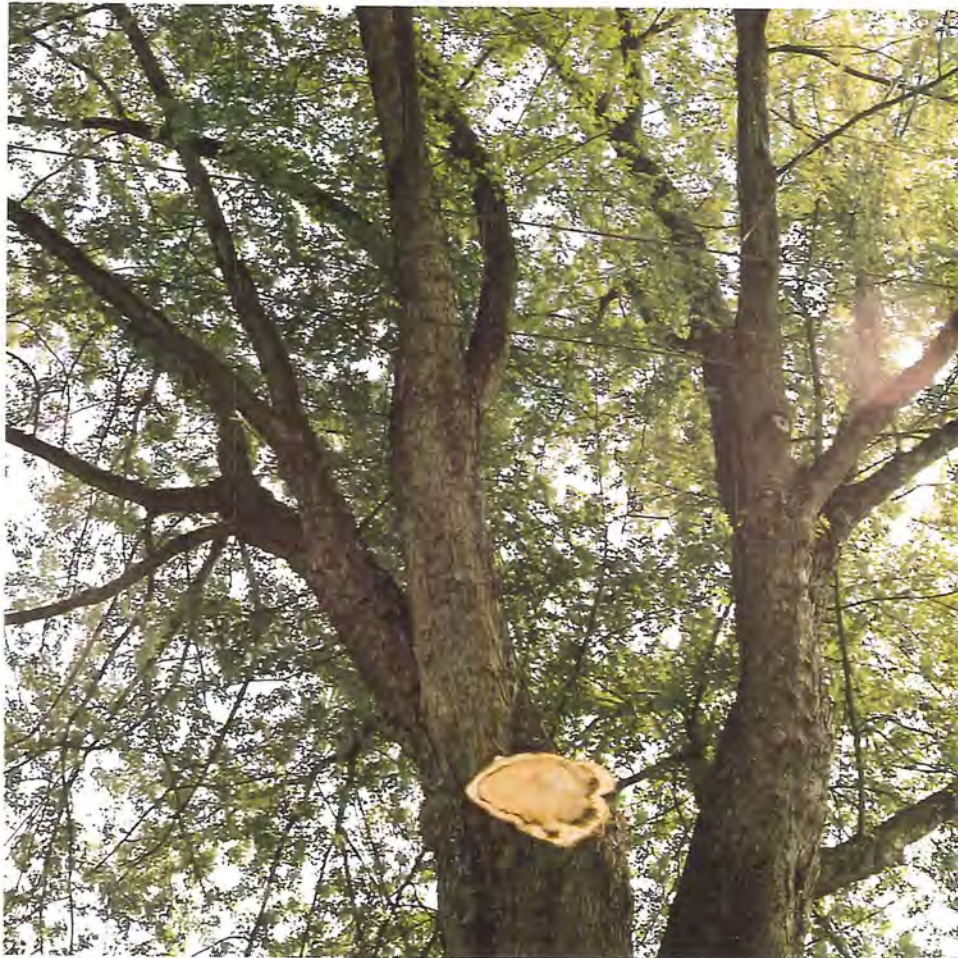
Stub cutting limbs like this, with no alternative growth directional branches, will stimulate a frill of undesirable and very poorly attached but aggressively growing suckers.

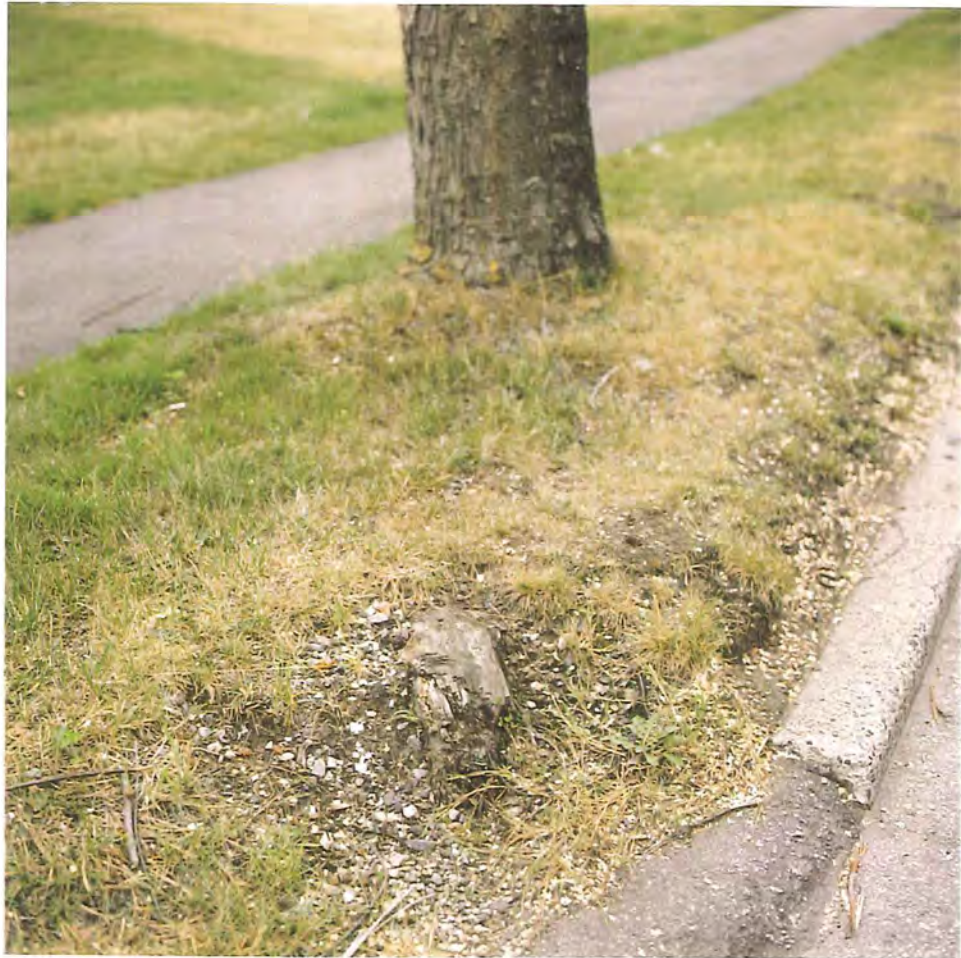
Damaged curb edges and broken root ends support the contention that road reconstruction will have negative impacts on any trees suggested for retention.

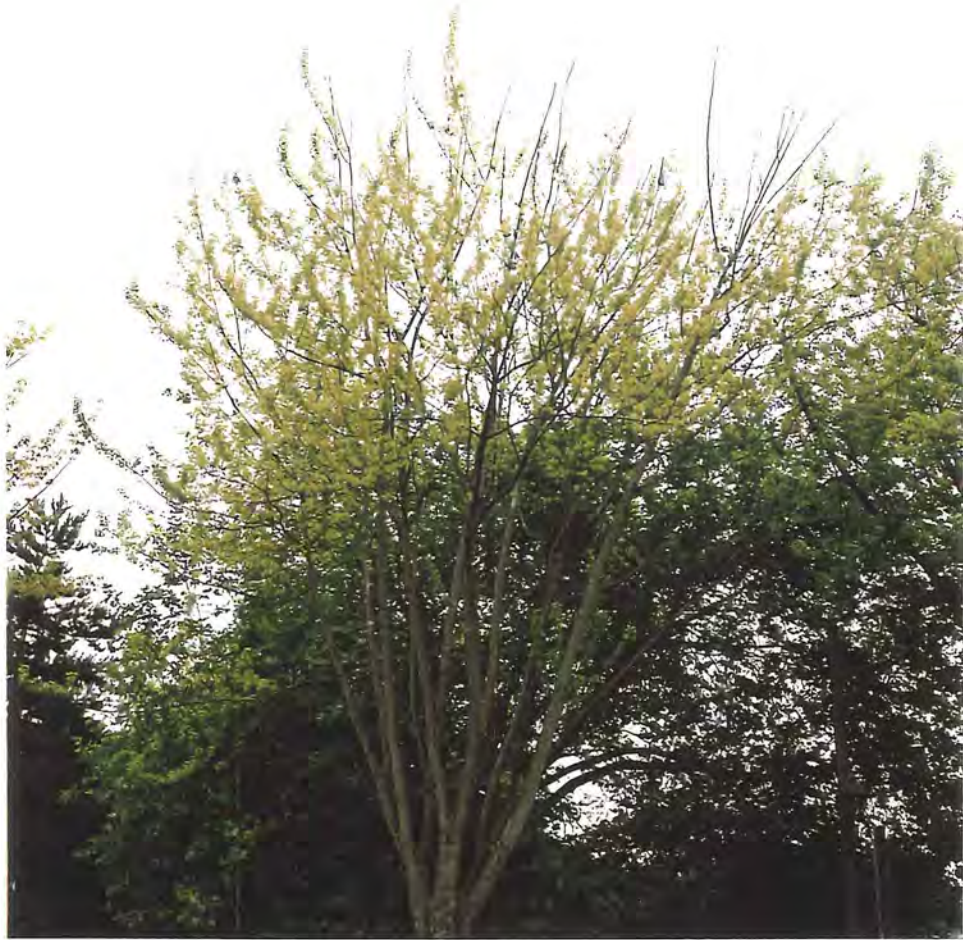
This tree close to Westbrook shows the symptoms of diminishing vigour. Many smaller branch ends are devoid of leaves and are dying back.

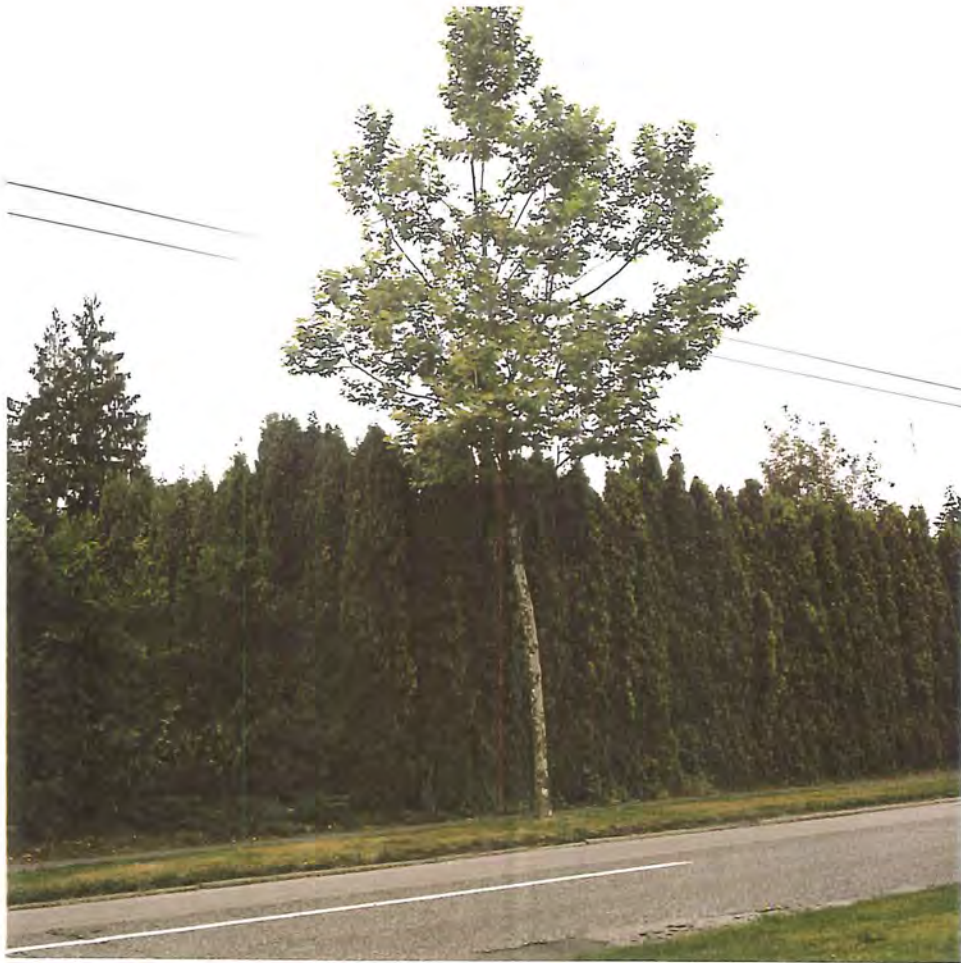
This London plane, the other species that has been planted on the Boulevard, is showing signs of being unthrifty.

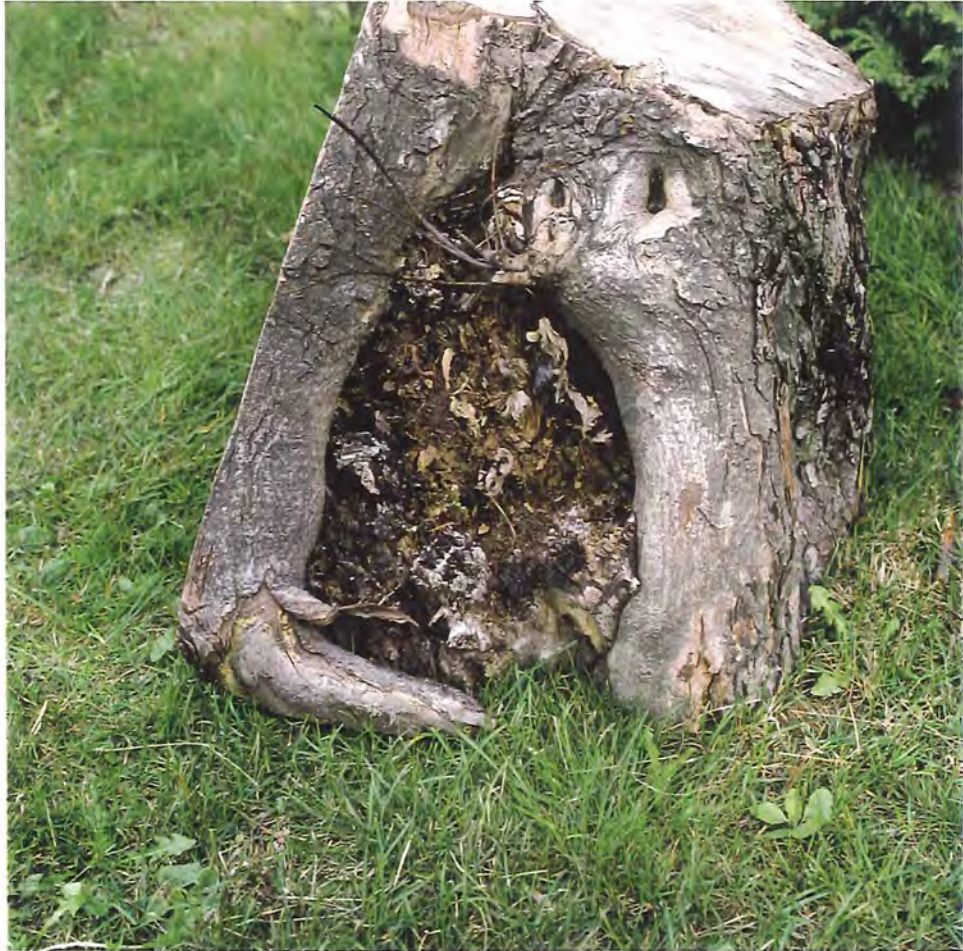
Old pruning wounds are the entry point for decay organisms. The larger the wound the more extensive the entry surface and subsequent decay column.

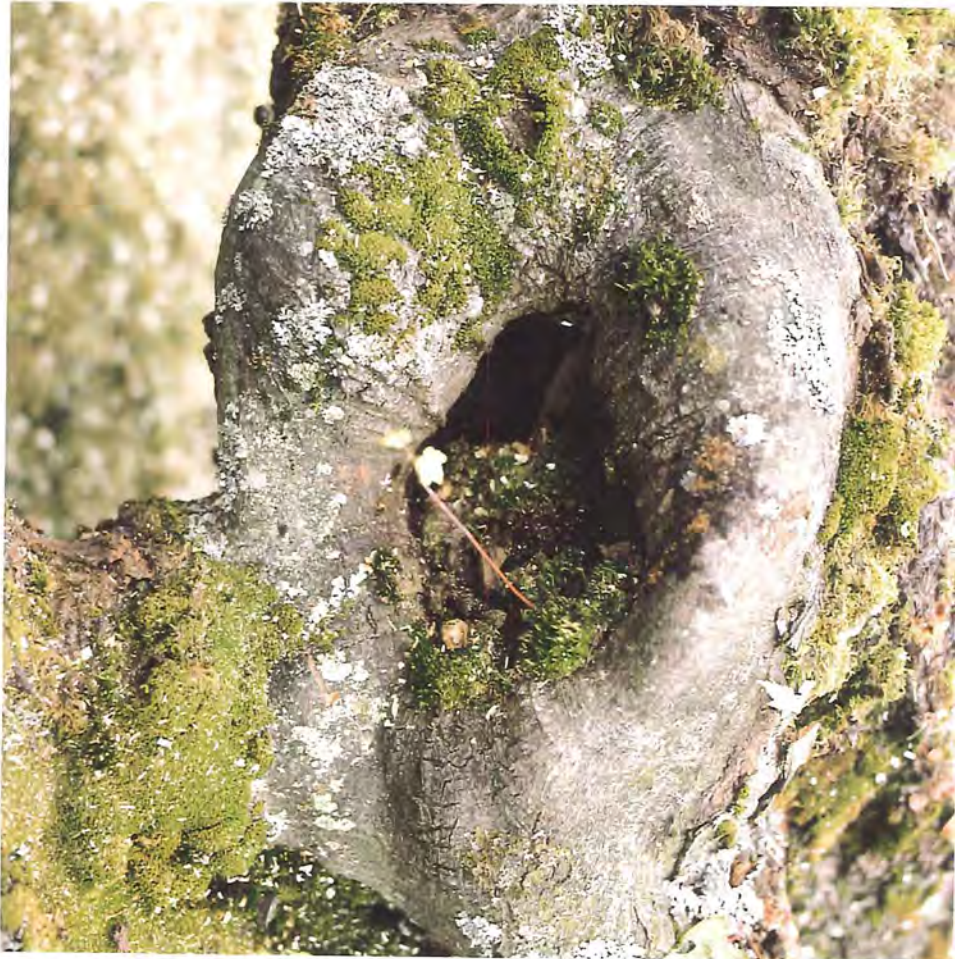
Large, partially occluded wounds almost hide entry points for decay wherever branch break or pruning occurred in the past.

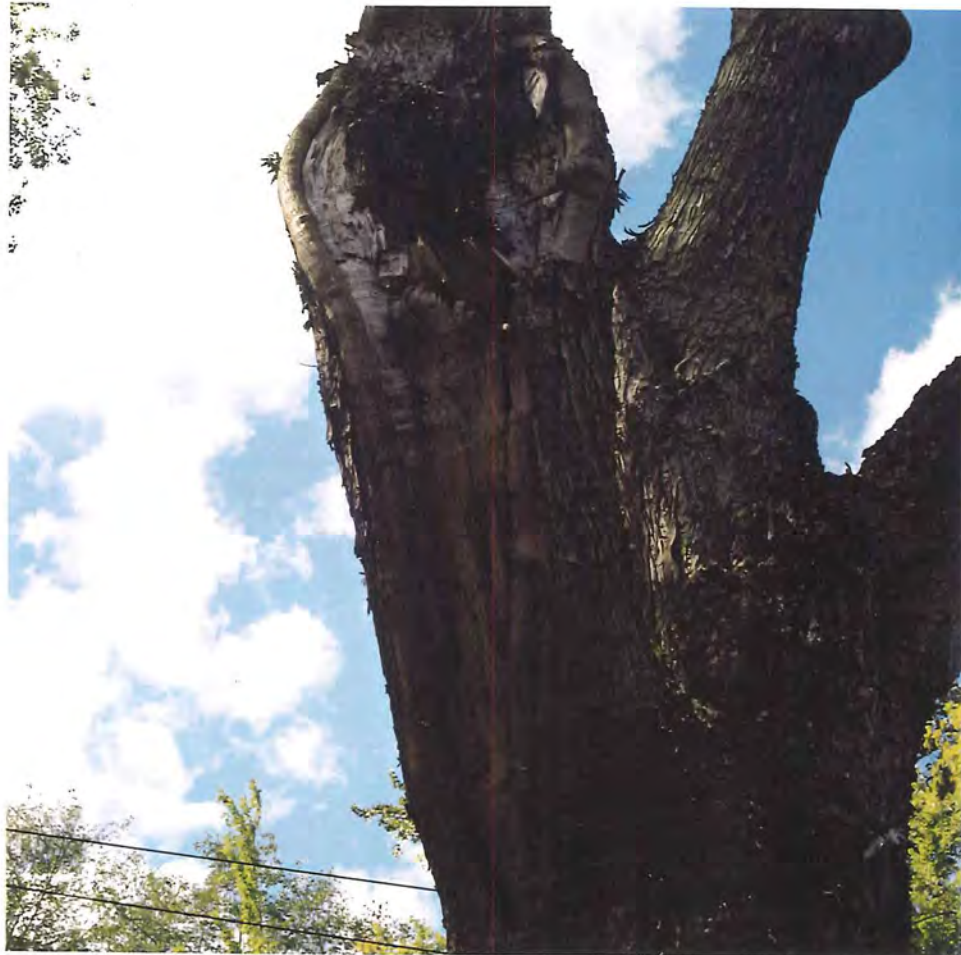
Large tear wounds like this are found on some trees. Large scaffold limbs with weak crotches allowed this large branch once attached here to fall as a jagged spear of considerable weight onto the pedestrian pathway.

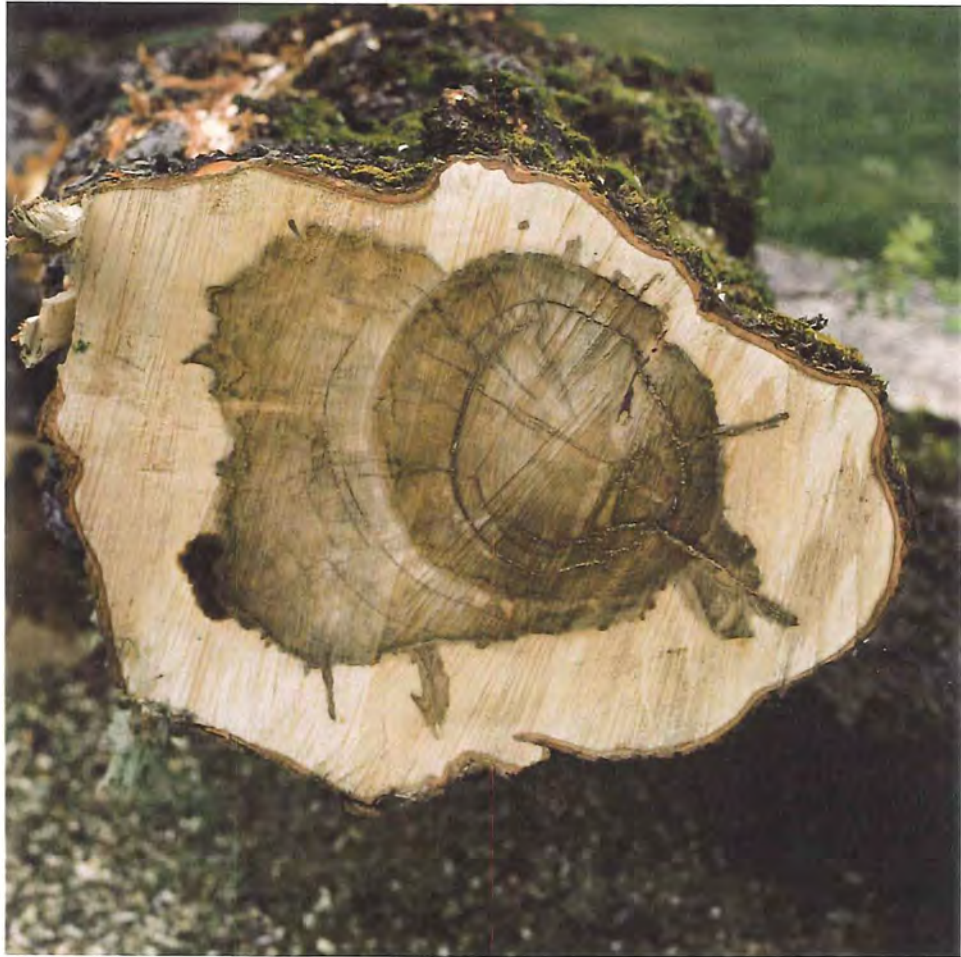
Sap stain and incipient decay is seen in most of the Silver Maple. The effect of this internal activity of tree vigour, if any, is not known. Lateral spread of this activity is weakly resisted by Silver Maple. Vertical compartmentalization is minimal.

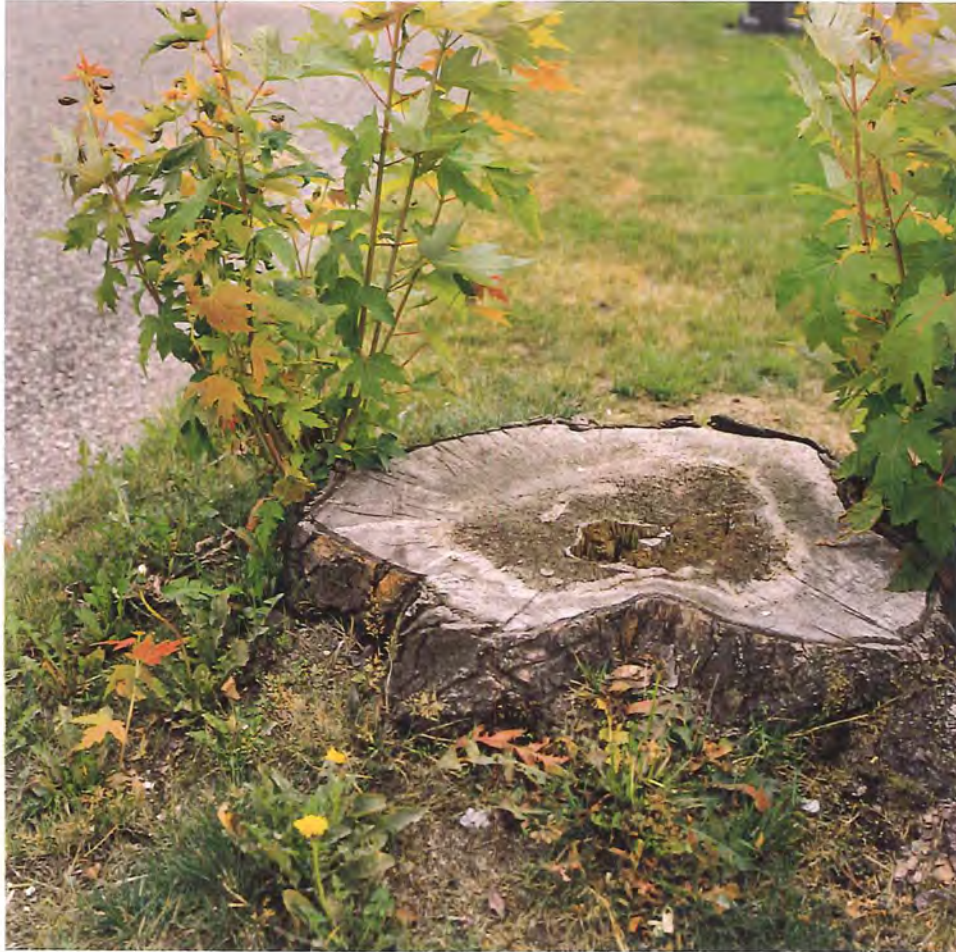
This old stump is still alive below grade. The roots are supplying sustenance to live tissue which in turn is supplying auxin levels that stimulate dormant buds. These show as sucker growth. Hard pruning of large limbs would stimulate similar poorly attached growth.

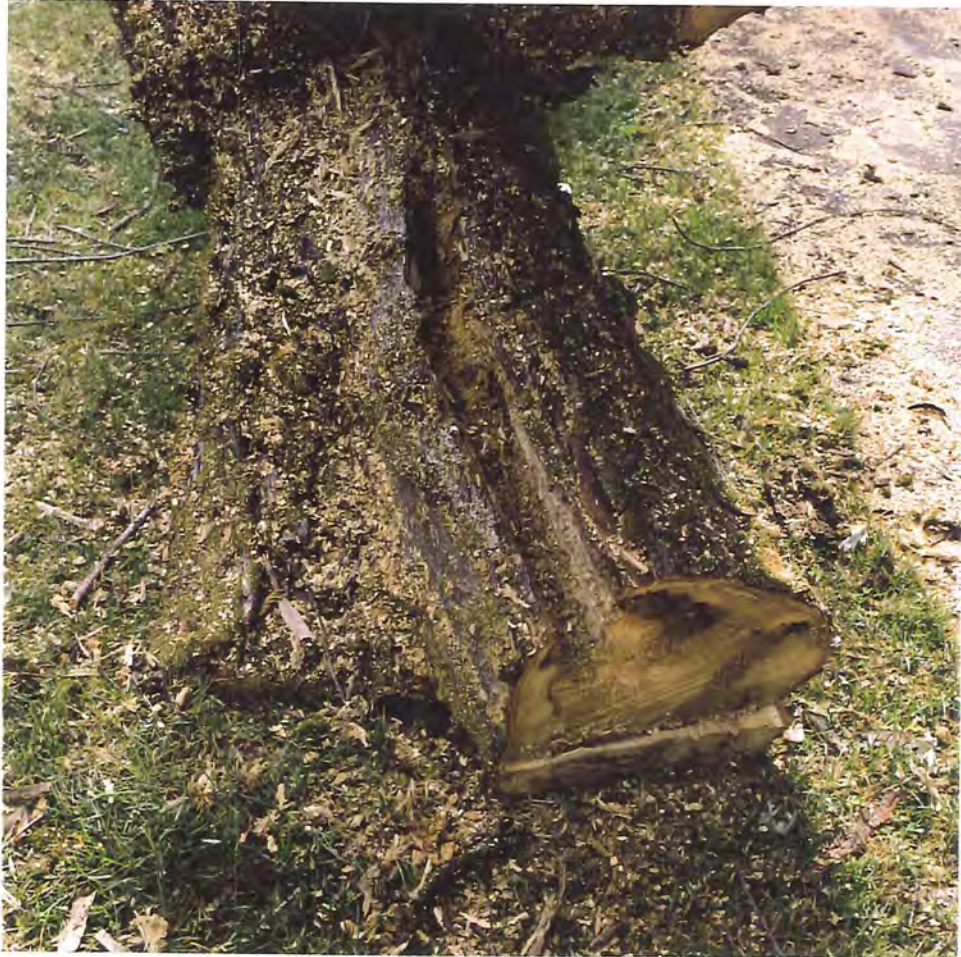
Some limbs of significant diameter show decay rifts and internal loss of structure that they present a hazard of failure under the strain of any adverse weather conditions.
