FIELD VISIT SITE REVIEW

THE HYDROLOGY AND GEOMORPHOLOGY

OF DRAINAGE BASINS

For: Dr. M.C. Roberts
By: M. R. Gardner
76290-0124

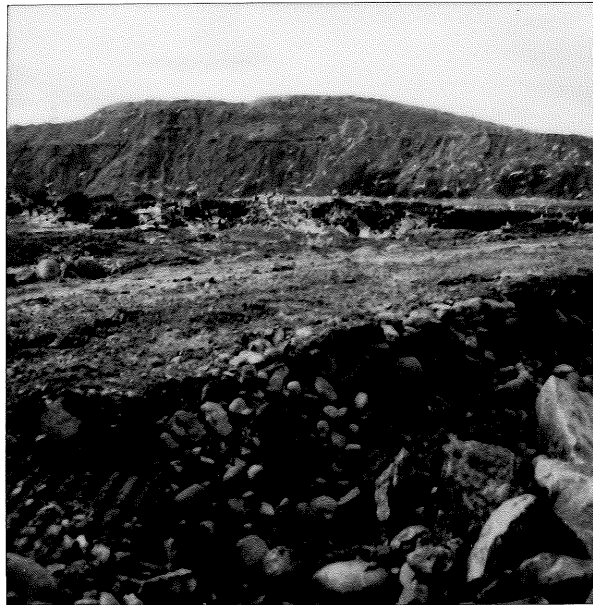
It was suggested that a 100-year flood could breach the dyke system particularly at the outside curve to the north of the site. It was apparent that the site is operated as a "dump and cover" method with solid refuse being sequentially dumped in layers which are then covered with trucked-in fill later spread with heavy construction equipment. This operation helps to compact and stabilize the dumped material. In portions of the site already filled, filling has reached a depth of approximately 150 metres. On more mature areas, where settling is largely complete, grass playing fields have been established. Methane generation is apparently accommodated with pipe collectors. Final cover depth seems to limit upworking of solid debris. The class of disposal site was not determined, however it is readily apparent that it is not suitable for liquid or toxic material disposal due to the site's proximity to Lynn Creek and the limited provision for collecting contaminated outflow from the dump.

North Vancouver disposal site with new dyke in foreground, refuse to be covered in midground and depth of piling and covering to date in the background.

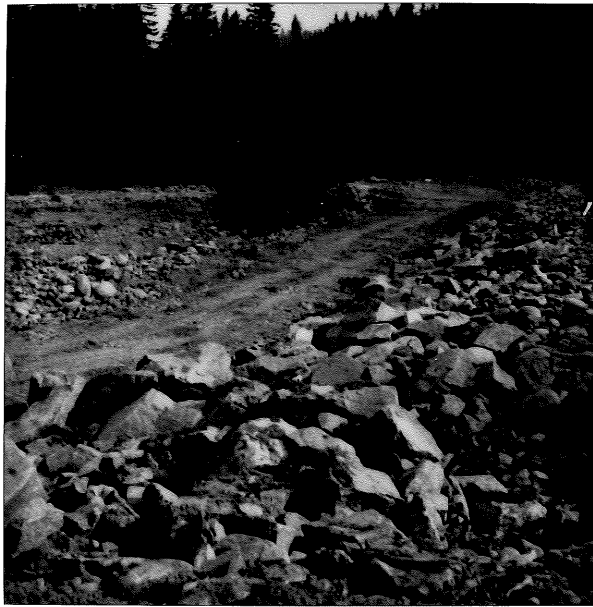
North Vancouver disposal site dyke with rock protection from Lynn Creek on the left.

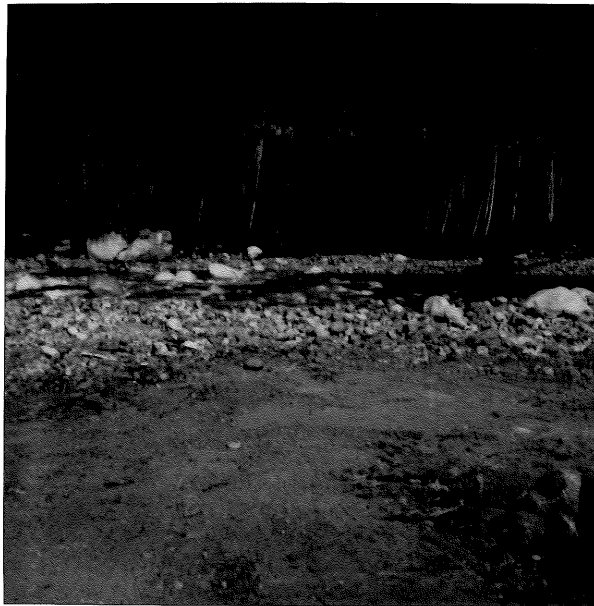
Lynn Creek river terraces from the new protective dyke.

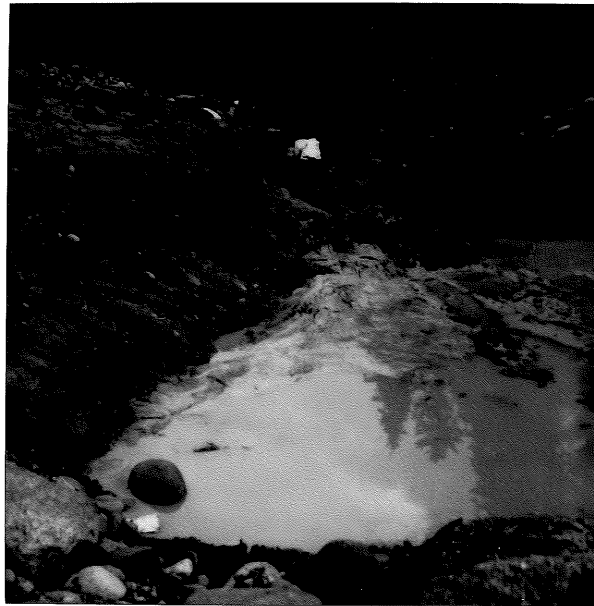
Surface water, leachate and surface erosion at the North Vancouver disposal site.

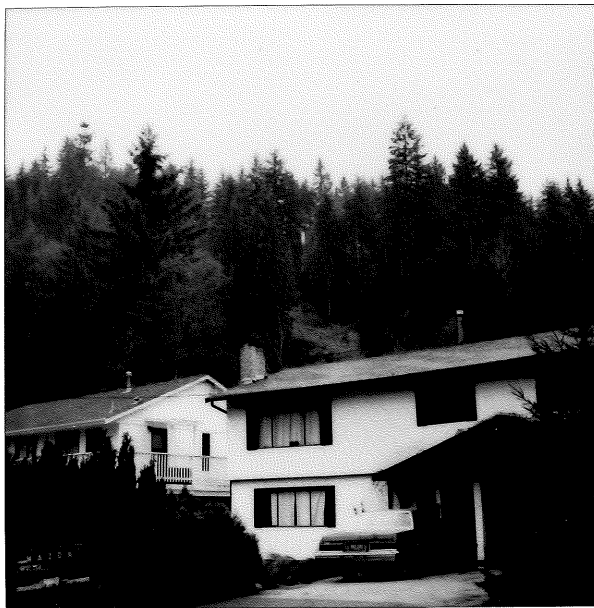
In the second portion of the stop, a silt terrace typical of the lower mainland of British Columbia was examined. Here, housing had been constructed at the toe of the slope. Previous history of the site includes a debris flow from the terraces above. Inadequate water management from above was attributed as a partial cause, the flow being triggered at a time of intense and prolonged rain causing saturation of the silt. Hazard mapping was discussed as a measure to prevent building on high-risk sites. The use of down-slope engineering solutions such as retaining walls was discounted because of cost to produce a "safe" design.

Track of debris flow behind housing on Riverside Drive.

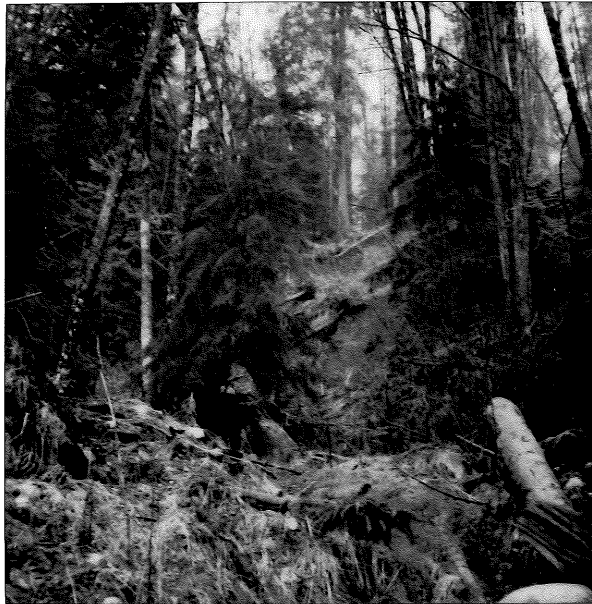
Track of small debris flow showing extent and size of trees moved toward Treetop Lane, where housing encompasses the toe of the slope.

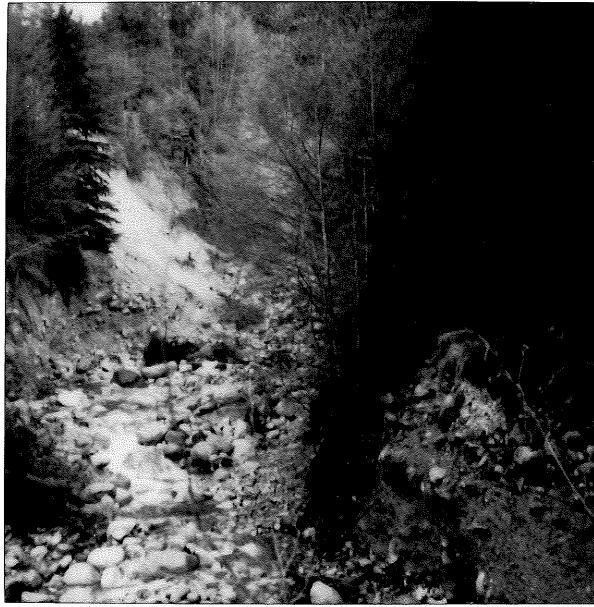
Upper reach of Mosquito Creek showing deep incision and soil profile containing rounded boulders probably of glacial origin. High energy of stream soon removes debris generated by undercutting.

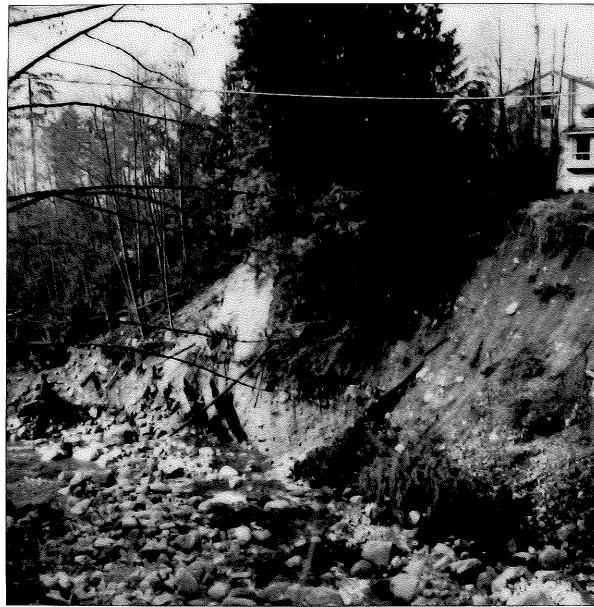
The westerly bank of Mosquito Creek, showing some undercutting and bank slippage. The river is deeply incised with little likelihood of flooding of this point.

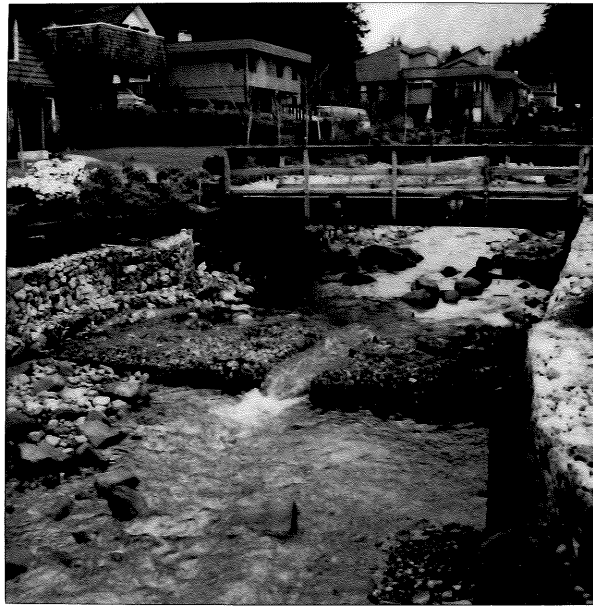
New gabion construction with cross-bar concentrator to ensure self-cleaning and to minimize stagnant water at low flows.

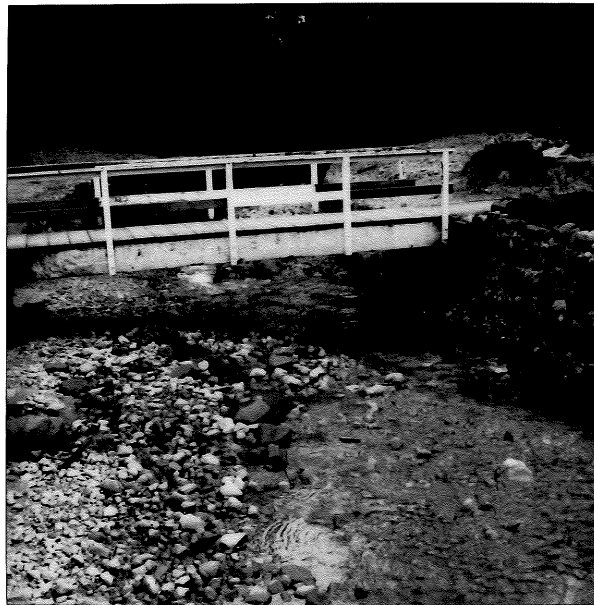
Observations made concerning the new channel included the very narrow mouth below the site where the gabions finished, giving rise to a possible construction that could cause a backup into the subdivision, an apparent attempt to concentrate low flows for sanitary, aesthetic and silt removal purposes and the low level that the property driveway bridges were set at into the stream channel, where they would act as partial dams to river flow in flood conditions.

Bridge construction for property access intrudes into stream channel and will act as a partial dam at high flows. Design could be improved fairly simply.

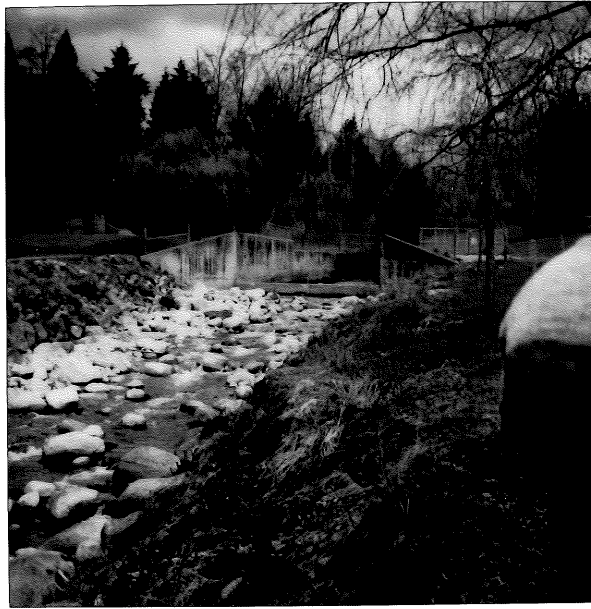
Outfall of lower Mosquito Creek tunnel shows wings, safety fence and energy dissipator. Stream banks are kept clean to provide unimpeded flow.

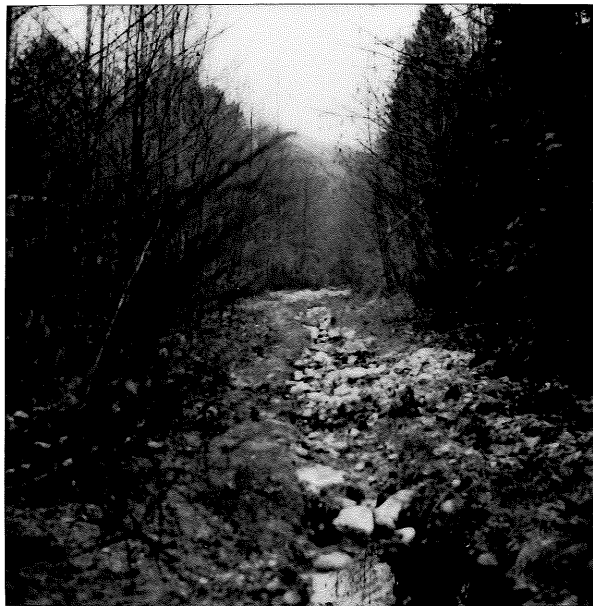
First order tributary streams with no access to Mosquito Creek are now cutting down the old channel toward the underground concrete casement.

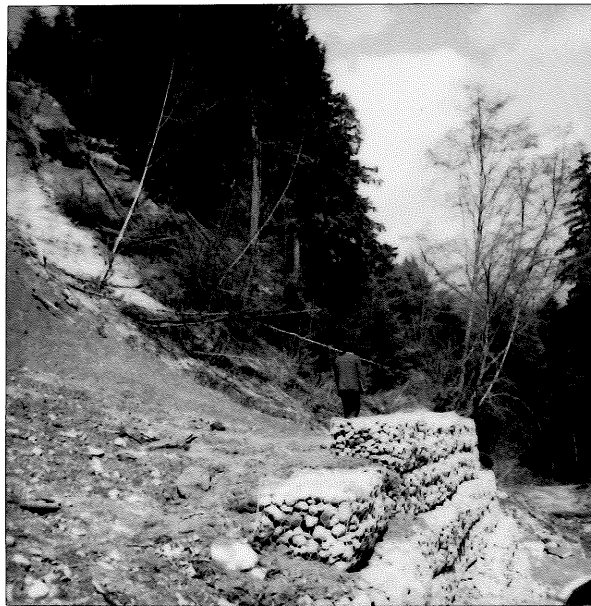
New clearing on Rabbit Lane has been followed by slumping now kept back by gabions. Little extra protection is afforded but the angle of repose for the lower slope may have been reached although it can be recharged from above.

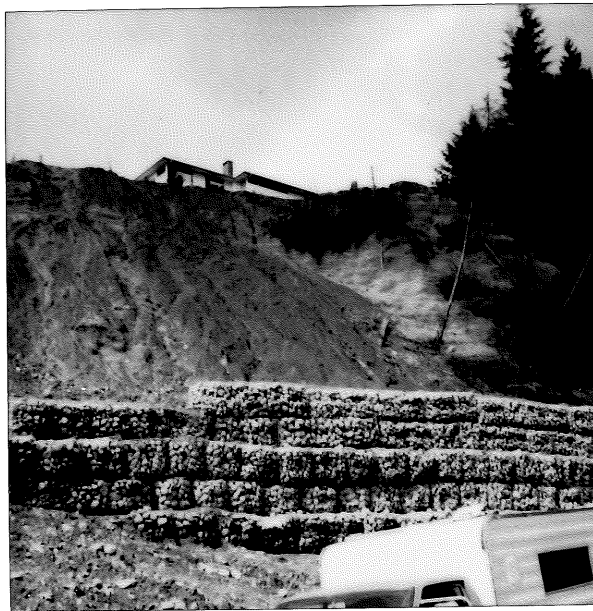
The proximity of housing to the edge on this silty terrace is becoming of concern particularly since no apparent measures have been made to protect the slope from erosion. New gullies can be seen caused by surface water from above.

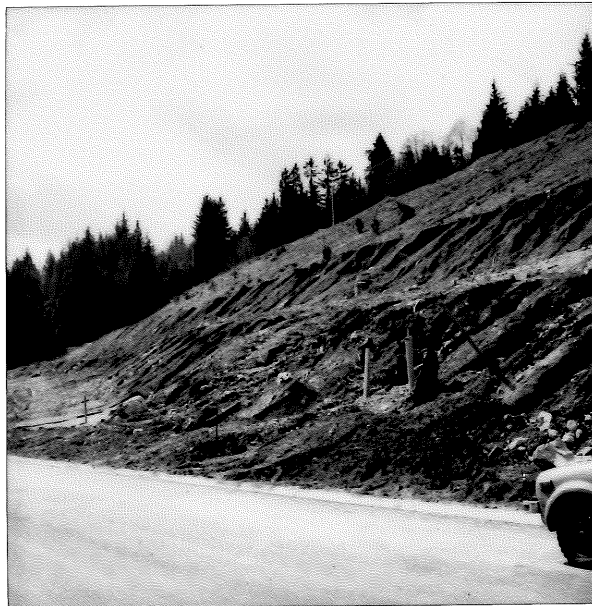
The extent of the cleared area at Rabbit Lane is evident as too are the many rills and gullies caused by surface water movement.

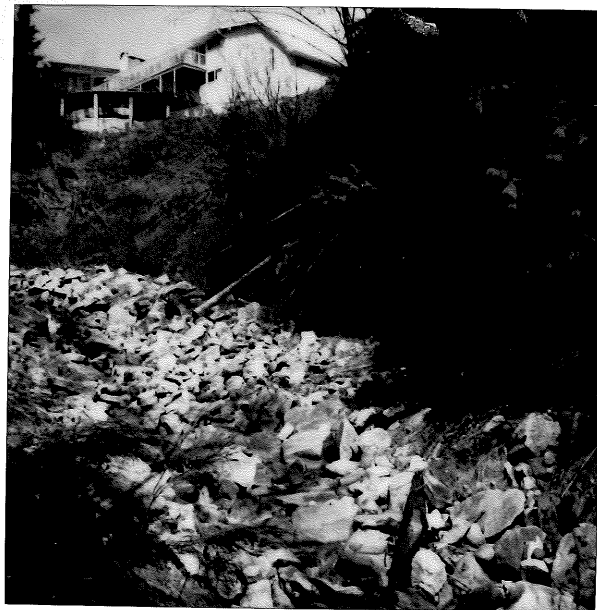
The second aspect viewed was that of Brothers Creek, a tributary to the Capilano River. Since this river is continuing to lower its channel bed, feeder streams are being rejuvenated. In turn, these are becoming steep and, where the sinuosity, bank or bed conditions allow, are cutting rapidly. In the most apparent reflection of this, an outside bend below a large swimming pool had been eroded. Some rip-rap armouring had been undertaken in concert with rechanneling the river. The previously eroding bank below the swimming pool was now stable but no attempt had been made in revegetation. The height of flood was evident from debarking of streambank trees and would indicate very substantial flows in peak conditions, suggesting the measures taken so far will provide only temporary and possibly misleading security.

The support columns and wall for the swimming pool adjacent to this house are seen above Brothers Creek. Continued undercutting by the creek has been temporarily prevented by rechanneling and armoury of the creek bank particularly on the outside of the curve top left.
