THE CITY OF VANCOUVER BOULEVARD TREE PROGRAM

HISTORY, ANALYSIS AND
RECOMMENDATIONS FOR MANAGEMENT

VOLUME III PHOTOGRAPHS

M. R. Gardner
1980

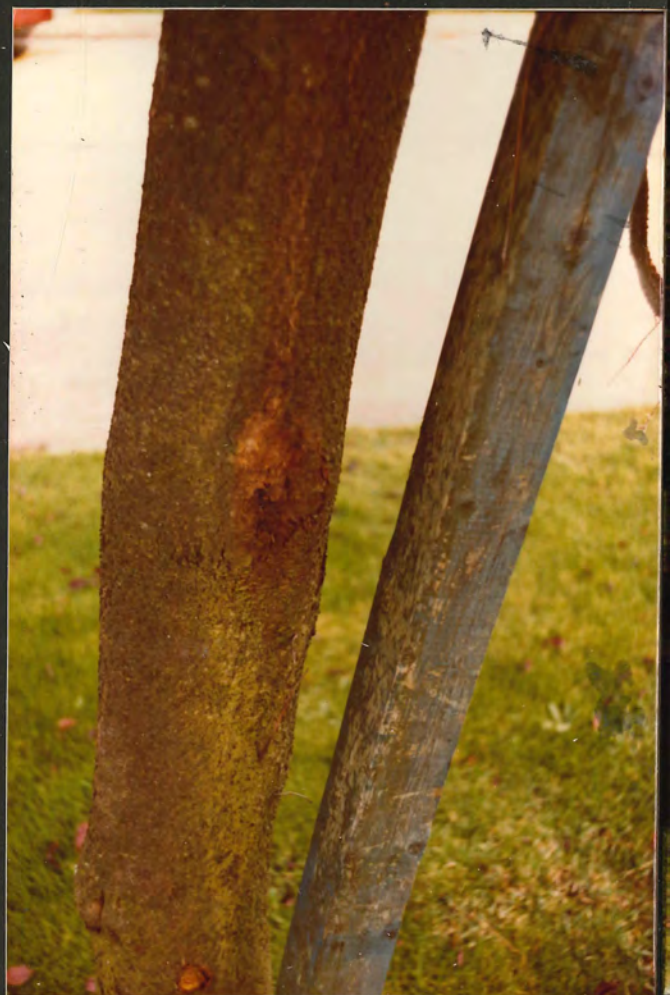
WITHOUT A SMALL TREE MAINTEN-
ANCE GROUP, MANY TREES GO
WITHOUT INSPECTION FOR A CON-
SIDERABLE SPAN OF YEARS.
HERE, AN OLD STAKE LONG SINCE
BROKEN HAS CONTINUED TO WOUND
THE TRUNK.

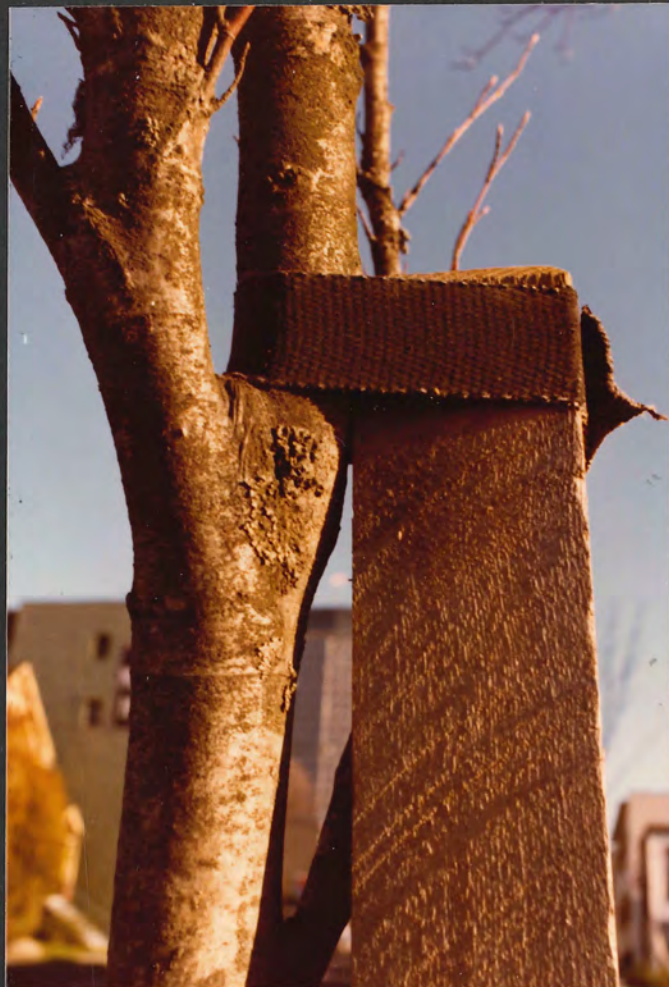
ABOVE: DESPITE AN ATTEMPT TO TIE TREES TO PREVENT WIND DAMAGE THE CONSTANT ROCKING MOTION WITH THE POST AS A FULCRUM SOON DAMAGES THE TREES SEVERELY.

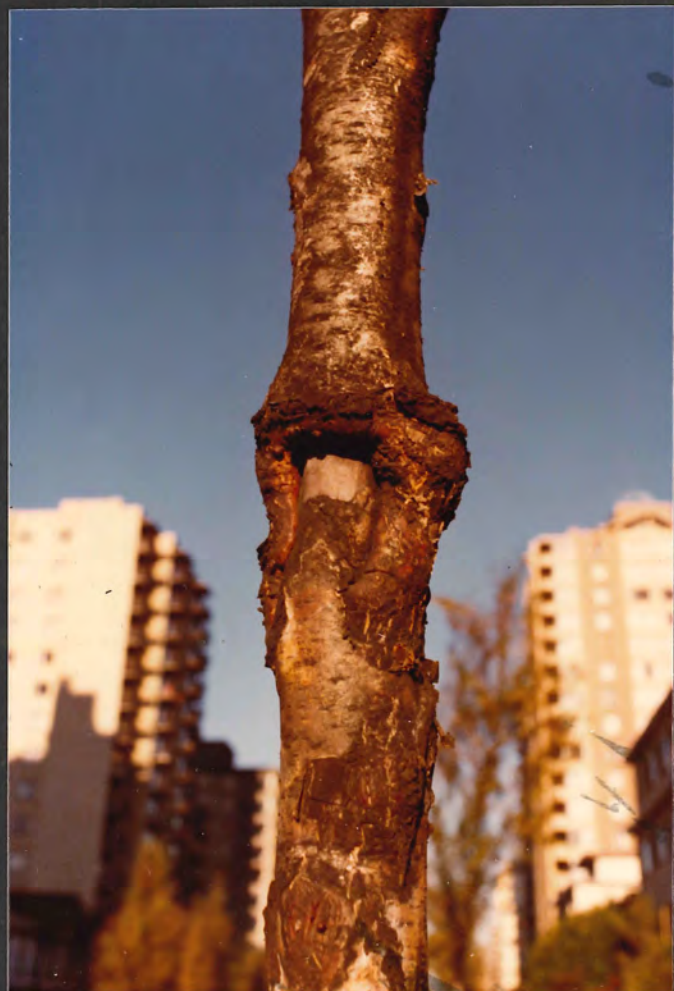
BELOW: THIS STEM DAMAGE WILL TAKE MANY YEARS TO HEAL AND IN THE MEANTIME PREDISPOSES THE TREE TO VANDALISM, WINDBREAK, INSECTS AND DISEASE. THE DAMAGE IS COMMON TO A VERY LARGE NUMBER OF SMALL TREES IN VANCOUVER.

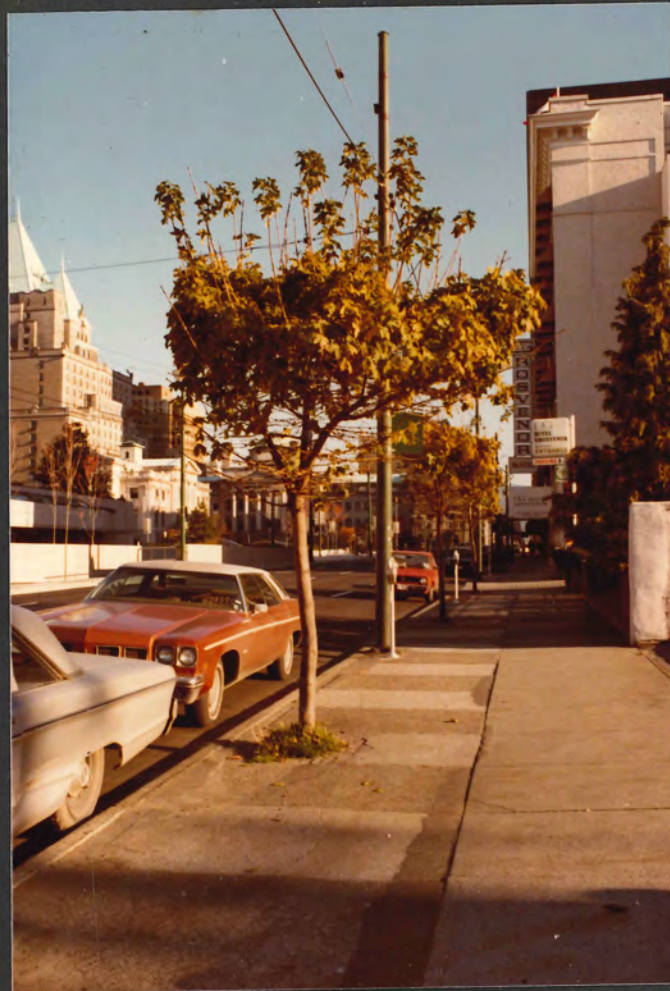
ABOVE: REPETITIVE HAND PRUNING TO CONTAIN THE CROWN OF THIS MAPLE BELOW TROLLEY WIRES CAUSES RAPID SUCKER REGROWTH.

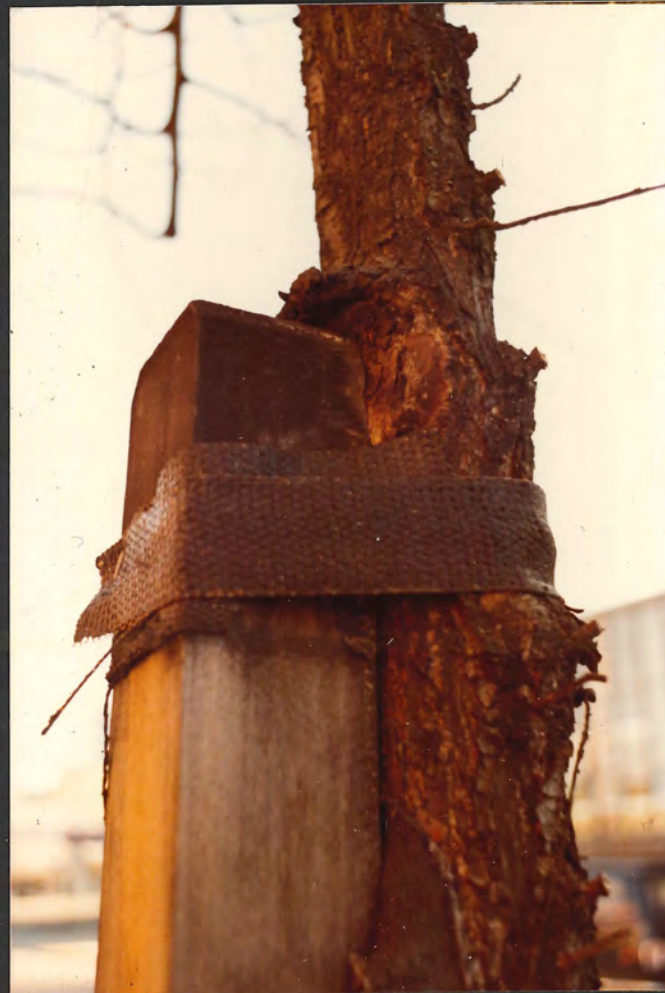
BELOW: THE CONTINUED PRACTICE OF TAPING TREES TO STAKES INSTEAD OF USING PROPER TREE TIES IS DAMAGING A HIGH PERCENTAGE OF YOUNG TREES IN THE CITY.

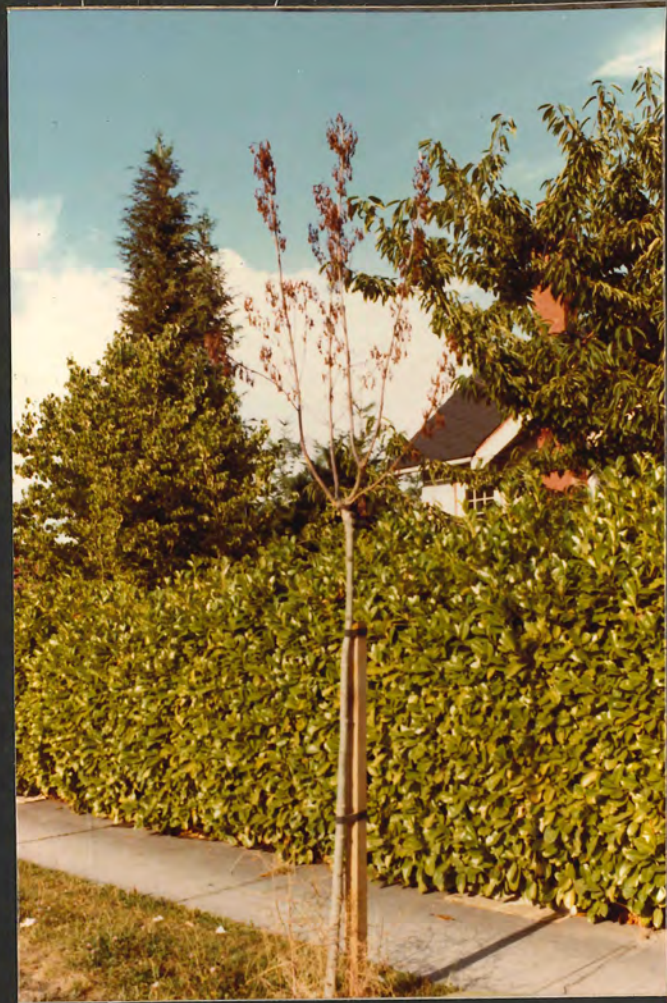
LACK OF SUMMER WATERING CAUSED
THE MORTALITY OF THESE TREES.
THE PROBABLE LOSS IN 1978 MAY
HAVE BEEN AS HIGH AS 2,000
TREES WITH A PLANTED VALUE OF
BETWEEN \$100,000 and \$200,000.

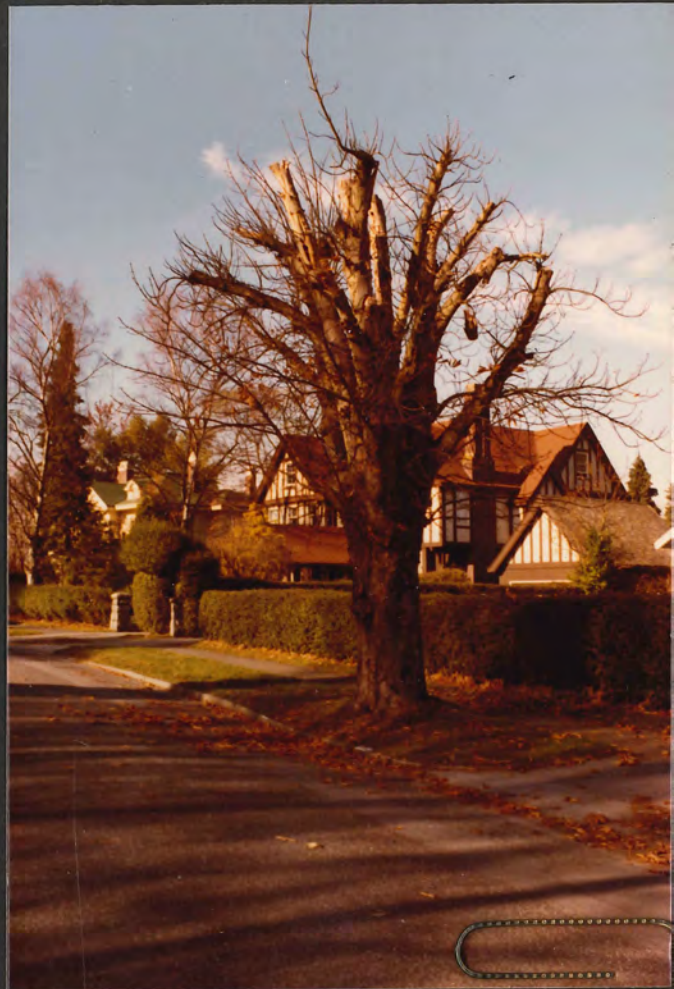
ABOVE: THIS BUTCHERED PLANE TREE IN A RESIDENTIAL PART OF THE CITY - THE CRESCENT - DOES NOTHING TO ENDEAR THE PRESENT PROGRAM TO CITIZENS WHO TAKE PRIDE IN THEIR OWN PROPERTY.

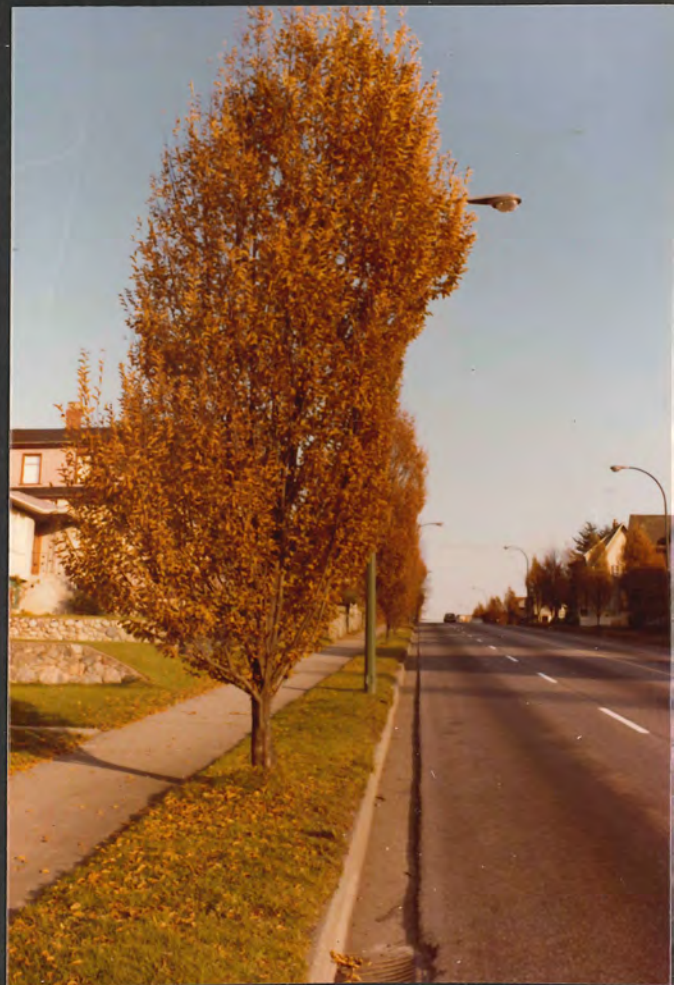
BELOW: THE HORNBEAM IS WELL SUITED TO THE SITE BUT IS STILL IN NEED OF MAINTENANCE. PRESENT PRUNING RELIES ON TRAFFIC ALONE TO SHEAR THE STREET-SIDE BRANCHES. LATER THE TREE WILL BECOME UNBALANCED IN APPEARANCE.

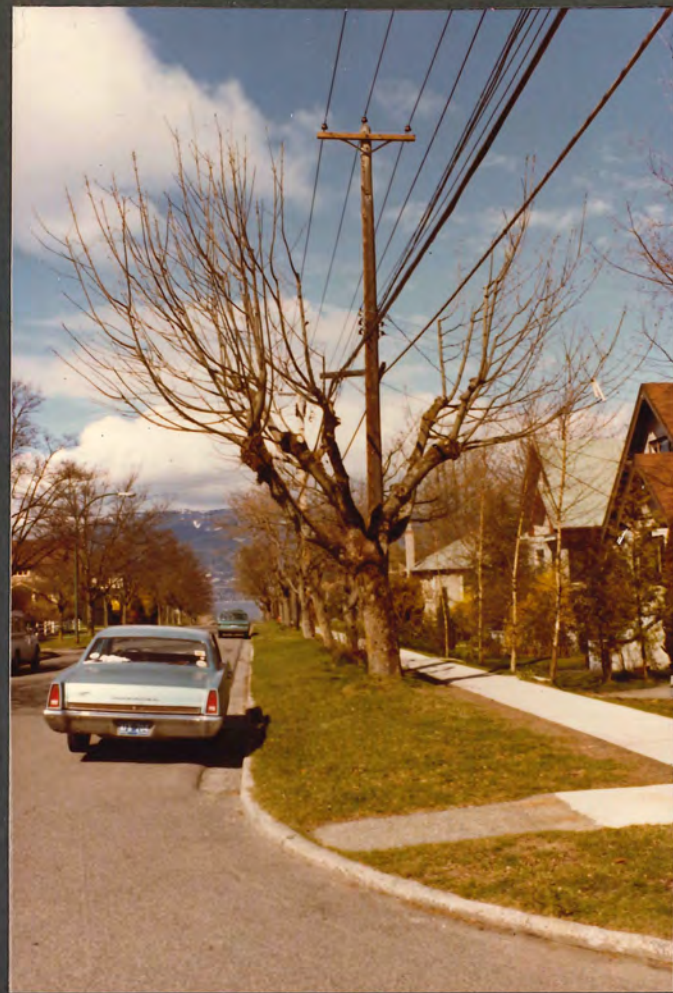
ABOVE: THIS TUNNEL PRUNING, ALTHOUGH PROVIDING CLEARANCES FOR THE AERIAL UTILITIES, PRODUCES A COSTLY AND UNSIGHTLY TREE TO MAINTAIN. REMOVAL OF THE WIRES TO BACK LANES OR REPLACEMENT OF THESE TREES WITH SMALLER NARROW CROWNED TREES MAY BE A SOLUTION.

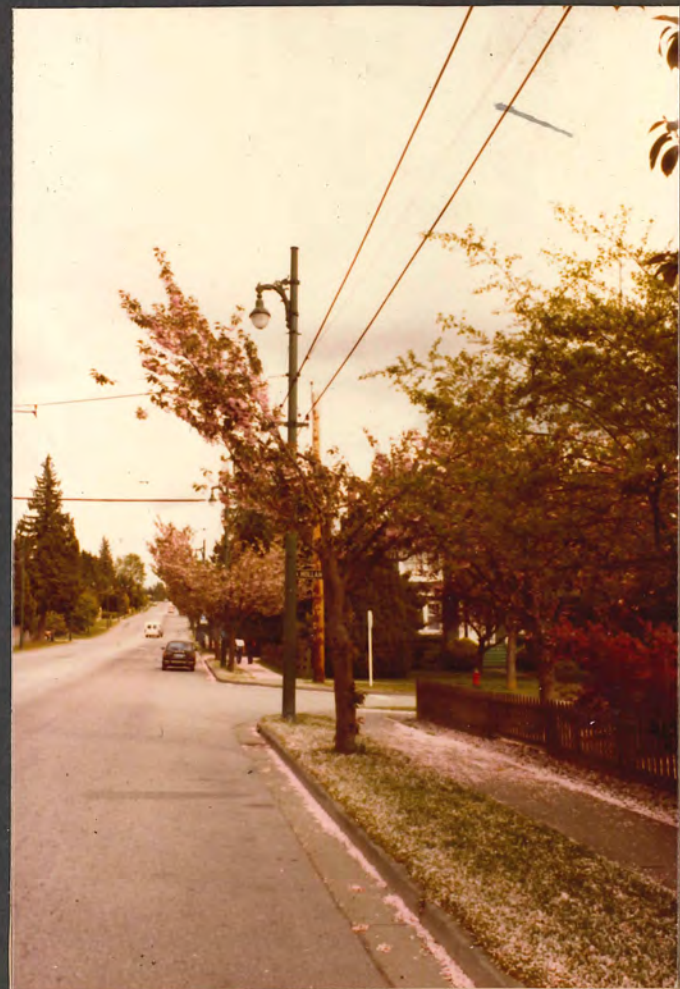
BELOW: THE CHERRY IN THE MIDDLE GROUND HAS HAD THE CENTRE REMOVED FOR THE TROLLY LINE FEEDER. THE TREE IS NOW PROBABLY UNSAFE AS WELL AS BEING UNSIGHTLY.

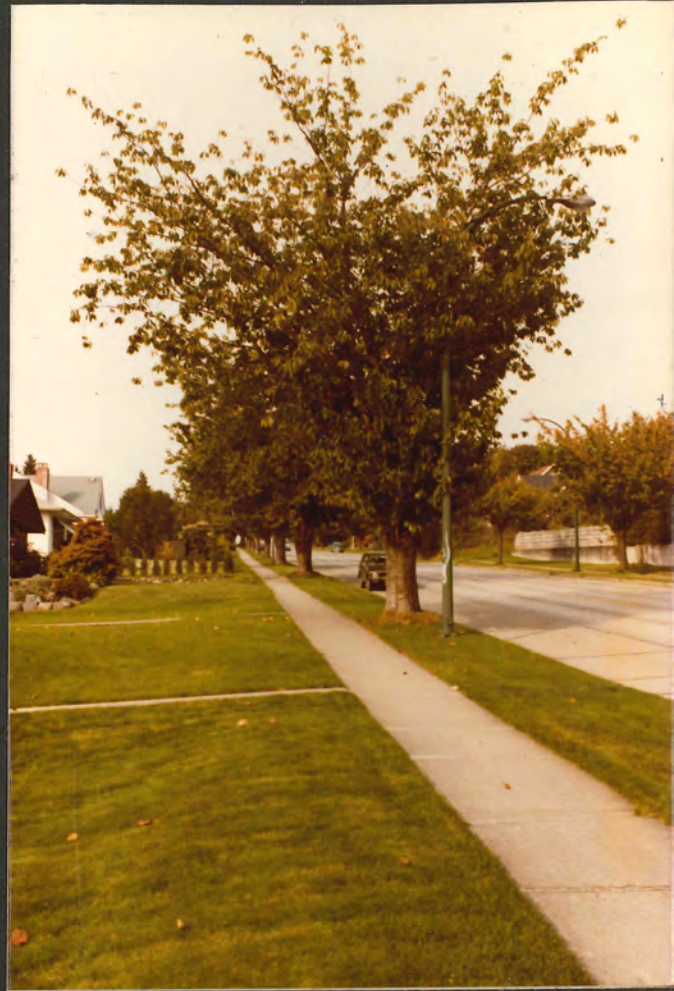
ABOVE: HYDRO PRUNING HAS MUTILATED MANY TREES IN THE CITY AND IS A CONSTANT COST BORNE BY ALL RESIDENTS. A CONCERTED PROGRAM OF REMOVAL AND REPLACEMENT WITH COMPATIBLE TREES, COUPLED WITH UNDERGROUNDING OR BACKLANING UTILITIES, IS NECESSARY.

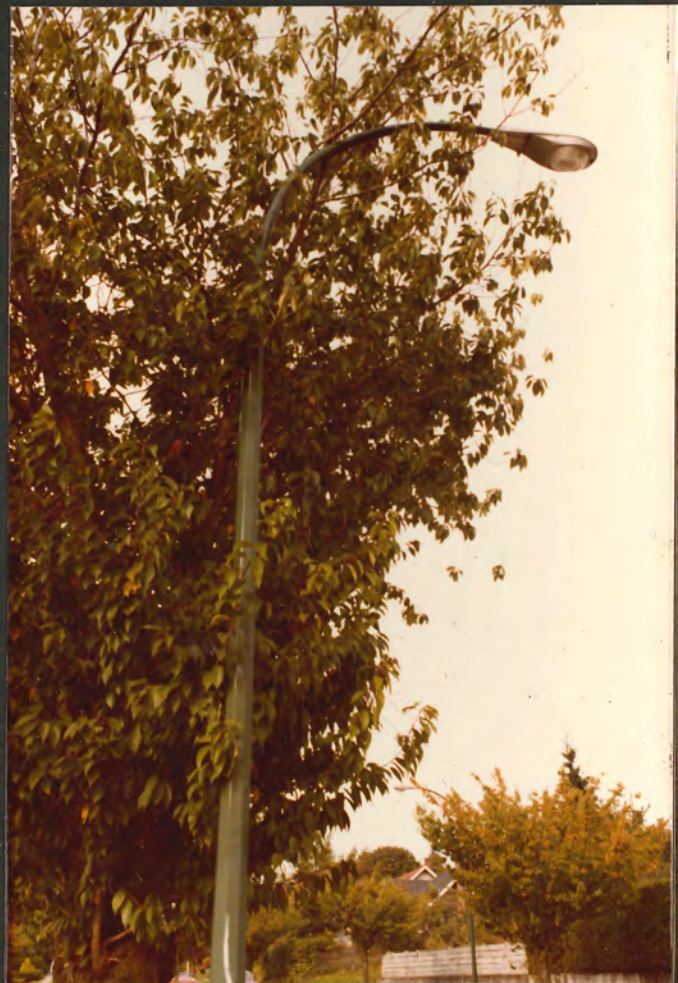
BELOW: CONFLICTING CROWNS ARE EVIDENT WHERE HOMEOWNERS HAVE NEGLECTED PRUNING OF THEIR OWN TREES. THE CITY SHOULD SERVE NOTICE ON SUCH HOMEOWNERS THAT ENCROACHMENT TO THE DETRIMENT OF BOULEVARD TREES IS NOT ACCEPTABLE.

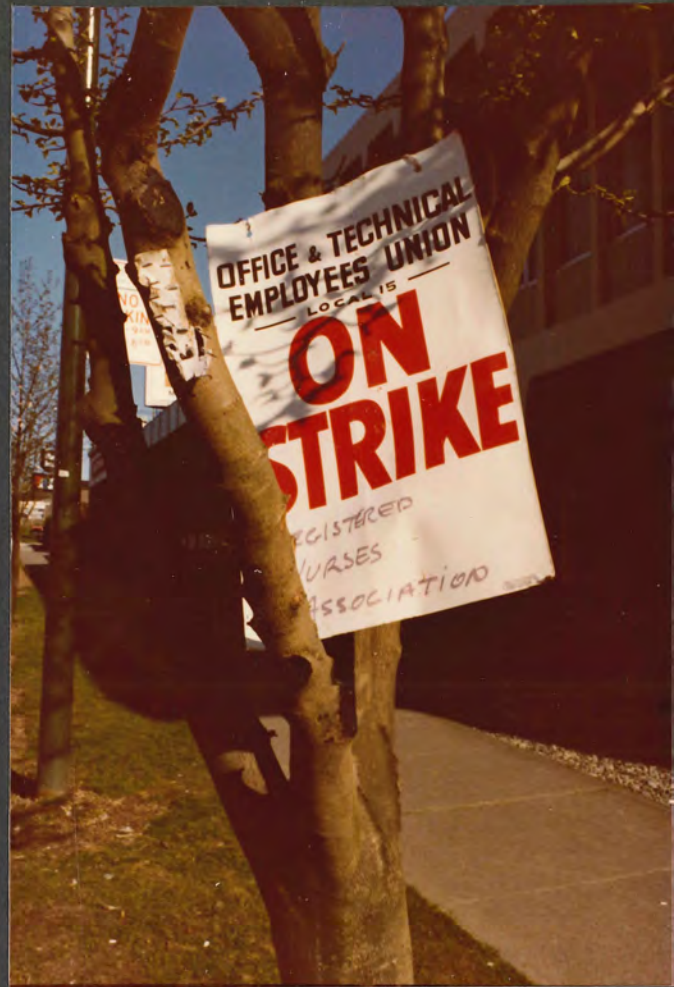
ABOVE: WITHOUT ADEQUATE BY-LAW PROTECTION, TREES ARE EASILY DAMAGED BY THOUGHTLESS USE AS SIGN POSTS. CLOSE INSPECTION REVEALED THIS TREE TO BE FULL OF METAL CONSTRUCTION STAPLES.

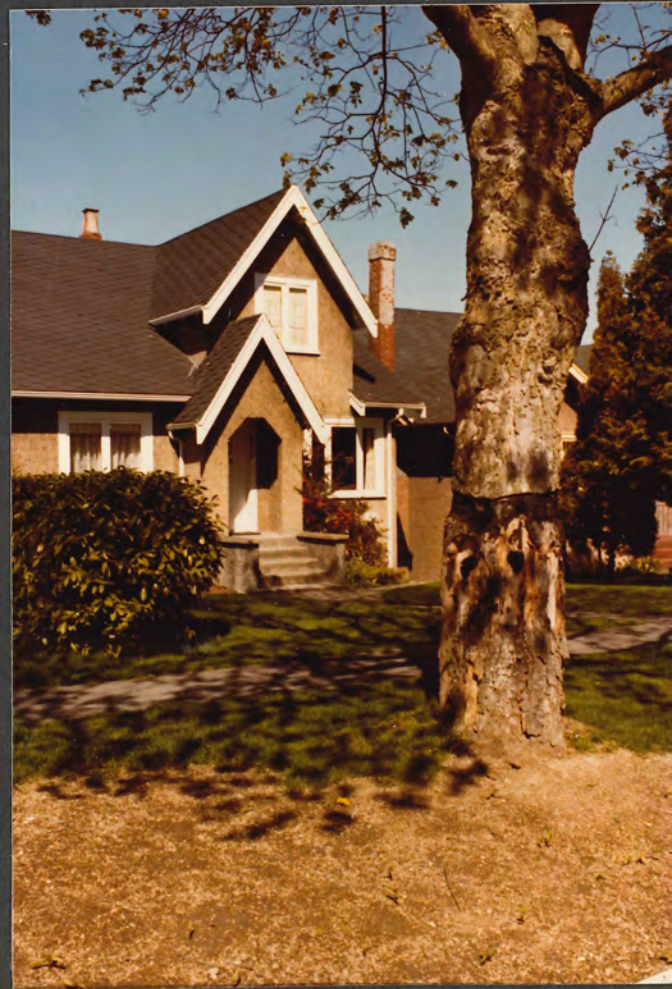
BELOW: ANOTHER EXAMPLE OF ADULT VANDALISM, THIS TIME BECAUSE THE TREE DROPPED A CONSIDERABLE NUMBER OF LEAVES ON THE ADJOINING LAWN.

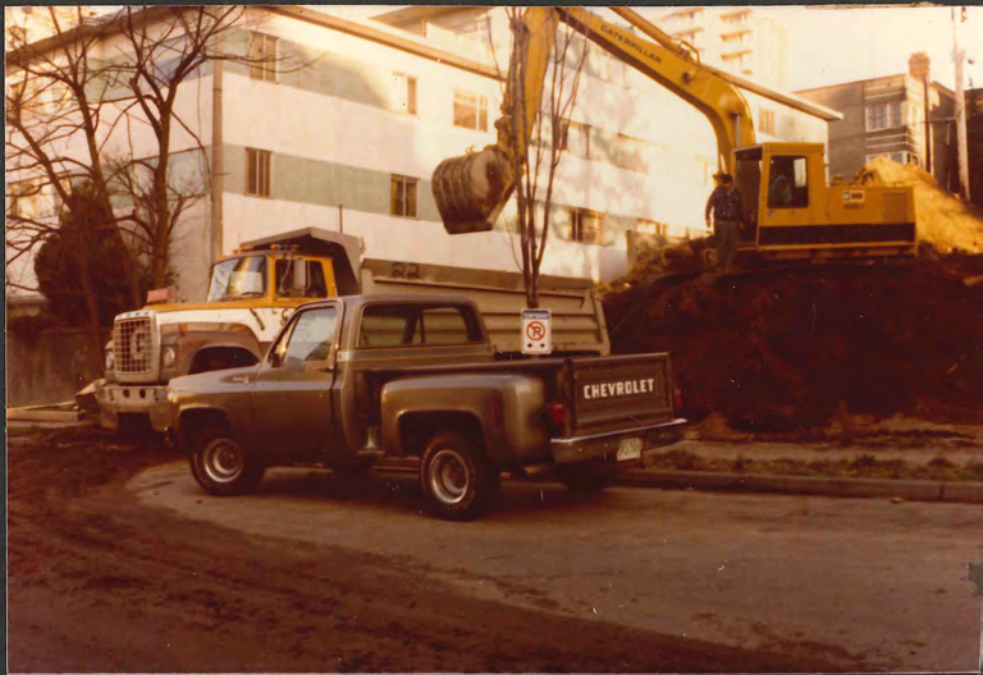
CONSTRUCTION BY CITY CREWS FOR A ROAD WIDENING AND CURBING PROGRAM CUT THE ROOTS OF THIS TREE ALLOWING IT TO FALL ACROSS THE ROADWAY AND ONTO A SMALL PRIVATE CAR.

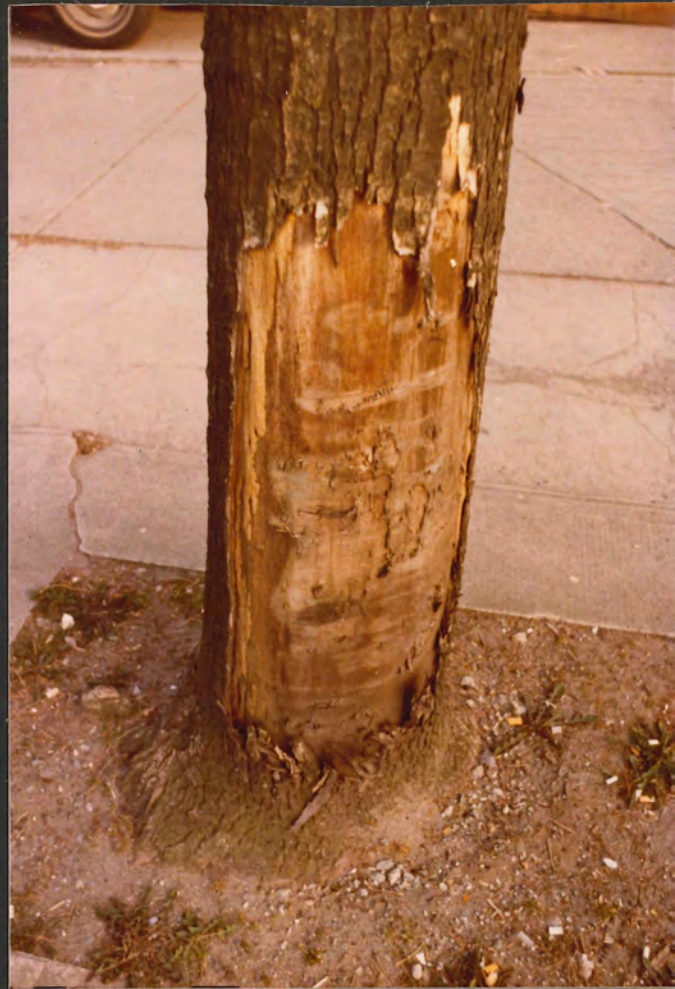
ABOVE: ALTHOUGH GIVEN SOME TREATMENT THE SIZE OF THIS CAVITY ON A SPECIES SUCH AS CATALPO MAY MAKE THE TREE STRUCTURALLY UNSAFE. REMOVAL WILL BE REQUIRED IF ANY INDICATION OF STEM SPLITS APPEAR.

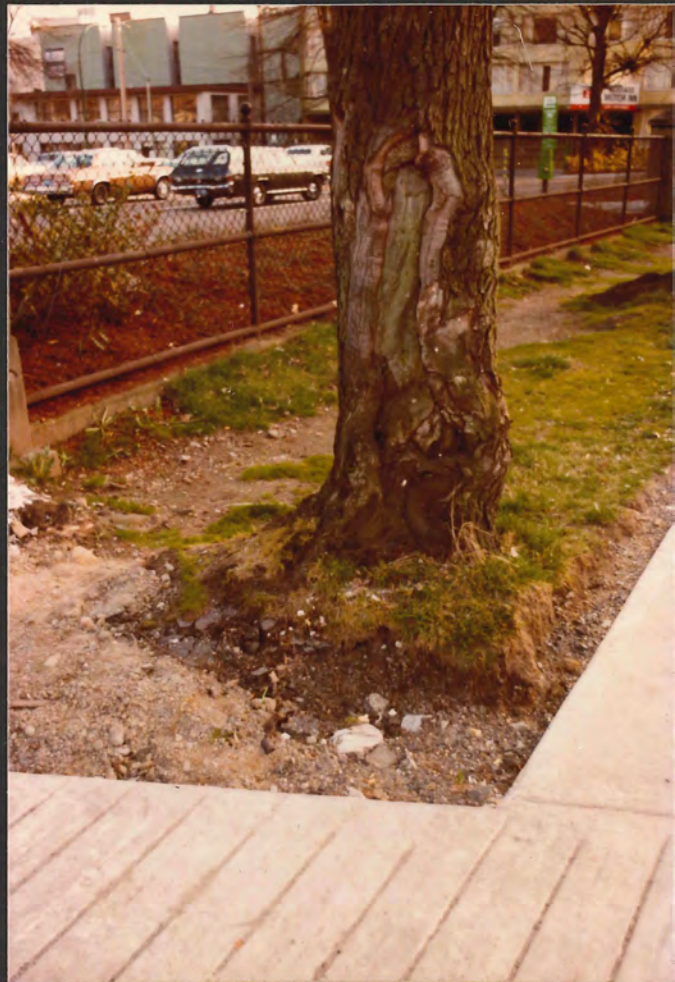
BELOW: THIS LARGE WOUND HAS TRIED TO HEAL BUT DID NOT DO SO BEFORE THE TREE BROKE. REPLACEMENT OF THE SPECIMEN IS REQUIRED.

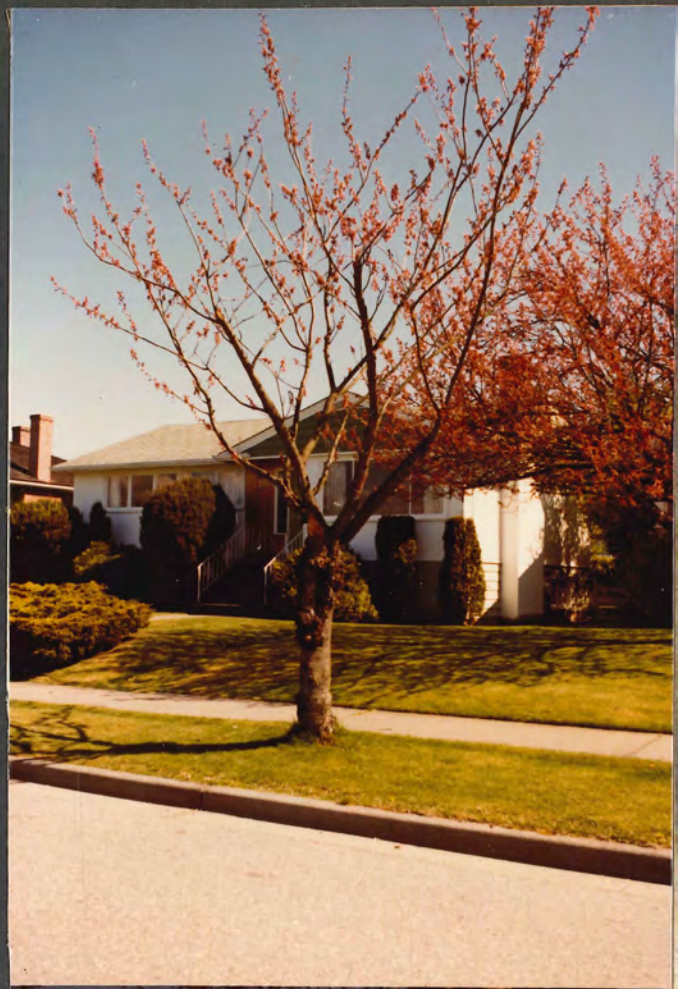
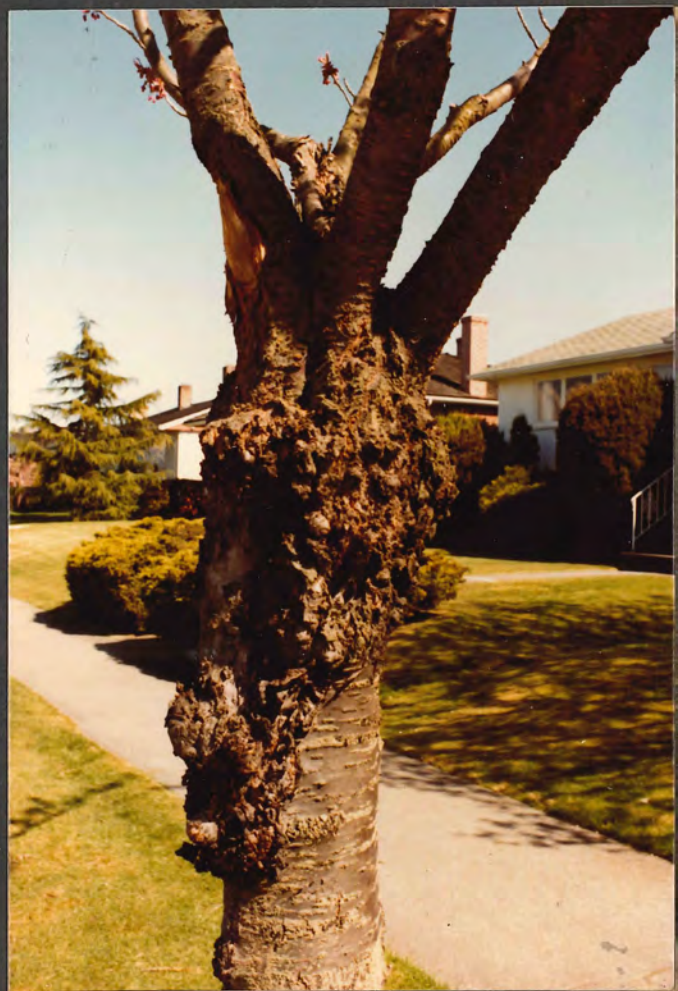
AT A DISTANCE THIS CHERRY APPEARS
IN GOOD HEALTH. HOWEVER, CLOSER
INSPECTION SHOWS DEADWOOD AND
PROLIFIC CANKEROUS GROWTH THAT
WILL GRADUALLY REDUCE THE VIGOR
OF THE TREE UNTIL IT DIES.

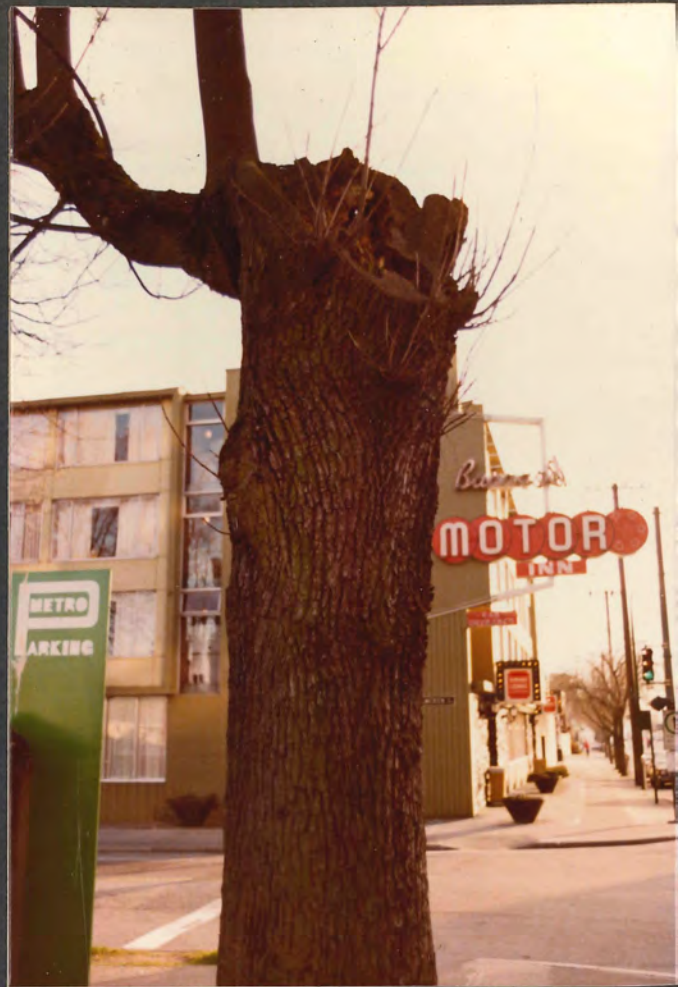
ABOVE: SEVERE PRUNING IN THE PAST HAS LEFT SOME TREES WITH LARGE CAVITIES. THESE TREES ARE NOW MISSHAPEN AND POSSIBLY UNSAFE. A THOROUGH TREE INVENTORY WOULD IDENTIFY THESE TREES AND PERMIT A REPLACEMENT PROGRAM TO BE PROPERLY PLANNED.

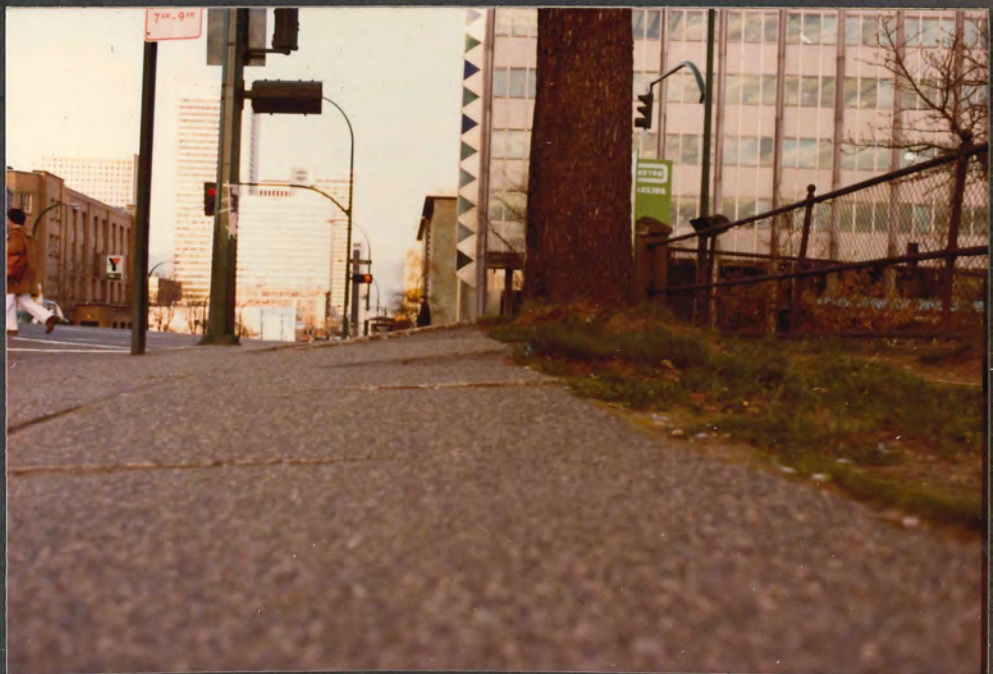
BELOW: SOME OLDER MATURE TREES HAVE NOW OUTGROWN THE CONSTRAINTS OF THEIR ORIGINAL PLANTING PLACE CAUSING EXPENSIVE AND POSSIBLY HAZARDOUS STREET CONDITIONS. TO DATE NO PROGRAM EXISTS TO LOCATE THESE SITUATIONS.
