X NORTHFIELD SUBSTATION

PRODUCTION DEPARTMENT -- VANCOUVER ISLAND

X SITE APPEARANCE IMPROVEMENT PROPOSAL

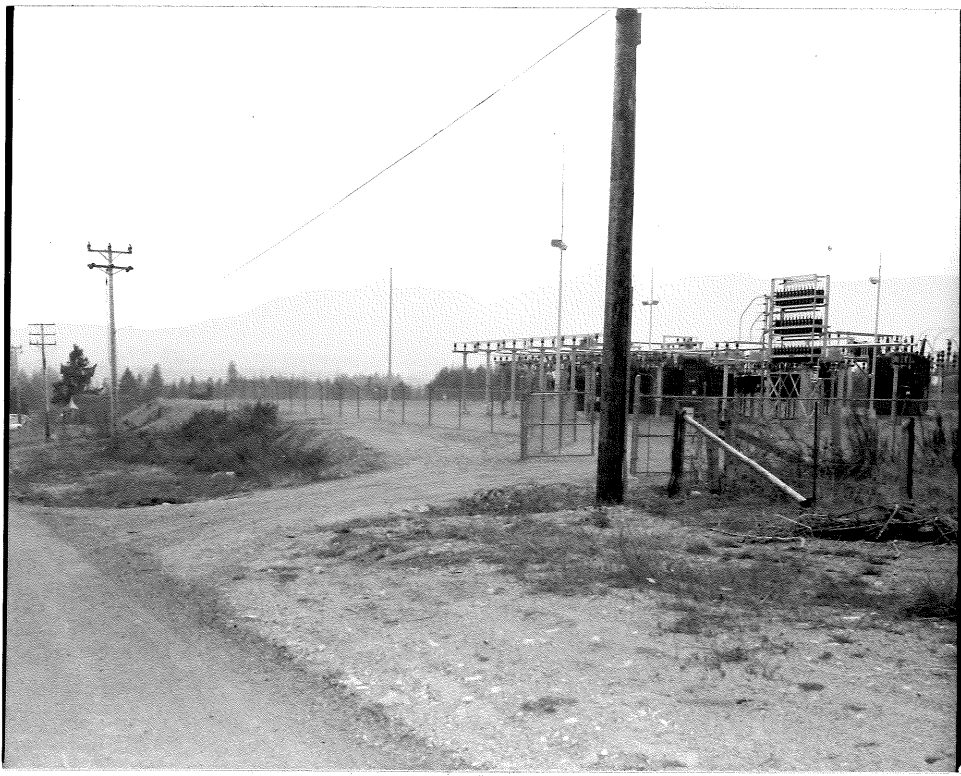
General View of Site Looking down
Boxwood Road is Now Blacktopped

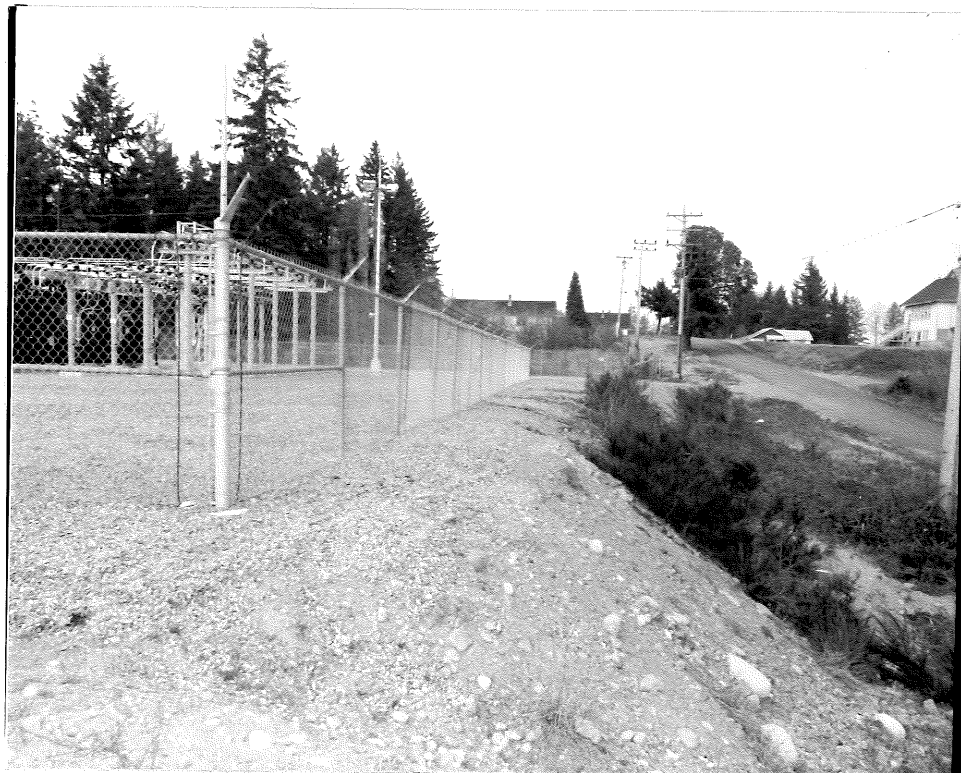
Erosion caused by surface runoff has washed a considerable quantity of gravel from the steep banks. Disturbance of the original top soil to construct the cable manhole and lay cable ductwork has left sub soil evident on the road allowance from the station to Northfield Road. Extremely low fertility and very rapid moisture loss have precluded any appreciable plant growth on the sandy gravel fill. This will necessitate drawing top soil on to the site after the existing banks have been reformed (refer to 2.3). Some 400 cubic yards of medium quality top soil will be required to provide a minimum 6" to 8" cover. At present a very narrow rim exists between the station fence and the

Steep Gravel Bank Showing Erosion
and Slow Plant Colonization.

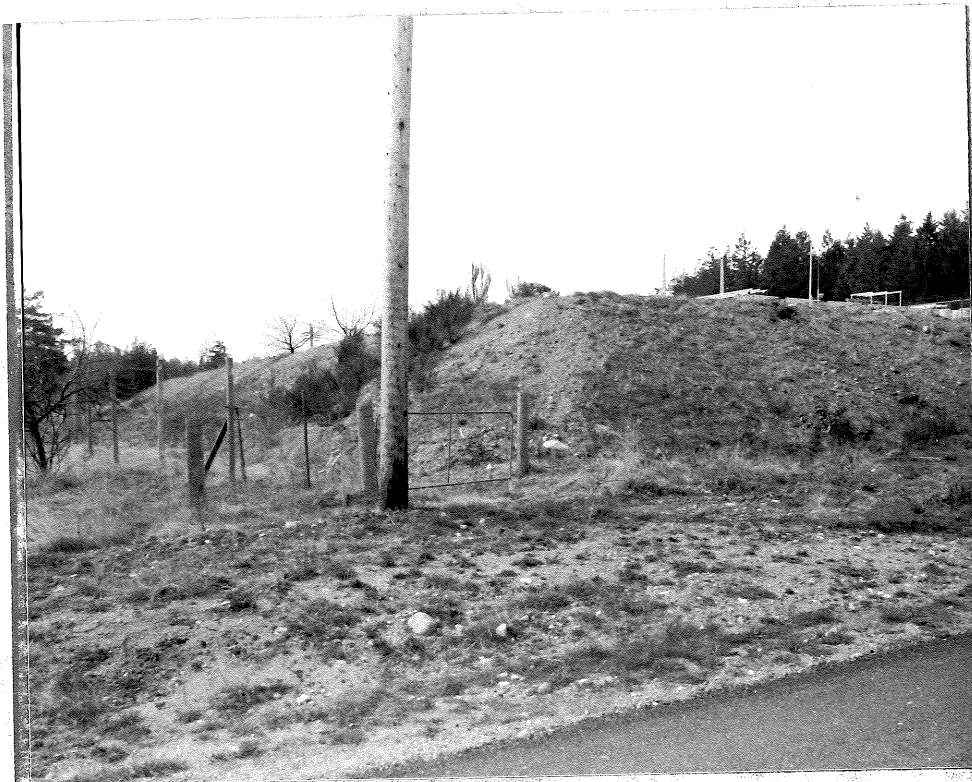
Steep Open Banks on the Southerly and Easterly
Perimeter of the Station

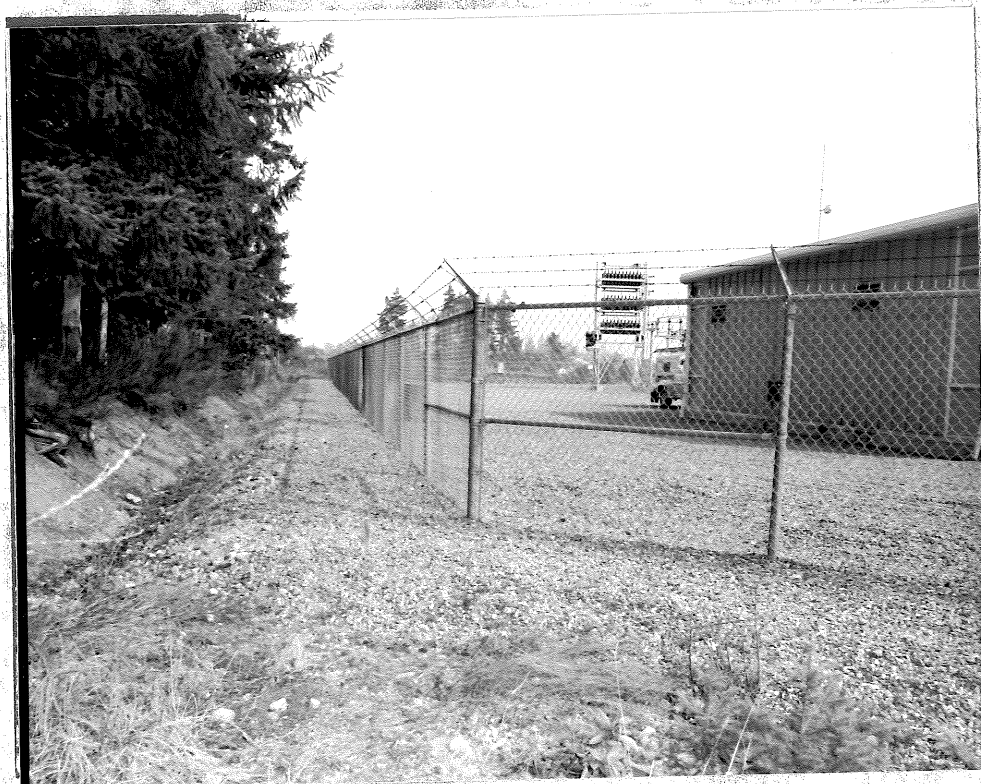
The northern boundary provides only some seven feet between the station fence and the property line. An open ditch provides drainage for surface runoff from the higher adjacent property. Blackberry, Wild Rose and some broadleaved weeds have colonized this ditch but again the extremely low fertility of the fill has resulted in little desirable ground cover. This same situation may be said to exist on the steep banks on the perimeter of the plateau. An open area some 90 feet long and 260 feet wide intended for future station expansion is supporting little growth despite an overdressing of pit run gravel.

Shallow Catchment Drain on the North Boundary

The previously noted ditch to the north of the property should be given a thin cover of top soil and seeded once the weed growth has been removed. This ditch feeds into a 12" culvert which passes under the station entry way. The culvert
