THE CITY OF VANCOUVER BOULEVARD TREE PROGRAM

HISTORY, ANALYSIS AND
RECOMMENDATIONS FOR MANAGEMENT

VOLUME III PHOTOGRAPHS

M. R. Gardner
1980

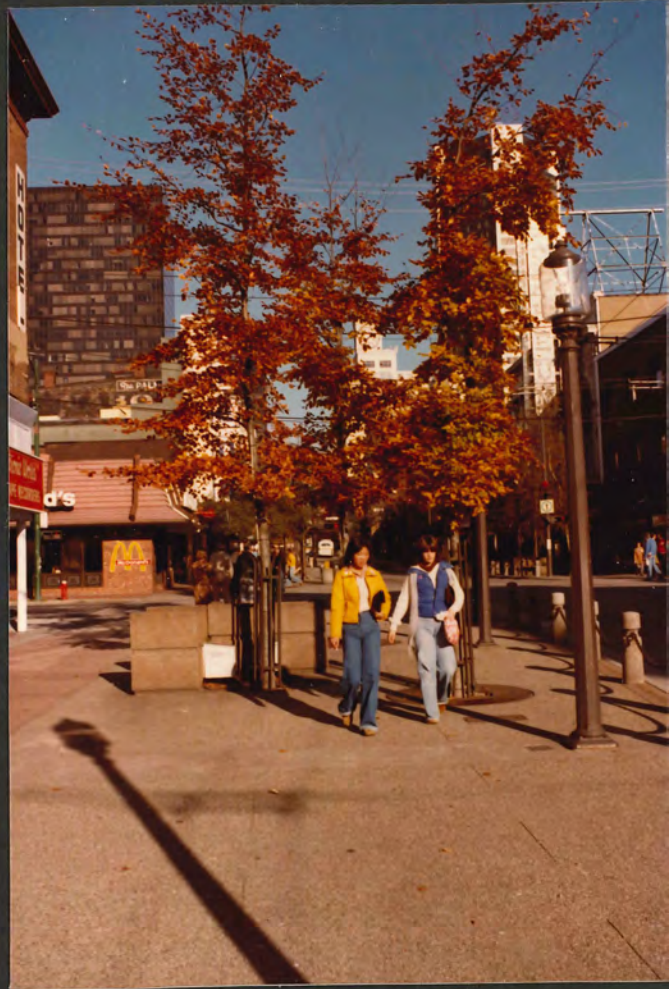
ABOVE: THE BEECH ON GRANVILLE STREET SHOWING FALL COLOUR. CLOSE INSPECTION, HOWEVER, REVEALS SUBSTANTIAL DAMAGE FROM TREE GRATES, TREE GUARDS, AND HIGH INTENSITY LIGHTS.

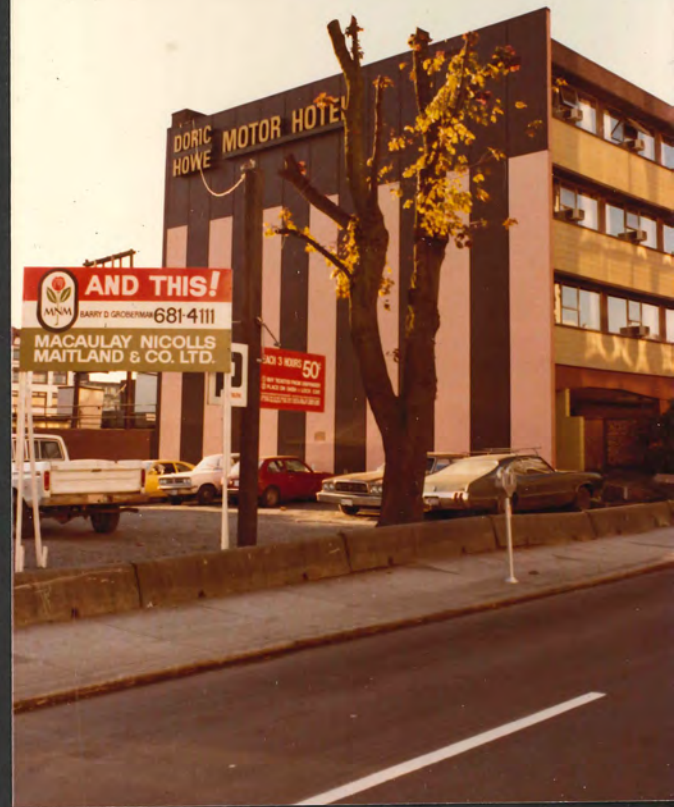
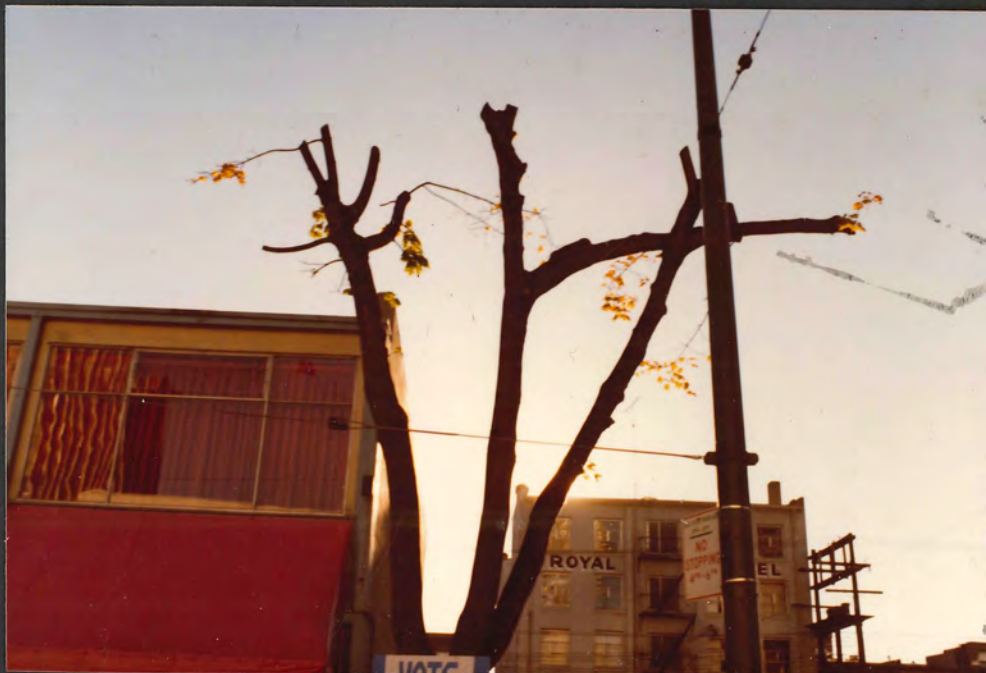
ECONOMY SEEMS TO HAVE PRE-
CLUDED USING PROPER TREE TIES.
HOWEVER, THE SHORT TERM
SAVINGS ARE FAR OUTWEIGHED
BY THE LONG TERM COSTS RESULT-
ING FROM TREE DAMAGE AND RE-
CURRING REPLACEMENT.

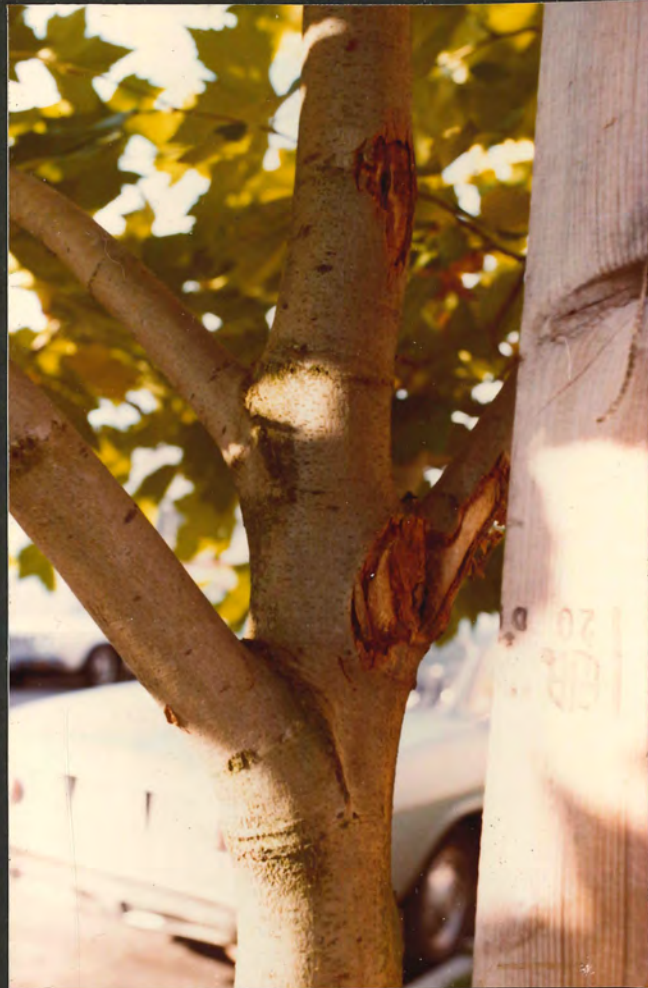
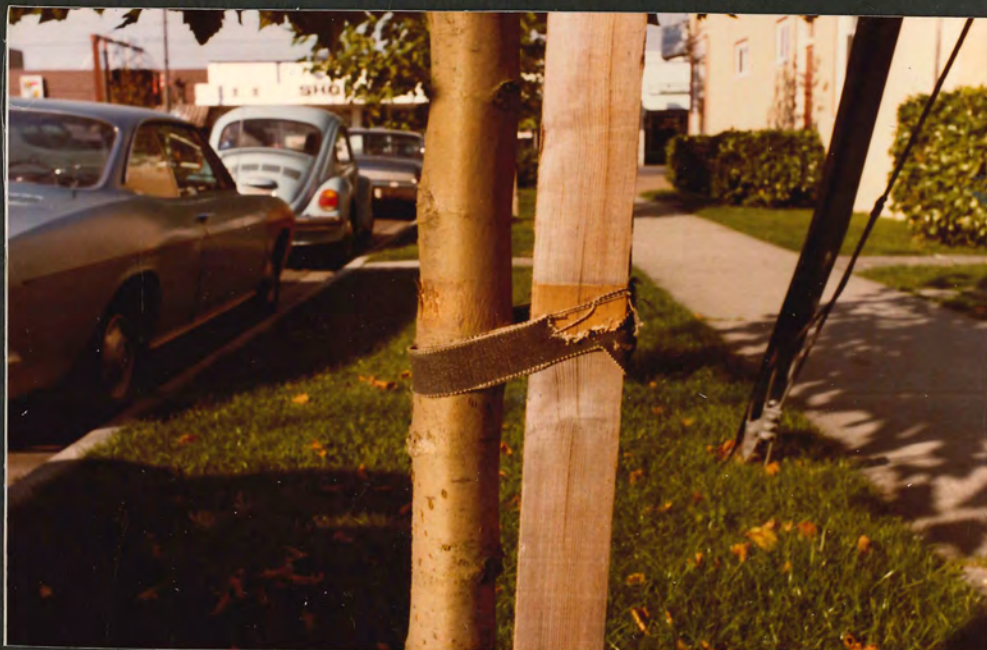
WITHOUT A SMALL TREE MAINTEN-
ANCE GROUP, MANY TREES GO
WITHOUT INSPECTION FOR A CON-
SIDERABLE SPAN OF YEARS.
HERE, AN OLD STAKE LONG SINCE
BROKEN HAS CONTINUED TO WOUND
THE TRUNK.

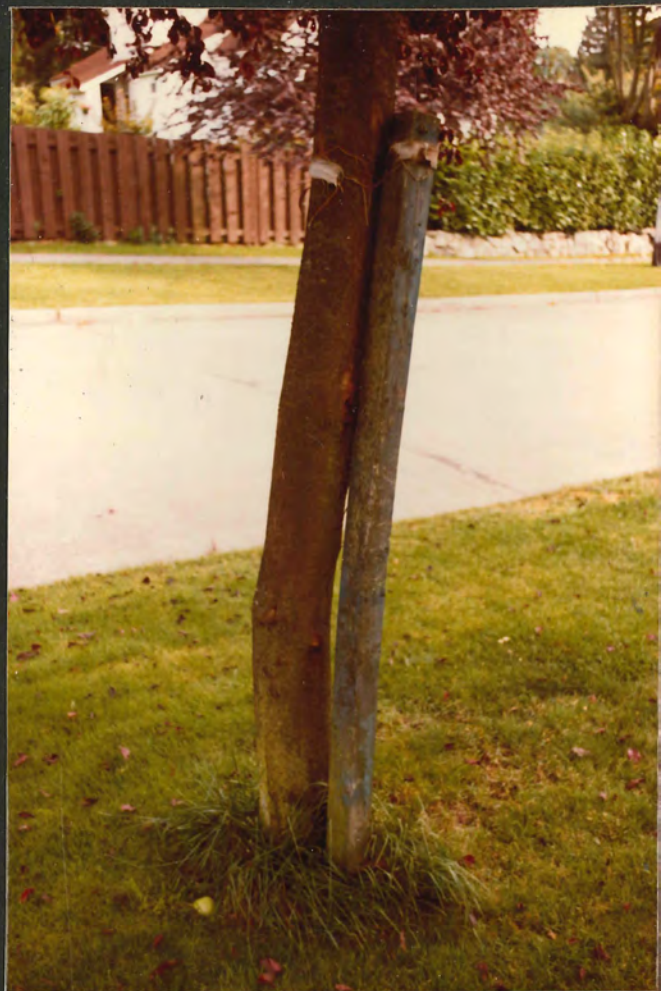
ABOVE: DESPITE AN ATTEMPT TO TIE TREES TO PREVENT WIND DAMAGE THE CONSTANT ROCKING MOTION WITH THE POST AS A FULCRUM SOON DAMAGES THE TREES SEVERELY.

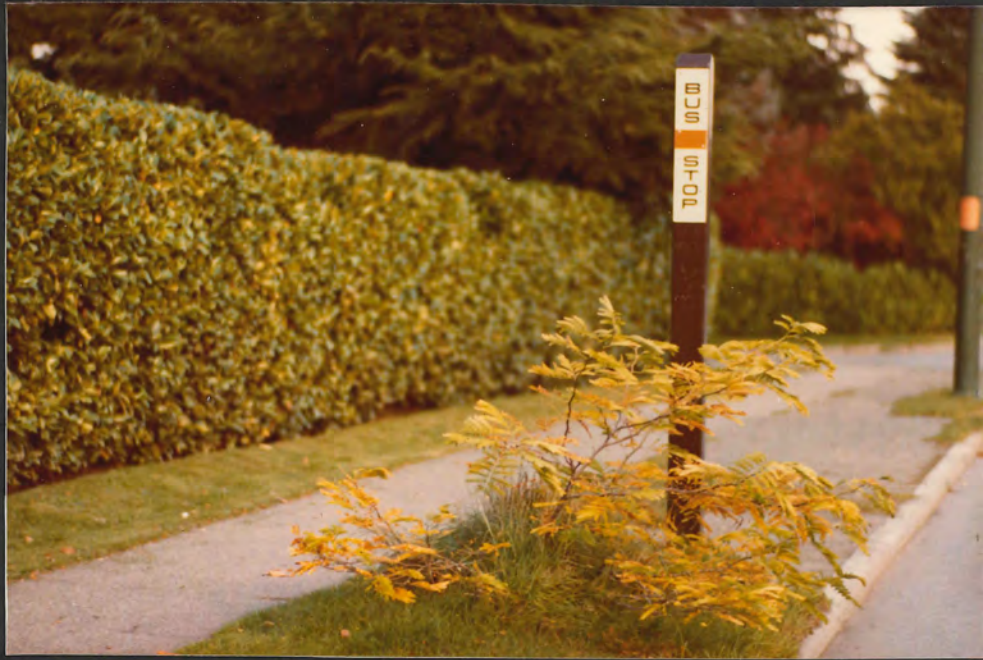
LACK OF ADEQUATE MAINTENANCE
PRODUCES SUBSTANTIAL, YET
UNNECESSARY, COSTS IN THE
FUTURE, AS WELL AS OBVIOUS
SAFETY HAZARDS.

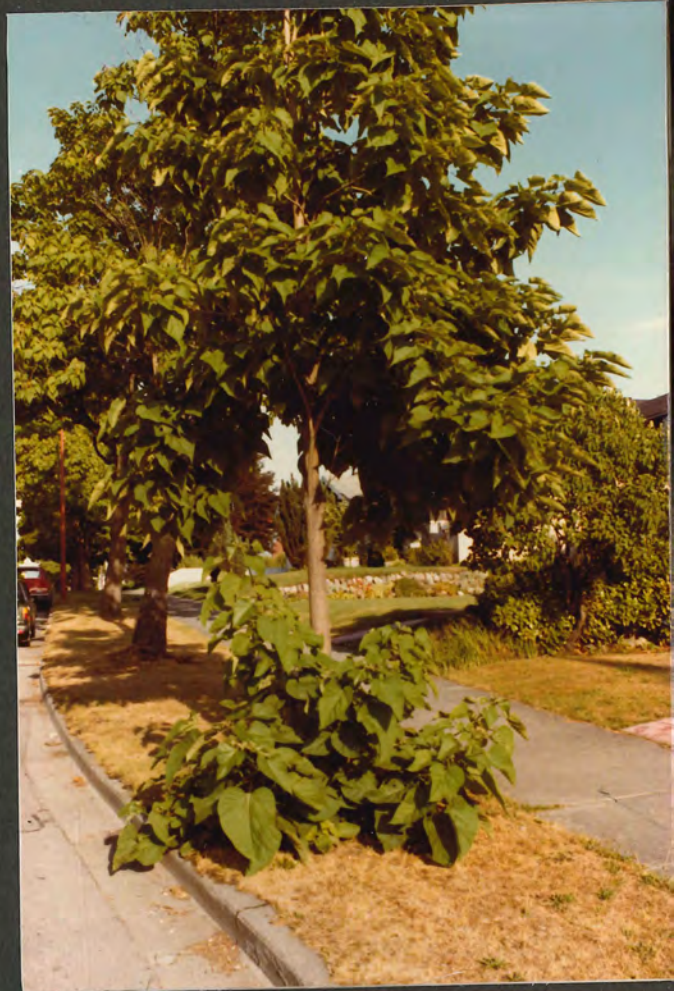
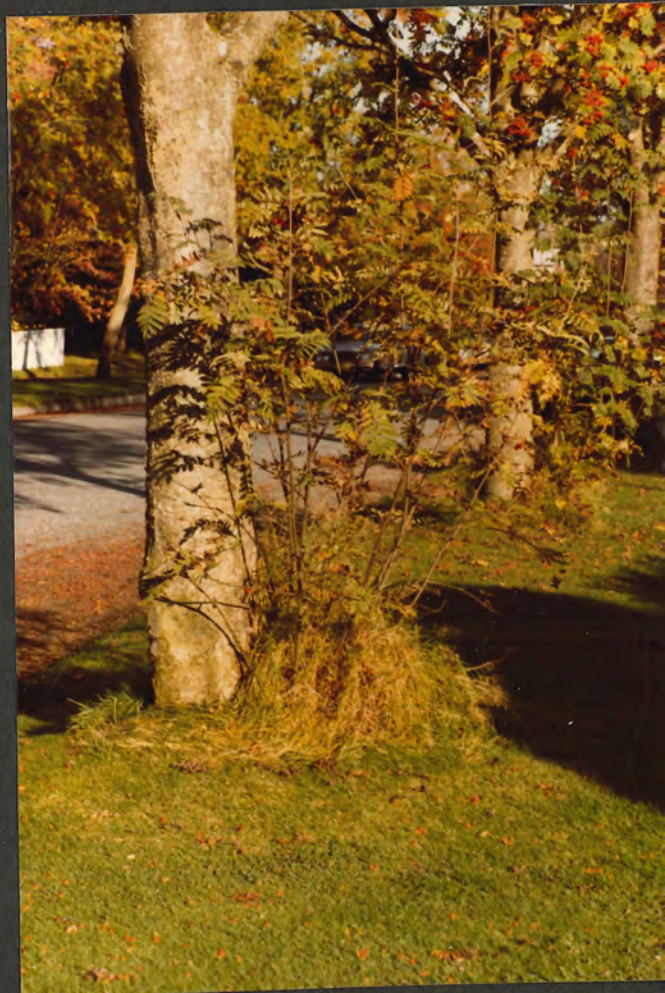
SOME SPECIES SUCKER AGGRES-
SIVELY AFTER BEING HEAVILY
PRUNED AND CAN BENEFIT FROM
BEING CARED FOR ON A REGULAR
BASIS AND HAVING WOUNDS
TREATED WITH A SUCKER-
CONTROLLING WOUND DRESSING.

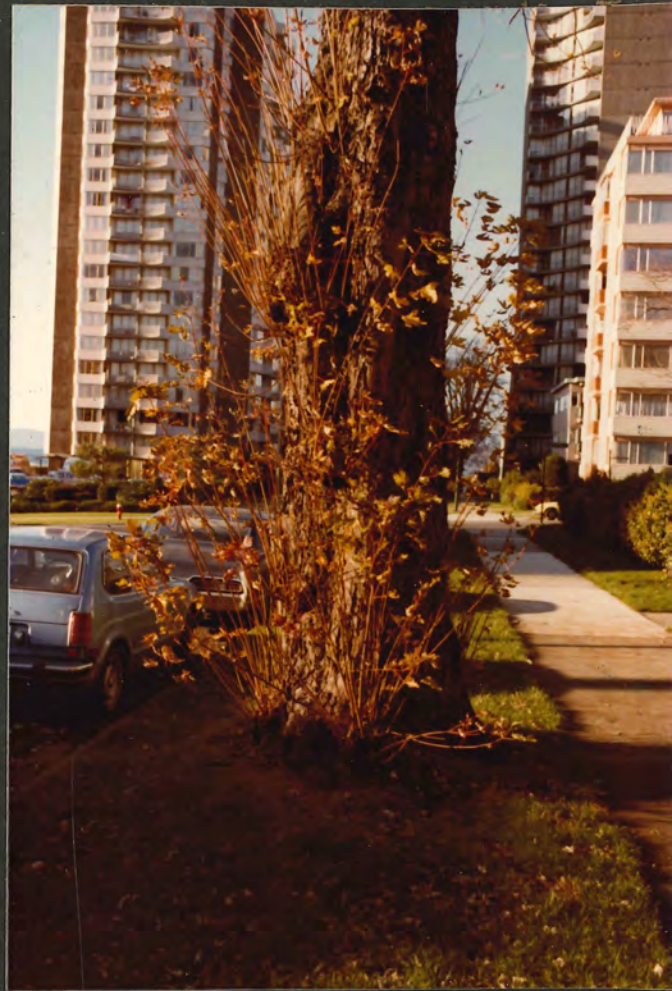
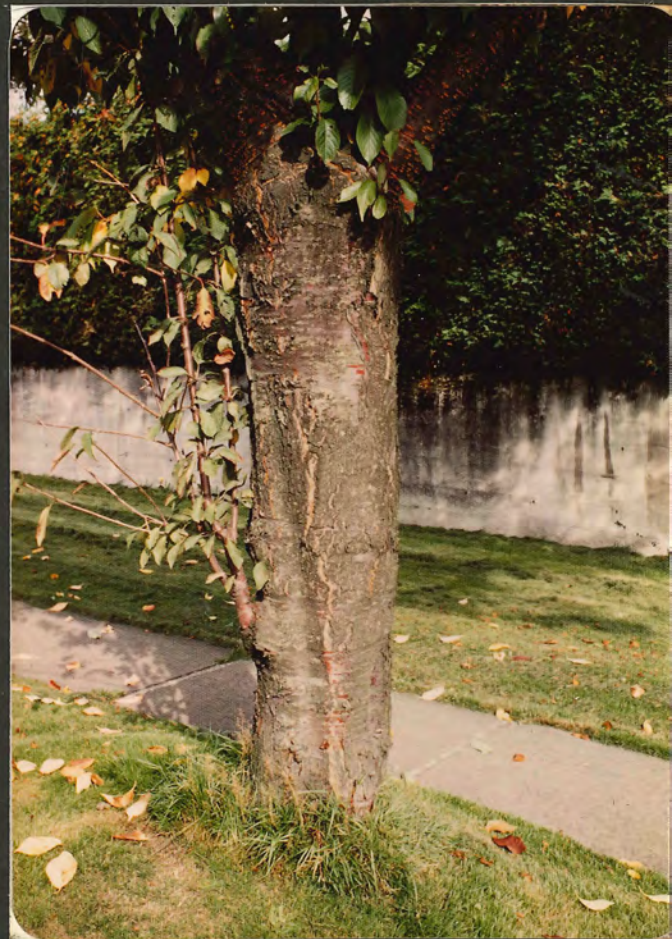
LACK OF SUMMER WATERING CAUSED
THE MORTALITY OF THESE TREES.
THE PROBABLE LOSS IN 1978 MAY
HAVE BEEN AS HIGH AS 2,000
TREES WITH A PLANTED VALUE OF
BETWEEN \$100,000 and \$200,000.

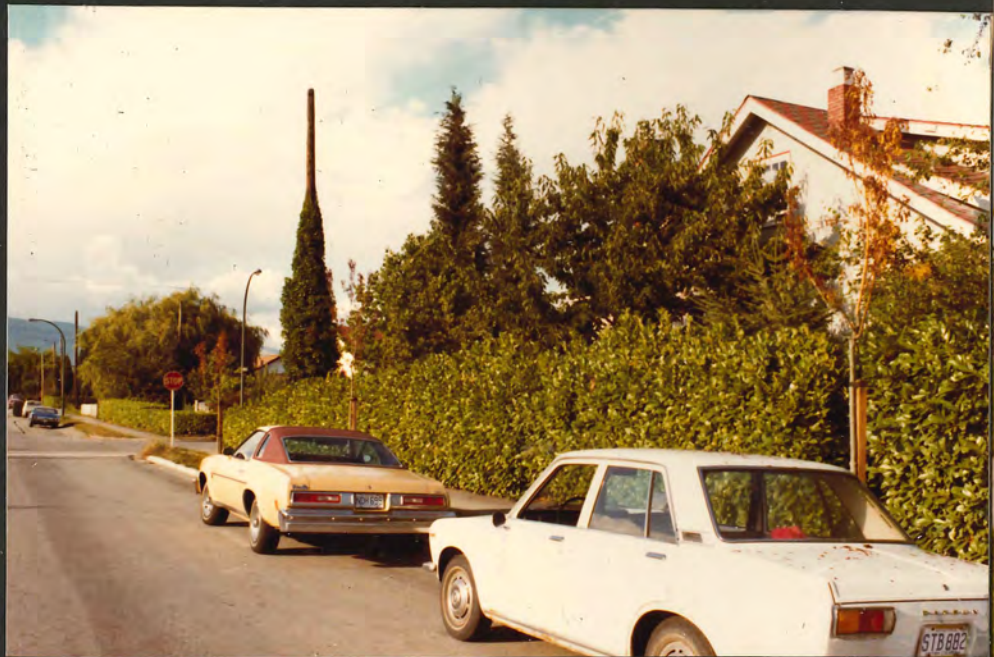
EVEN TREES ESTABLISHED FOR SOME TIME WERE KILLED BY THE DRY SUMMER OF 1978. ALTHOUGH PUBLIC APPEALS TO WATER HAVE HELPED, THE EMPHASIS MUST BE ON A PLANNED CO-ORDINATED WATERING PROGRAM BY THE CITY.

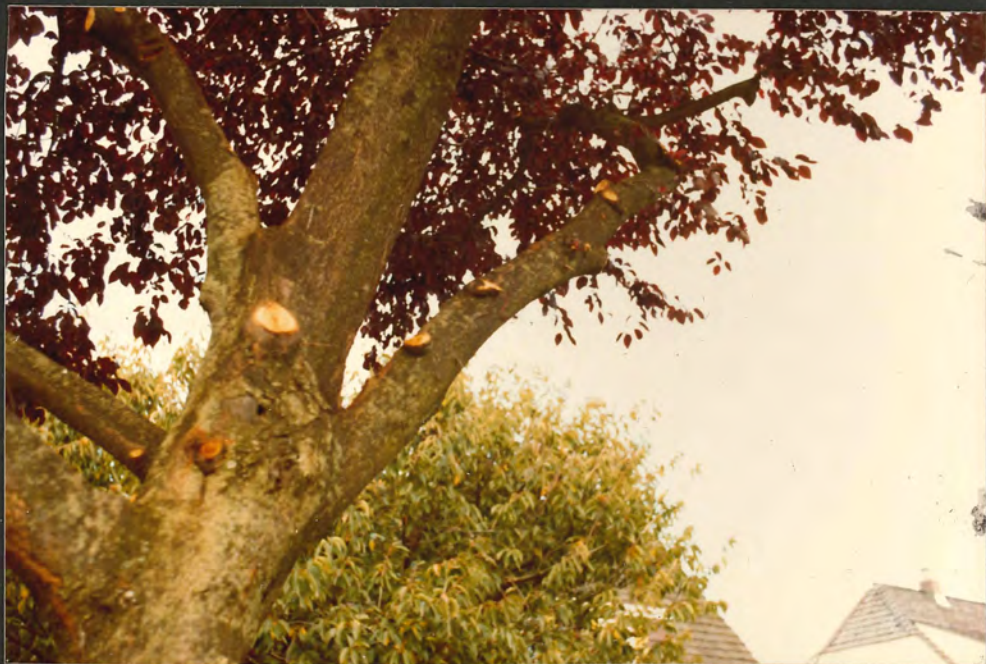
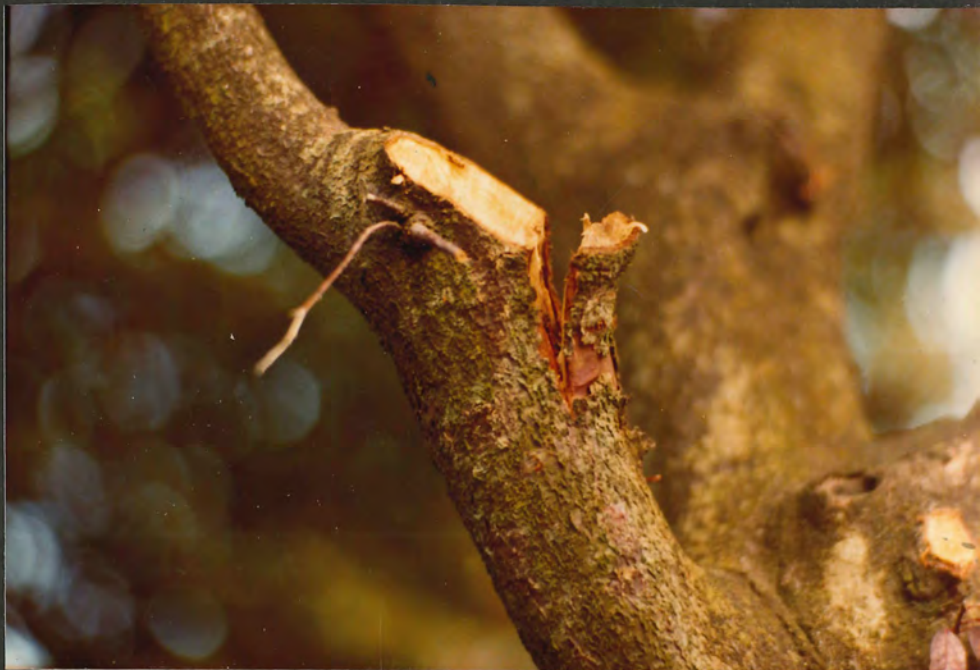
LACK OF TRAINING AND DIRECT
SUPERVISION CHARACTERIZES MANY
OPERATIONS AT PRESENT, RESULT-
ING IN MAINTENANCE THAT IS
OBVIOUSLY DETRIMENTAL TO THE
HEALTH OF BOULEVARD TREES.

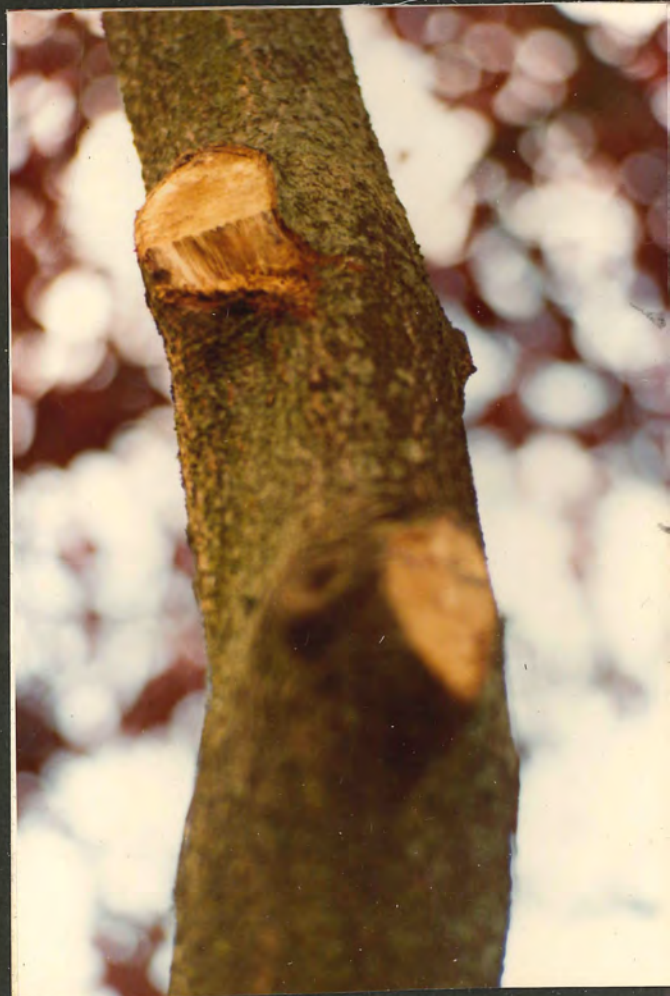
SUMMER PRUNING WITHOUT SUBSEQUENT PROTECTION OF THE WOUND ALLOWS CAMBIUM DIE-BACK AND A POTENTIAL FOR AN EVENTUAL CAVITY. THE DAMAGE RESULTING FROM CURRENT STRAP TIES CAN BE SEEN IN THE LOWER PLATE WHERE THE CAMBIUM IS GROWING OVER THE TOP OF THE STAKE.

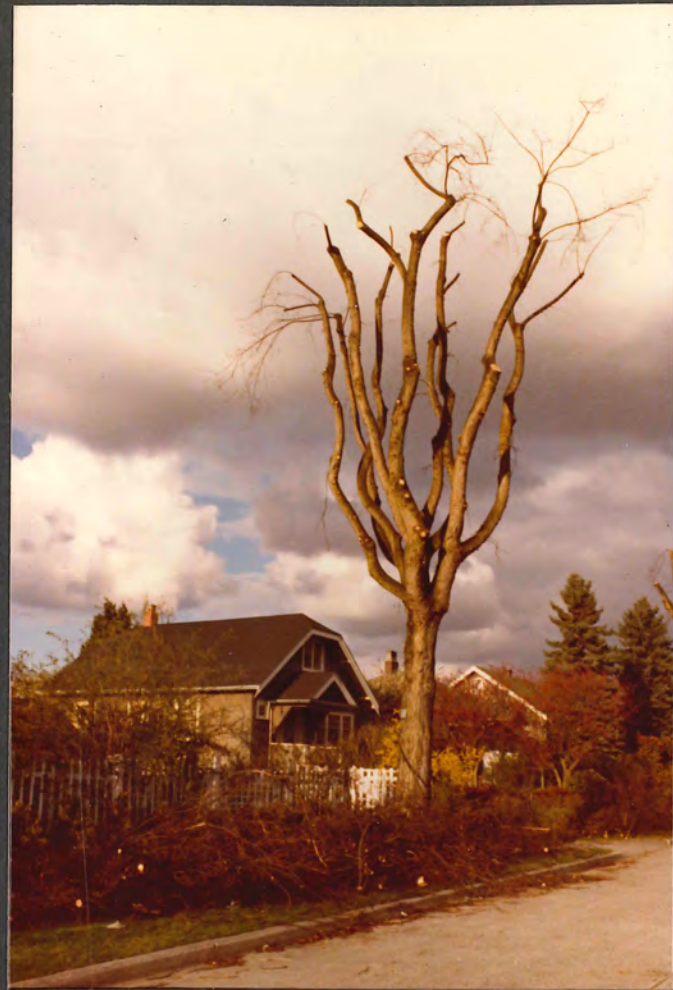
AS WITH THE PREVIOUS PAGE,
THIS BRUTAL PRUNING IS, AND
IS SEEN TO BE, DETRIMENTAL
TO THE TREES AND DOES NOTHING
TO ENCOURAGE PUBLIC SUPPORT
FOR A CITY BOULEVARD TREE
PROBLEM.

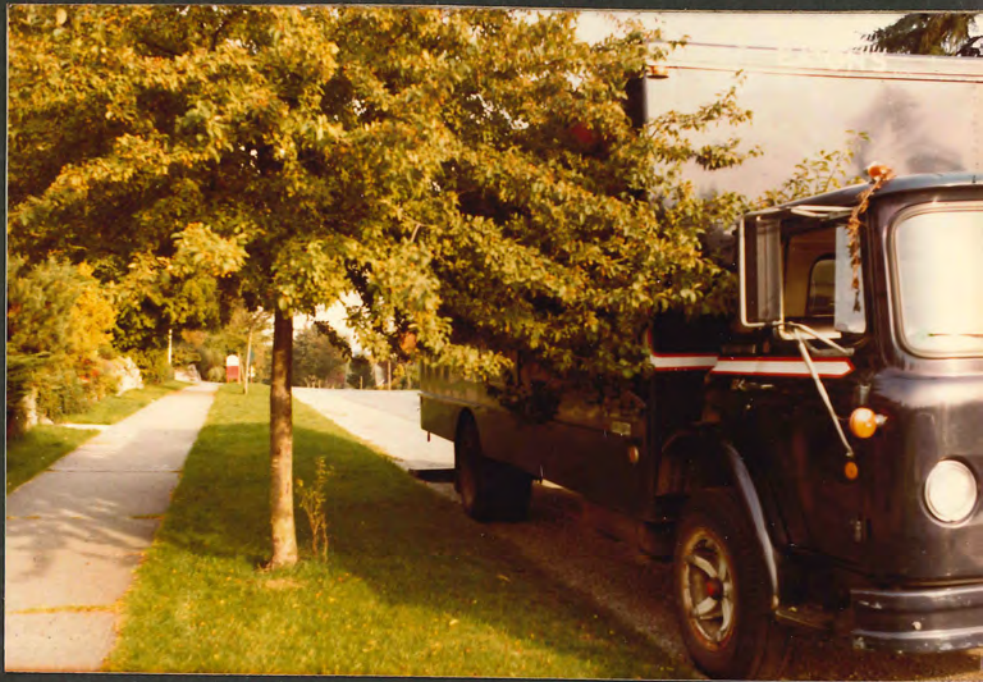
ROADSIDE TRIMMING IS NECESSARY
TO PREVENT CROWN DAMAGE BOTH ON
CURBED AND UNCURBED BOULEVARDS.

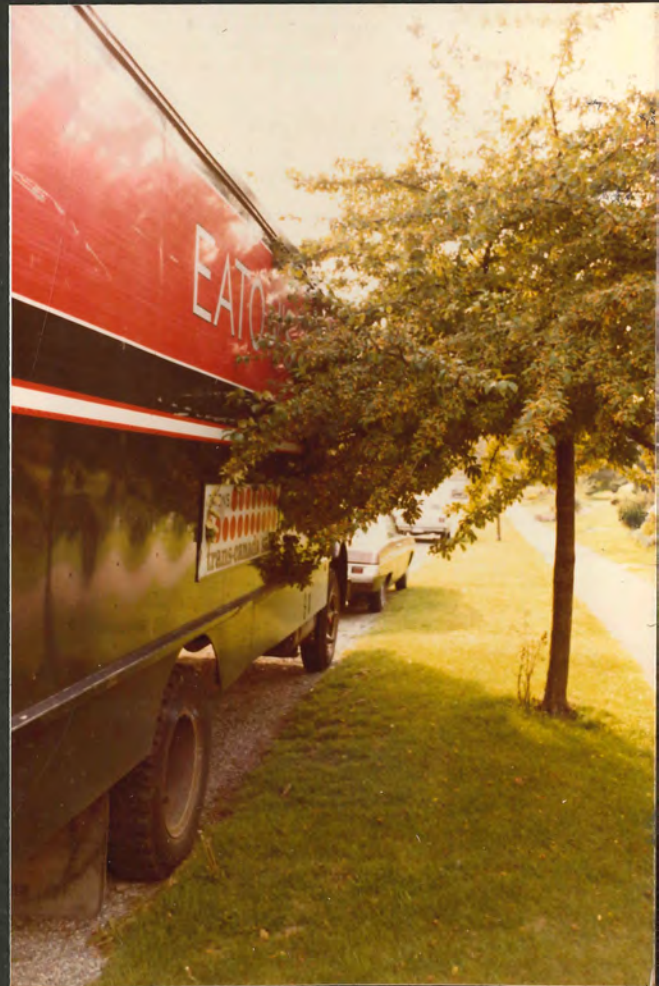
TELEPHONE AND ELECTRICAL UTILITIES PRESENT AN ONGOING PROBLEM, BUT VIABLE, CO-OPERATIVE SOLUTIONS ARE POSSIBLE WITH THE USE OF SMALLER TREES AND REMOVAL OF LINES TO BACK LANES WHEREVER POSSIBLE. IN SOME CASES, APPROPRIATE DROP CROTCH PRUNING HAS NOT BEEN PRACTICED REQUIRING COSTLY ANNUAL OR BI-ANNUAL RETURN FOR RE-PRUNING.

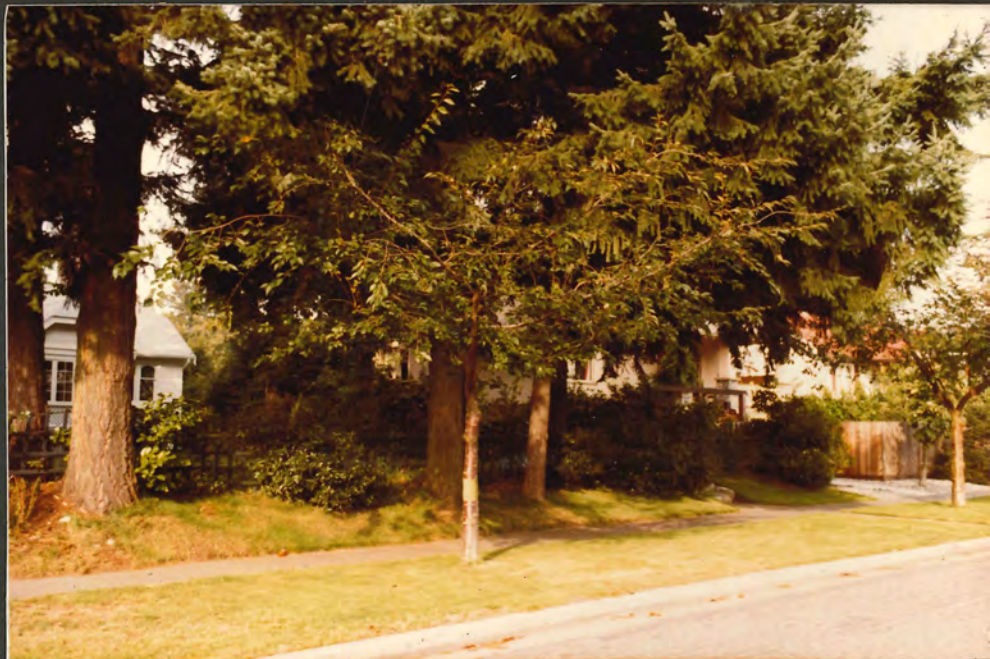
BELOW: SPECIMENS OF THIS NATURE ADD LITTLE TO THE STREETScape AND REQUIRE REMOVAL AND REPLACEMENT.

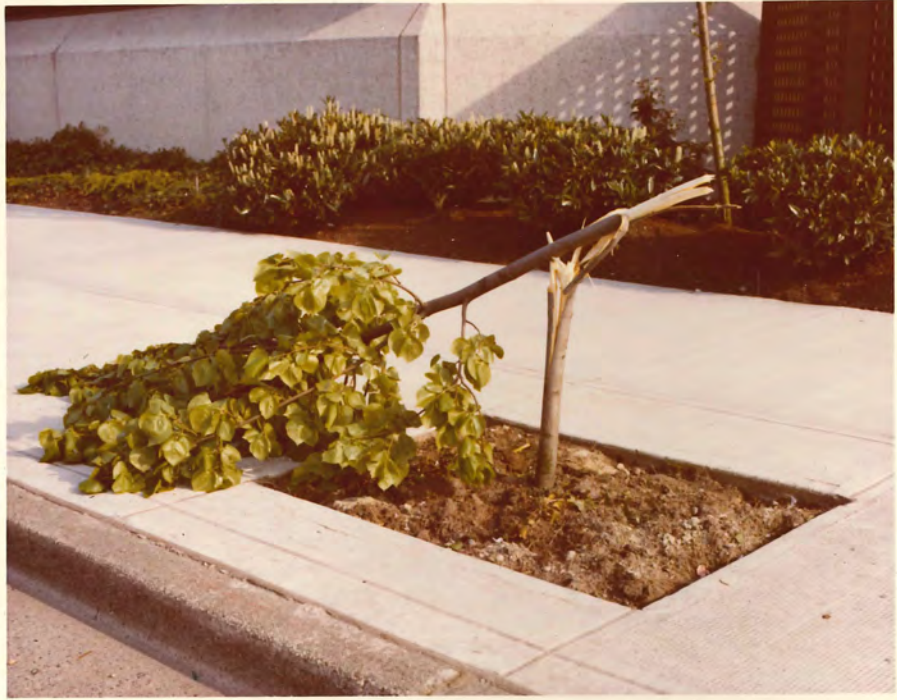
ABOVE: YOUNG LIME ON BROADWAY HAVE BEEN RUTHLESSLY DAMAGED. THESE TREES APPARENTLY HAD NO STAKES WHICH MIGHT HAVE PREVENTED THIS VANDALISM.

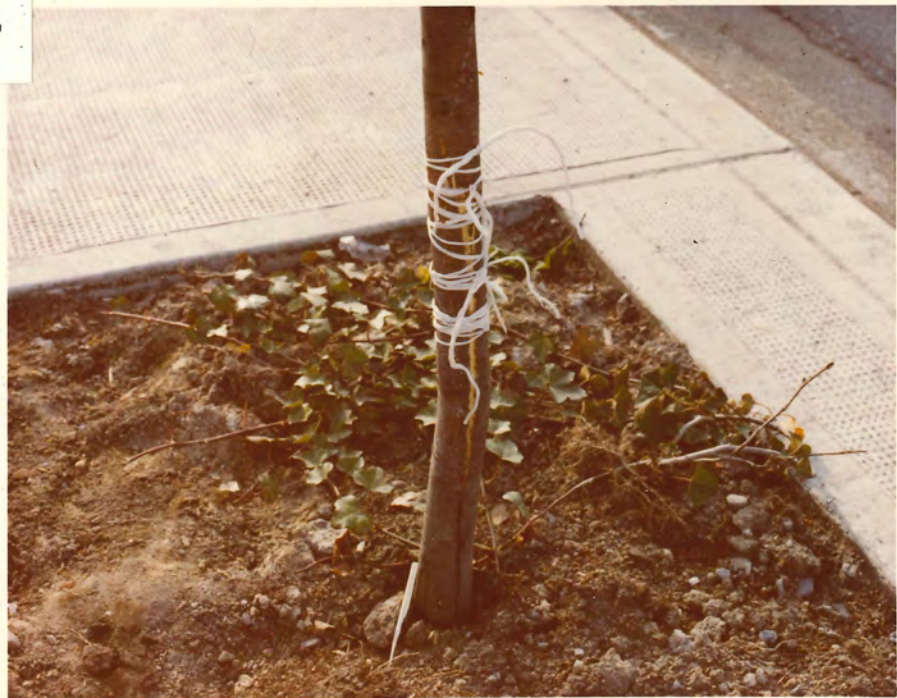
BELOW: THE POOR CONDITION OF THE TREE PIT AND A PUBLIC SPIRITED ATTEMPT TO REPAIR SOME TREES CAN BE SEEN. THE IVY GROWING HERE IS NOT TO BE RECOMMENDED AS IT WILL EVENTUALLY CLIMB THE TREES AND REQUIRE ANNUAL REMOVAL.

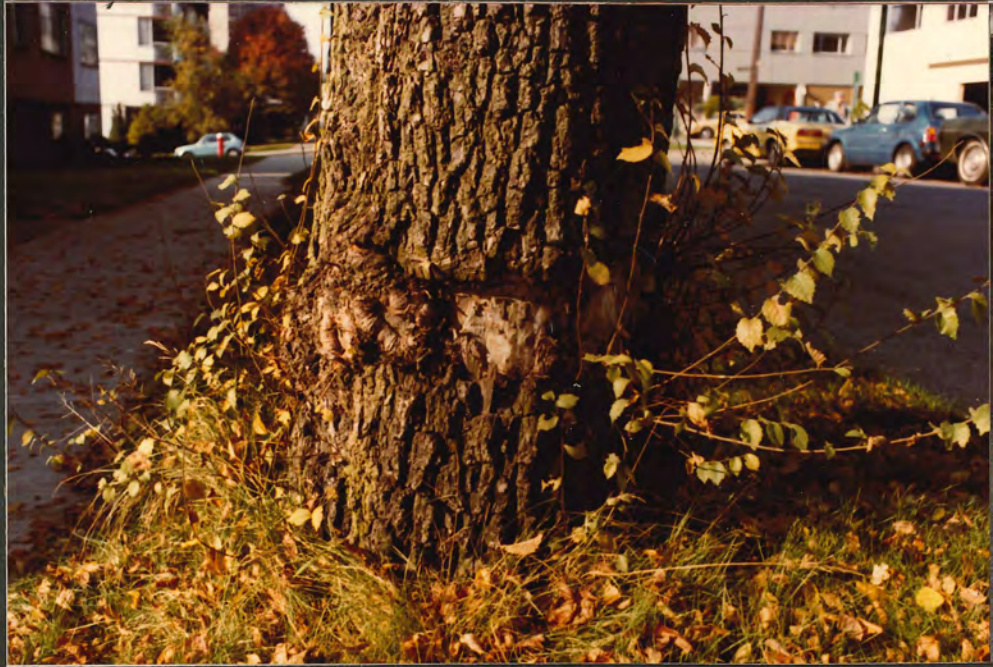
LARGE TREES (IN THIS CASE
ELM) BLOCKING LIGHT TO
APARTMENT BUILDINGS CAN RE-
SULT IN ADULT VANDALISM.

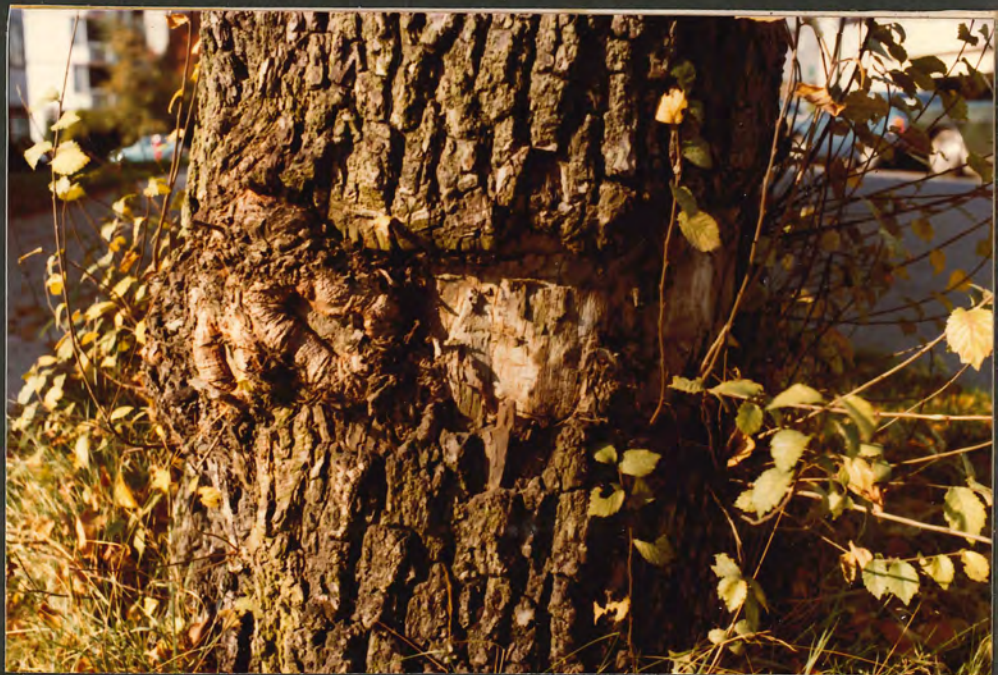
ABOVE: WITHOUT ADEQUATE BY-LAW PROTECTION, TREES ARE EASILY DAMAGED BY THOUGHTLESS USE AS SIGN POSTS. CLOSE INSPECTION REVEALED THIS TREE TO BE FULL OF METAL CONSTRUCTION STAPLES.

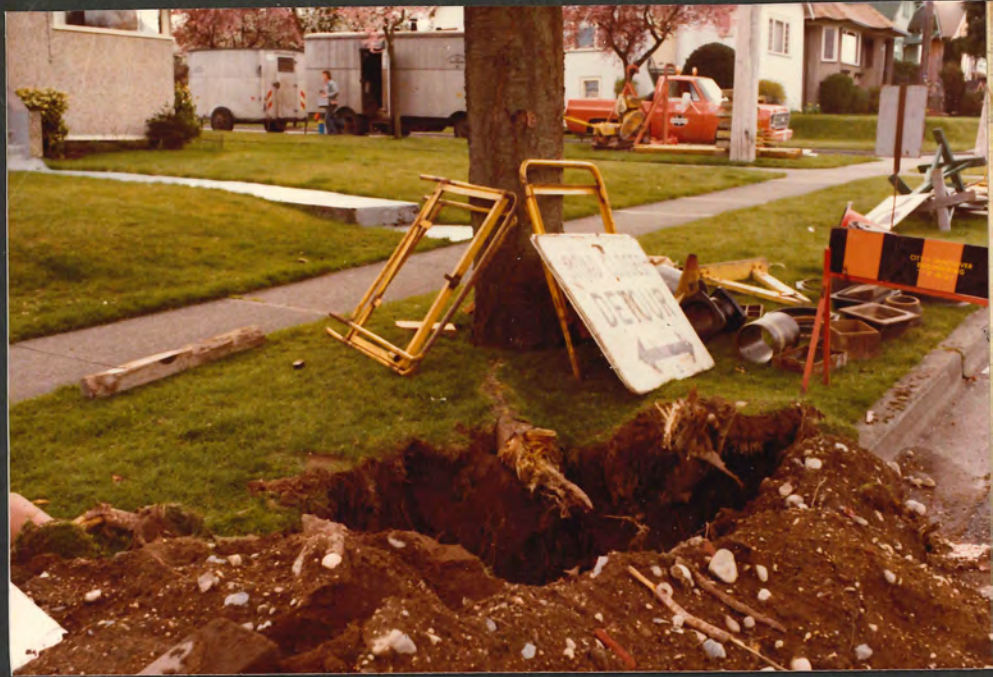
CONSTRUCTION BY CITY FORCES IS
ALSO TO BLAME FOR SOME SEVERE
DAMAGE TO BOULEVARD TREES.
EDUCATION, INFORMED SUPERVISION
AND TREE PROTECTION GUIDELINES
WOULD HELP REDUCE THIS PROBLEM.

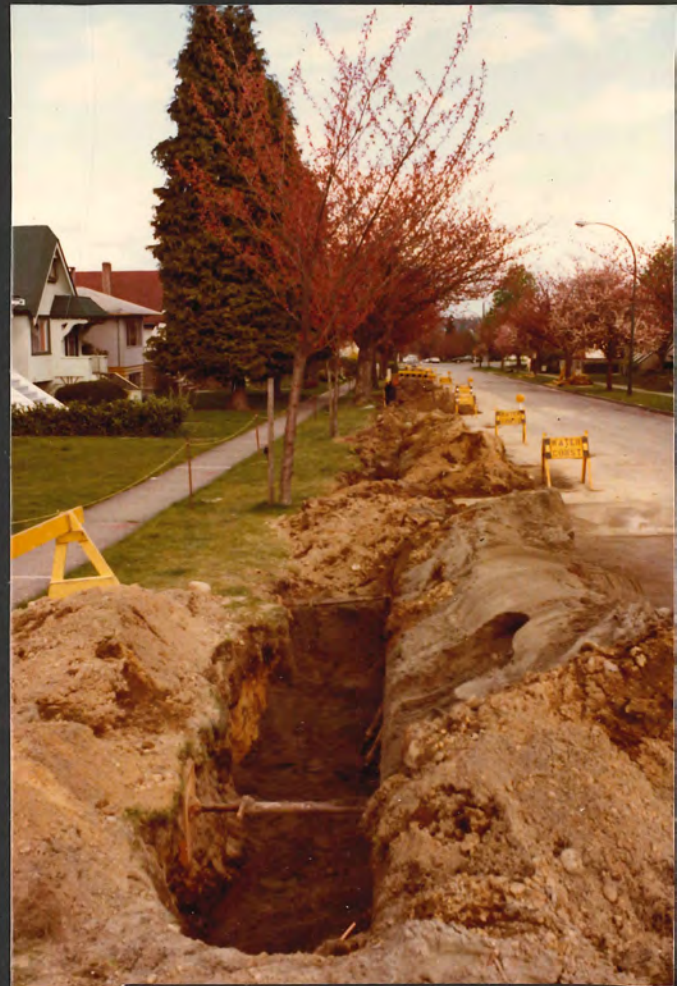
THE PRESENT POLICY OF NOT PLANTING UNTIL CURBS AND GUTTERS HAVE BEEN PUT IN WOULD SEEM WISE. IN THIS INSTANCE THE ROADWAY WAS WIDENED CAUSING SOME OBVIOUS ROOT DAMAGE BUT POSSIBLY ALLOWING CONTINUED RETENTION OF THE BOULEVARD TREES.

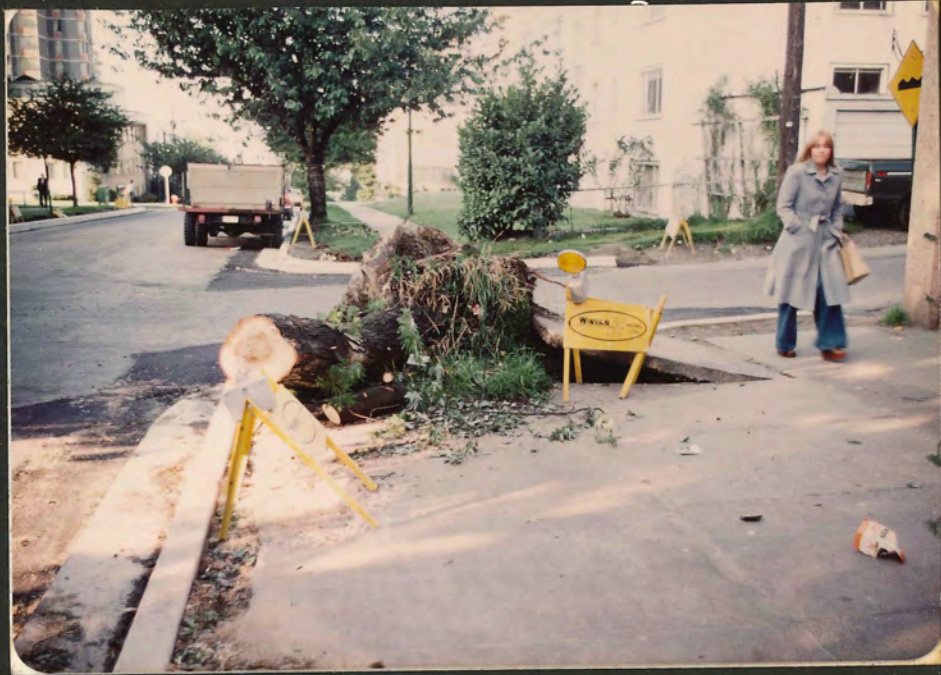
CONSTRUCTION BY CITY CREWS FOR A ROAD WIDENING AND CURBING PROGRAM CUT THE ROOTS OF THIS TREE ALLOWING IT TO FALL ACROSS THE ROADWAY AND ONTO A SMALL PRIVATE CAR.

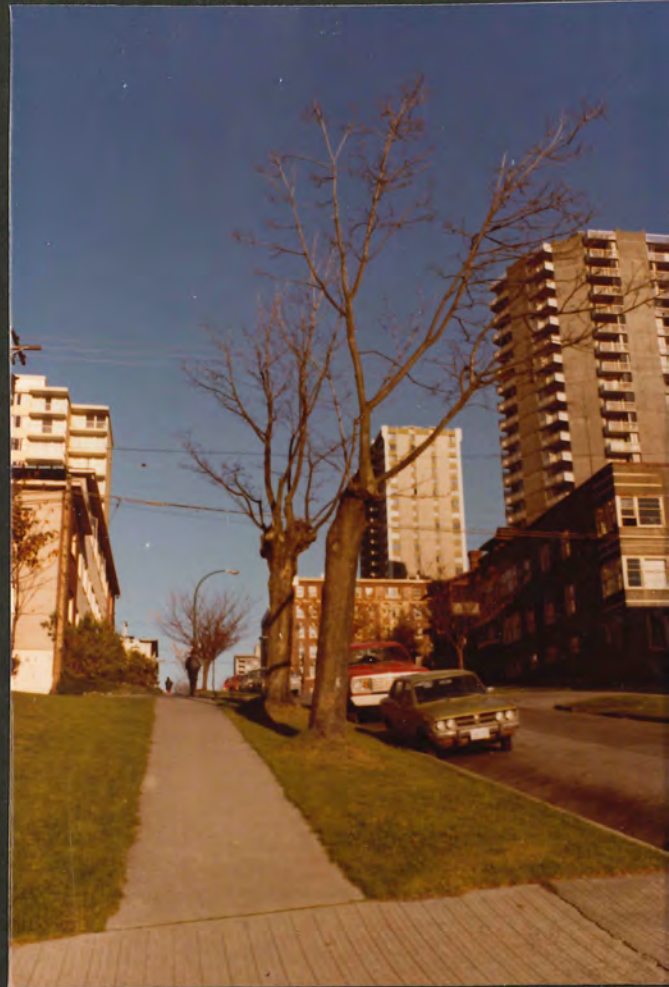
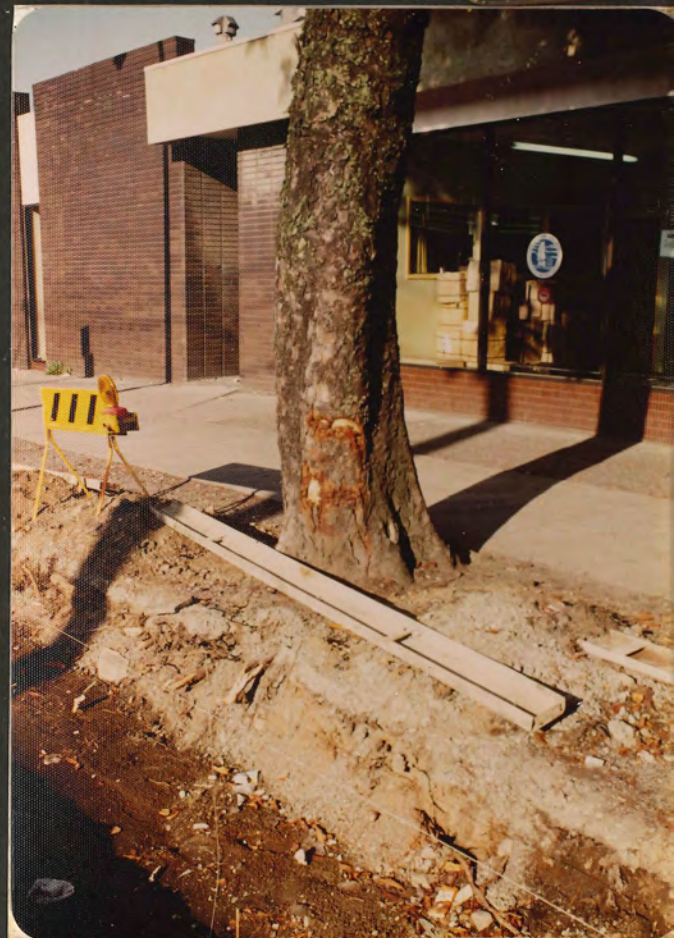
A TYPICAL CONSTRUCTION SITE
WHERE NO PROTECTION IS
AFFORDED THE STREET TREE
WHICH WILL EVENTUALLY DIE.
THAT COST IS BORNE BY THE
TAXPAYER AT PRESENT RATHER
THAN THE DEVELOPER.

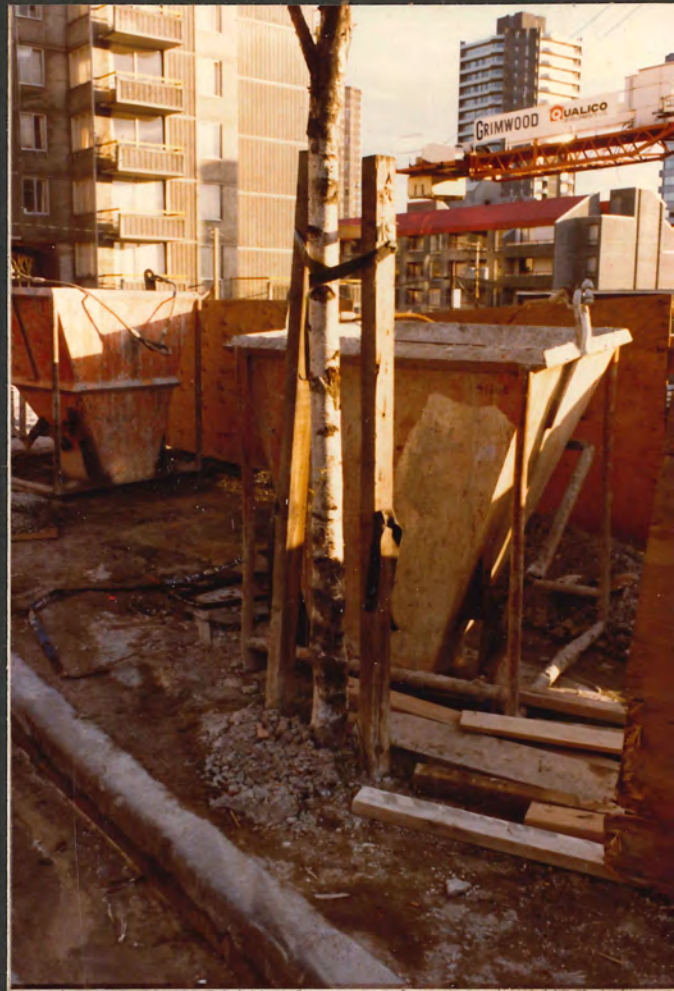
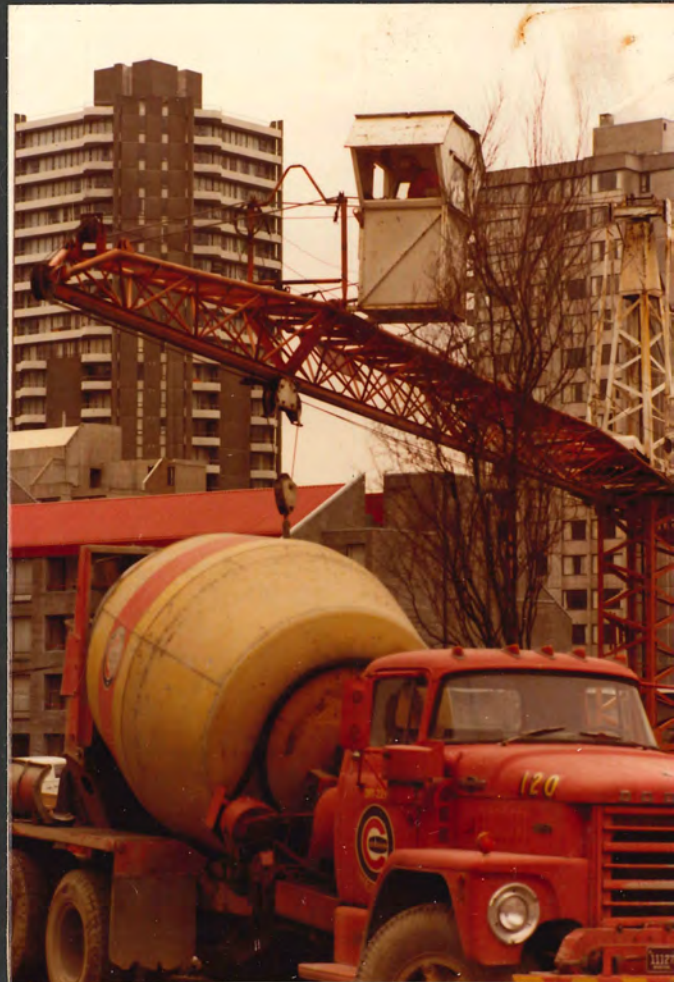
ALTHOUGH NO TREE SURGERY TO
CORRECT MAJOR DEFECTS OR
WOUNDS IS PRESENTLY UNDERTAKEN,
THE NEED CERTAINLY EXISTS.

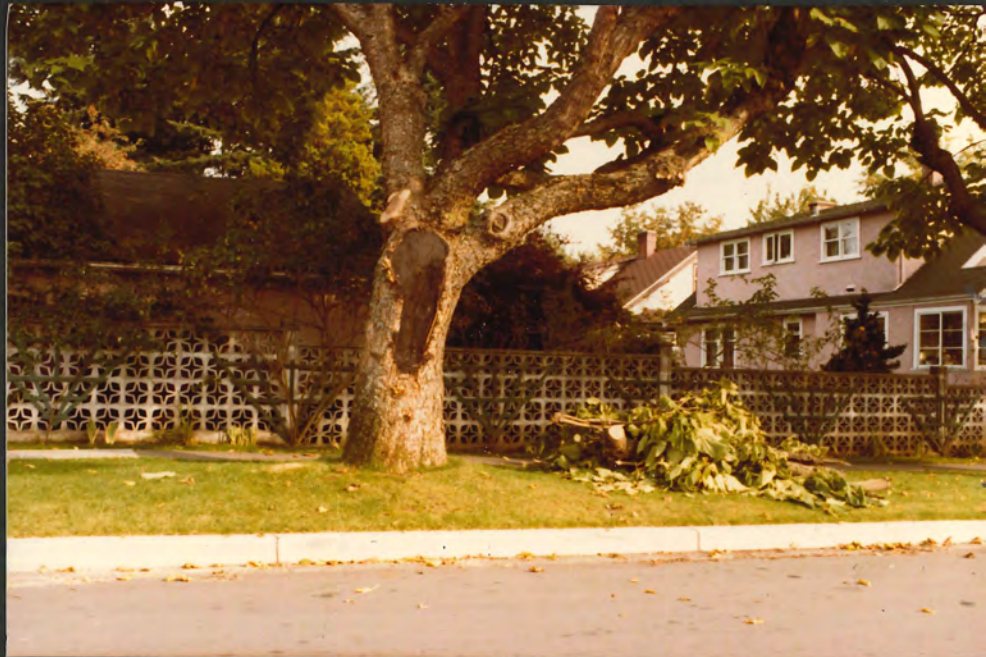
BELOW: THIS LARGE WOUND HAS TRIED TO HEAL BUT DID NOT DO SO BEFORE THE TREE BROKE. REPLACEMENT OF THE SPECIMEN IS REQUIRED.

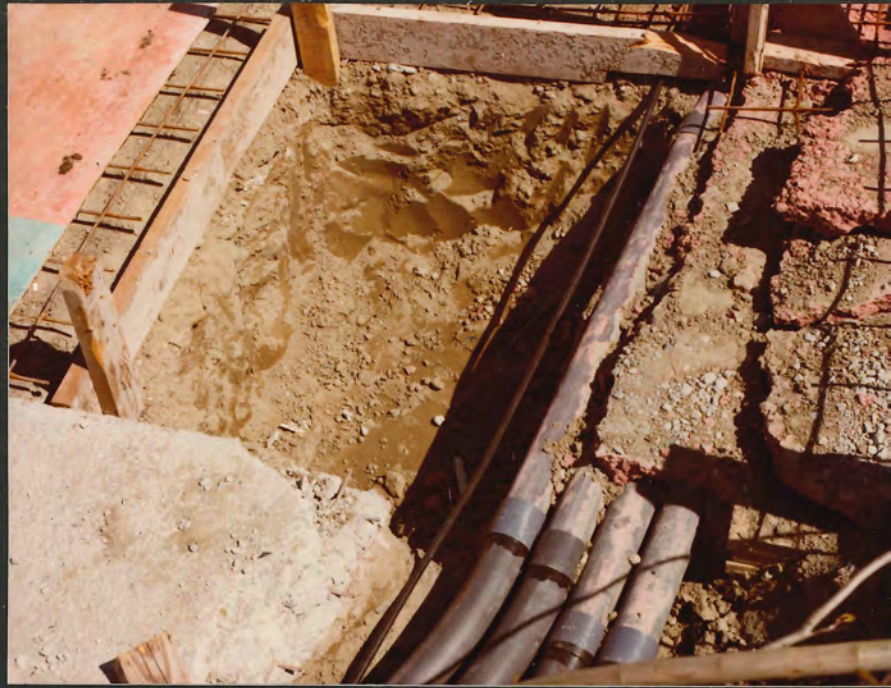
THE PLANTING SITES AROUND
THE COURTHOUSE COMPLEX
ARE LARGELY IN COMPACTED
CONSTRUCTION FILL. WATER
IS GOING TO BE A CONSTANT
REQUIREMENT. LONG TERM
SURVIVAL OF THESE TREES
IS DOUBTFUL.

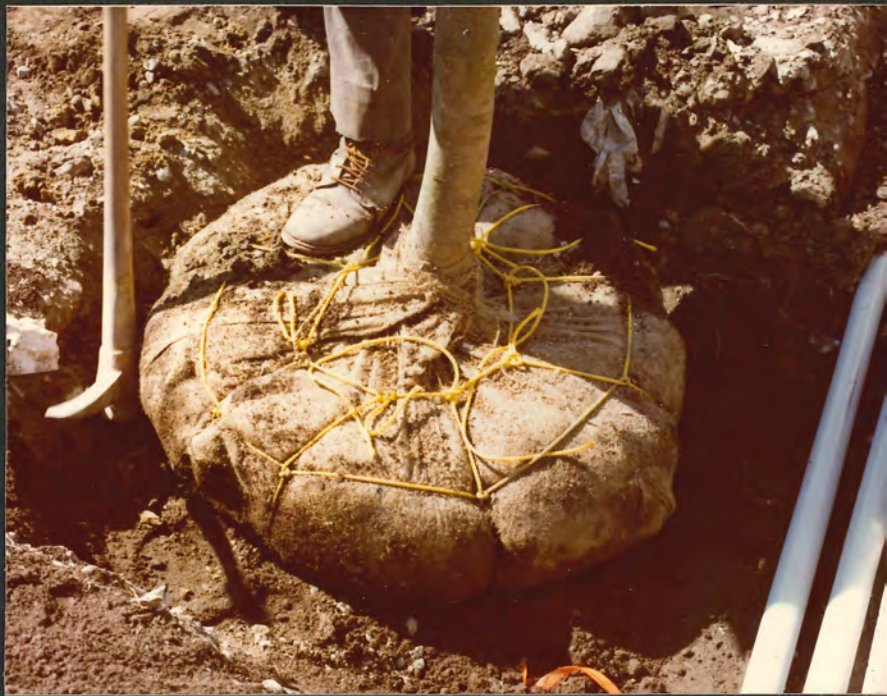
ABOVE: IT IS UNLIKELY THAT THE RED MAPLE TREE ROOTS WILL MAKE MUCH HEADWAY GROWING IN THE CONSTRUCTION HARDPATH, AT LEAST FOR A FEW YEARS.
