THE CITY OF VANCOUVER BOULEVARD TREE PROGRAM

HISTORY, ANALYSIS AND
RECOMMENDATIONS FOR MANAGEMENT

VOLUME III PHOTOGRAPHS

M. R. Gardner
1980

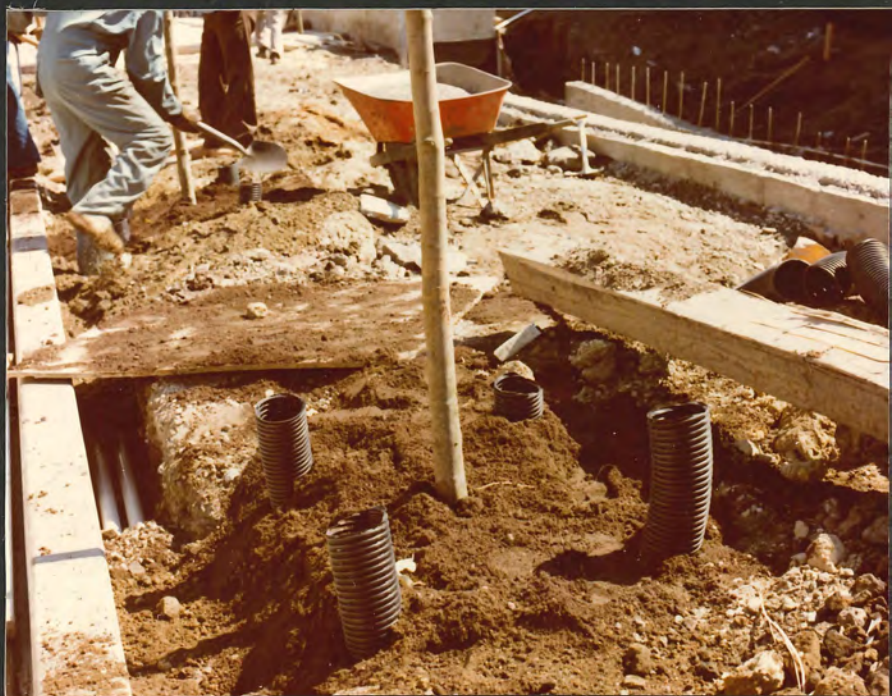
BELOW: ALTHOUGH A WATERING SYSTEM WAS INCORPORATED, THE PAVING SYSTEM SEEN ON THE FOLLOWING TWO PICTURES PRECLUDES SUBSTANTIAL WATERING UNTIL THE SIDEWALK CUTOUT IS REMOVED.

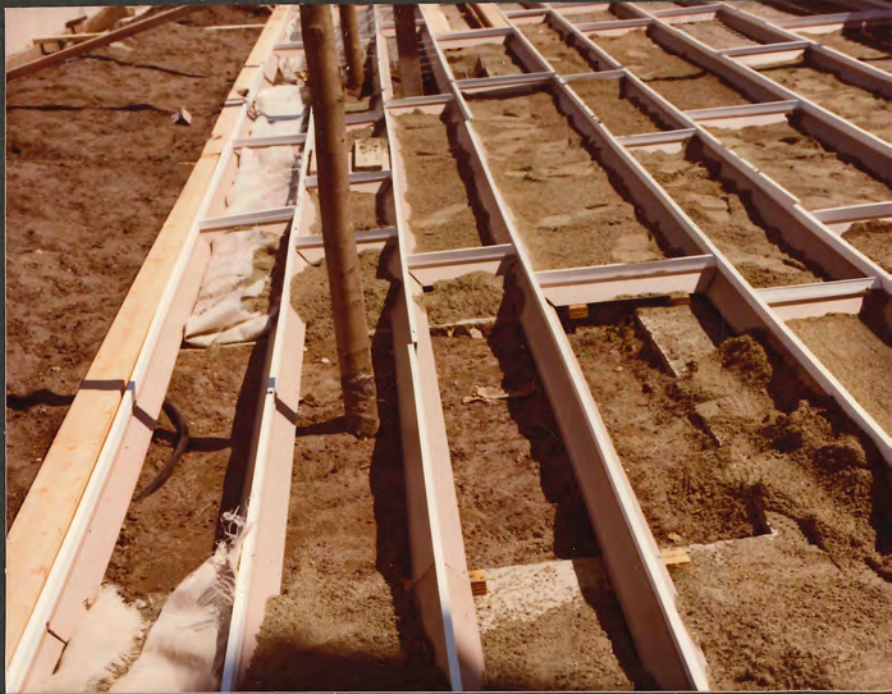
NO PROTECTION WAS GIVEN TO THE MAPLE DURING OR AFTER PLANTING AT THE COURTHOUSE COMPLEX AND CONSEQUENTLY THERE HAS BEEN UNNECESSARY BRANCH AND BUD DAMAGE AS WELL AS PROBABLY ROOT DAMAGE FROM CONCRETE LEACHATES.

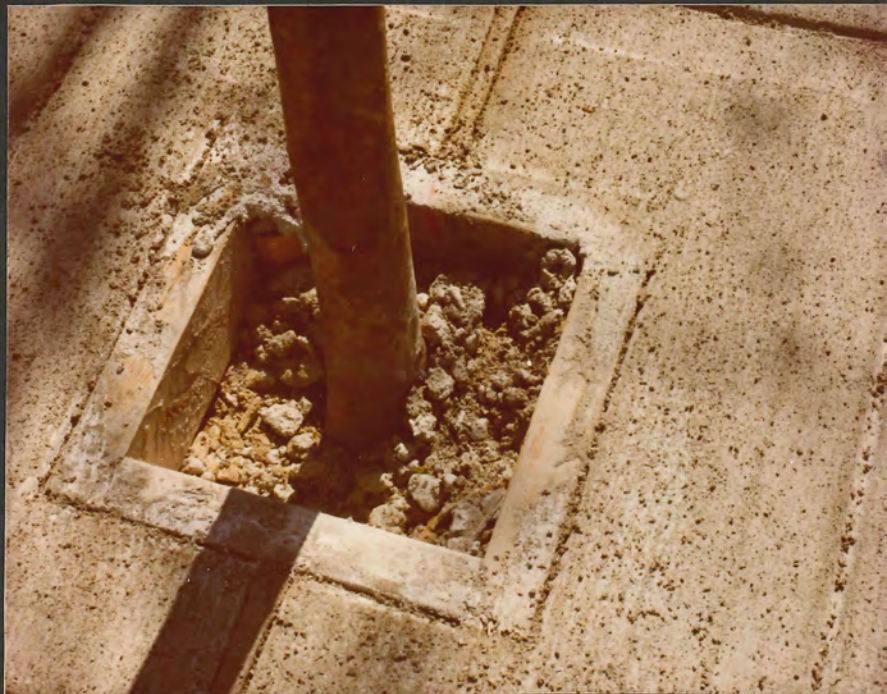
ALTHOUGH PLANTING SITES HAVE BEEN PREPARED ON THIS SIDEWALK, NO SITE PREPARATION WAS COORDINATED PRIOR TO CONCRETING. AS CAN BE SEEN IN THE LOWER PICTURE LITTLE PROVISION IS MADE FOR TWO PEOPLE TO PASS OR WALK SIDE BY SIDE PARTICULARLY IF BASE PLANTINGS ARE INCLUDED IN THE DESIGN.

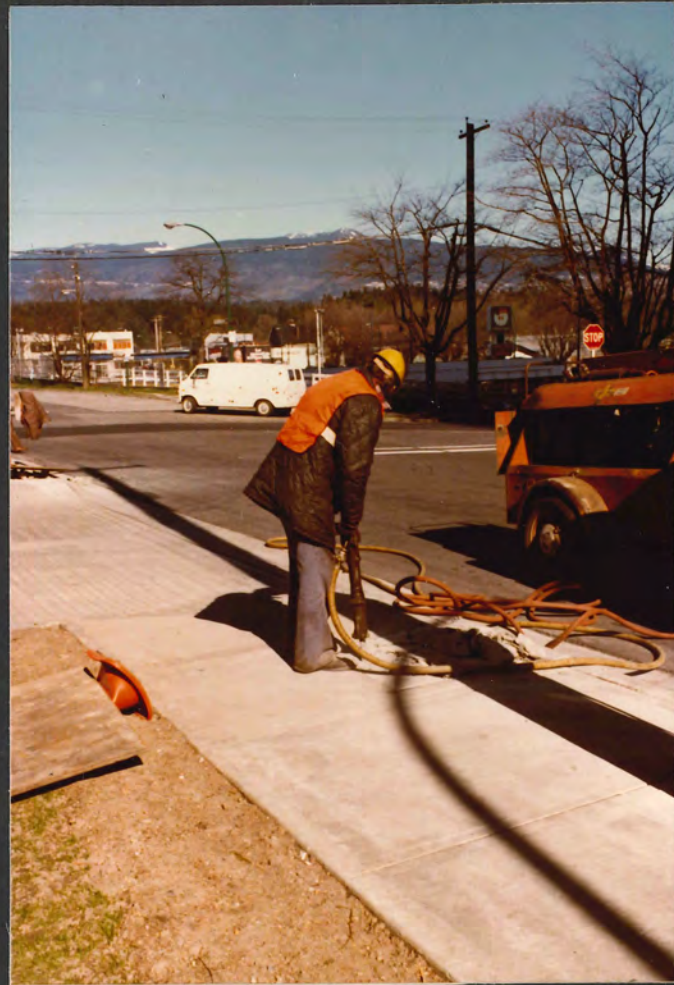
ABOVE: WHERE NO TREE LAWN EXISTS SIDEWALK CUTOUTS ARE THE ONLY METHOD OF PLANTING OTHER THAN THE USE OF LARGE ABOVE GRADE PLANTERS.

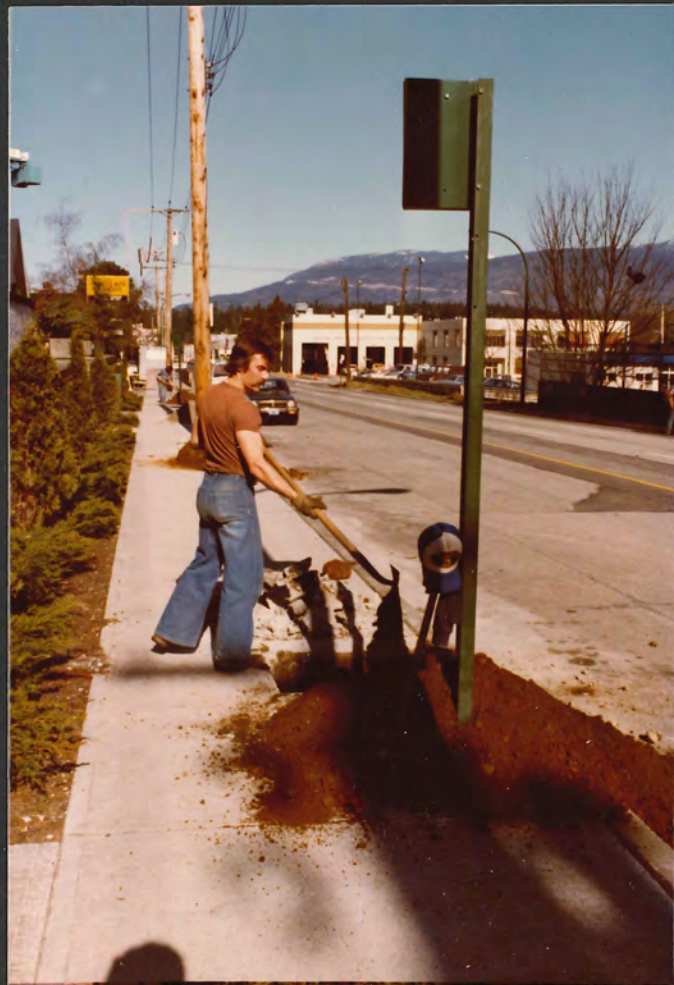
BELOW: DESPITE THE INITIAL CONSTRUCTION COST THESE PLANTING LOCATIONS ARE EFFECTIVE AND ONLY REQUIRE ONE INVESTMENT. HOWEVER, EVENTUAL MATURE TREE REPLACEMENT MAY BE A FORMITABLE TASK IF TREES IN THESE CUTOUTS DEVELOP LARGE ROOT SYSTEMS.

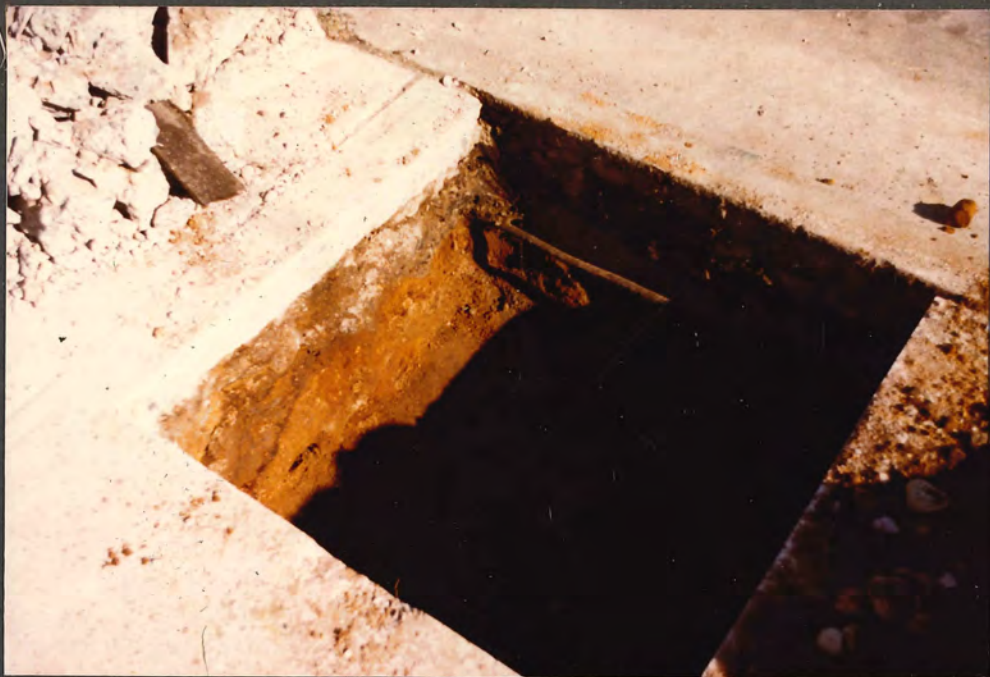
ABOVE: A CONSTANT PROBLEM WITH ALL TYPES OF BELOW GRADE PLANTING SITES IS THE PRESENCE OF UNDERGROUND UTILITIES. CONSISTENT RULES SHOULD GOVERN THE PLACEMENT OF THESE UTILITIES WHERE TREE PLANTING IS PLANNED.

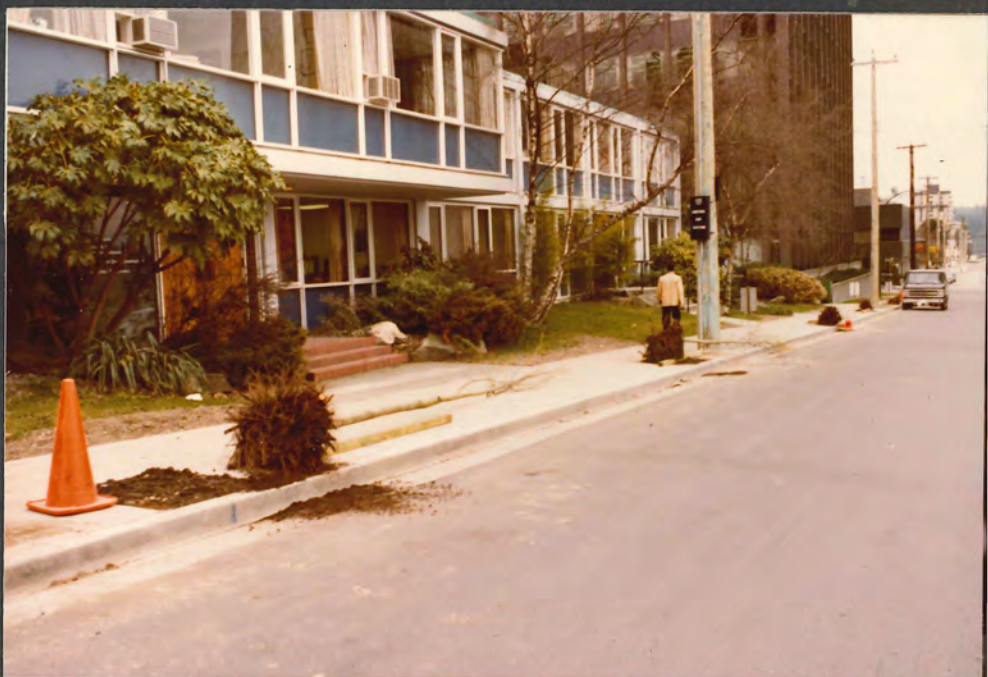
BELOW: THIS METHOD OF BARE ROOT PLANTING MAY BE TOLERATED BY SOME SPECIES BUT MOST WILL SUCCUMB TO TRANSPLANTING SHOCK. TRAFFIC PARKING IS DISRUPTED WITH THIS TYPE OF PLANTING.

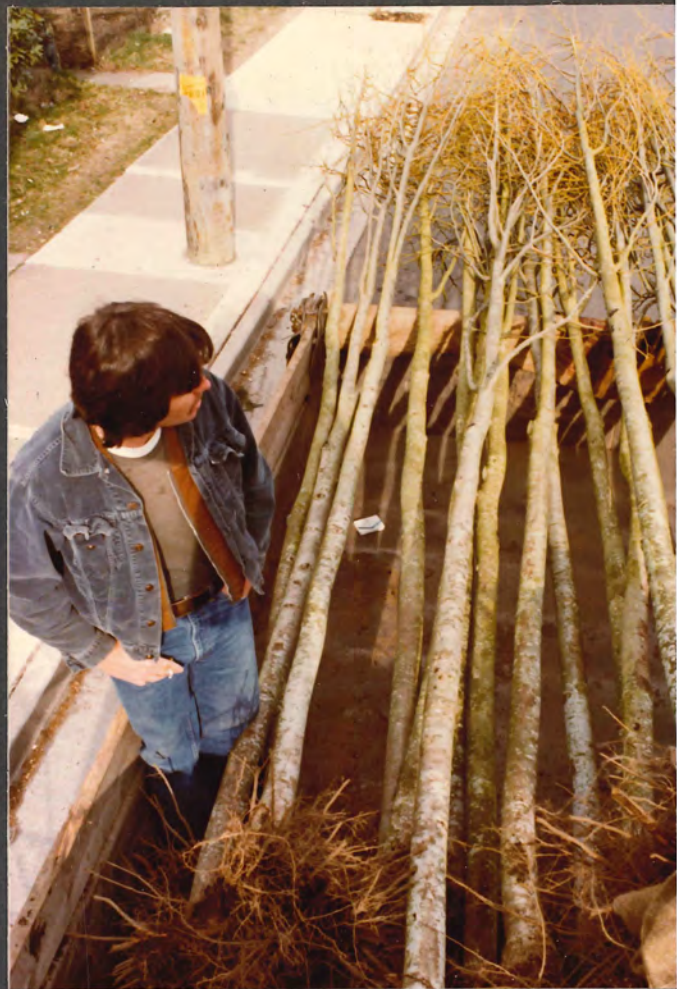
ABOVE: THESE TREES HAVE A MINIMUM OF ROOTS FOR THEIR SIZE. FEW SPECIES WILL SURVIVE THIS TYPE OF HANDLING PRIOR TO PLANTING AS WELL AS THE LIMES PICTURED HERE.

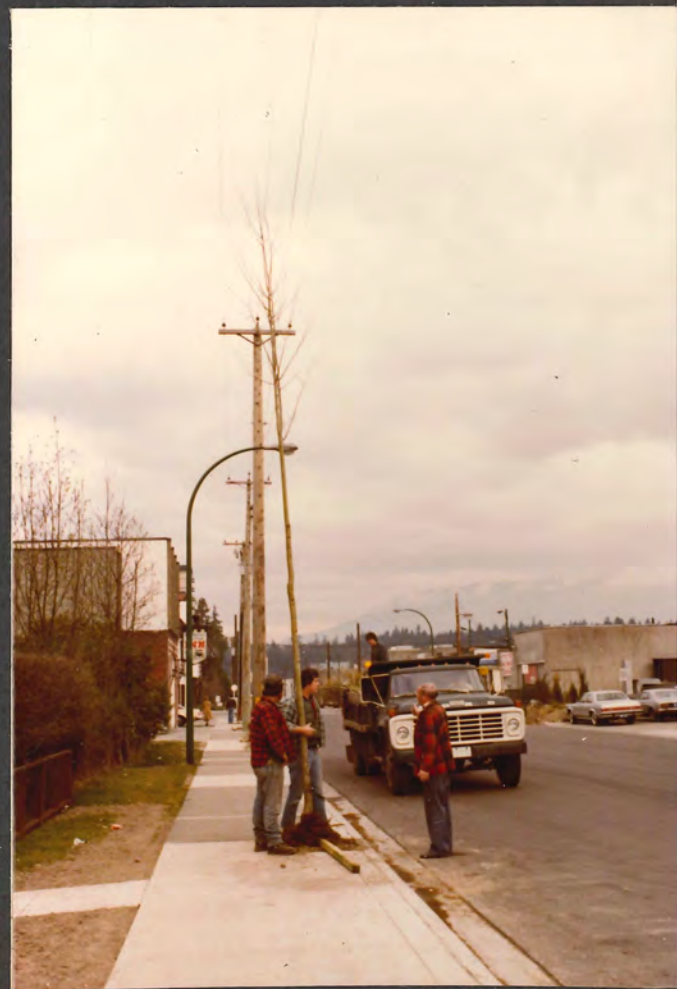
BELOW: THESE TREES WERE CLOSE GROWN IN THE NURSERY AND ARE DRAWN UP WITH FEW LATERAL BRANCHES. ALREADY SOME INDIVIDUALS ARE SO TALL THAT THEY ARE TOO CLOSE TO THE HYDRO WIRE. ANOTHER SPECIES WOULD HAVE BEEN MUCH MORE SUITABLE FOR THIS SITE.

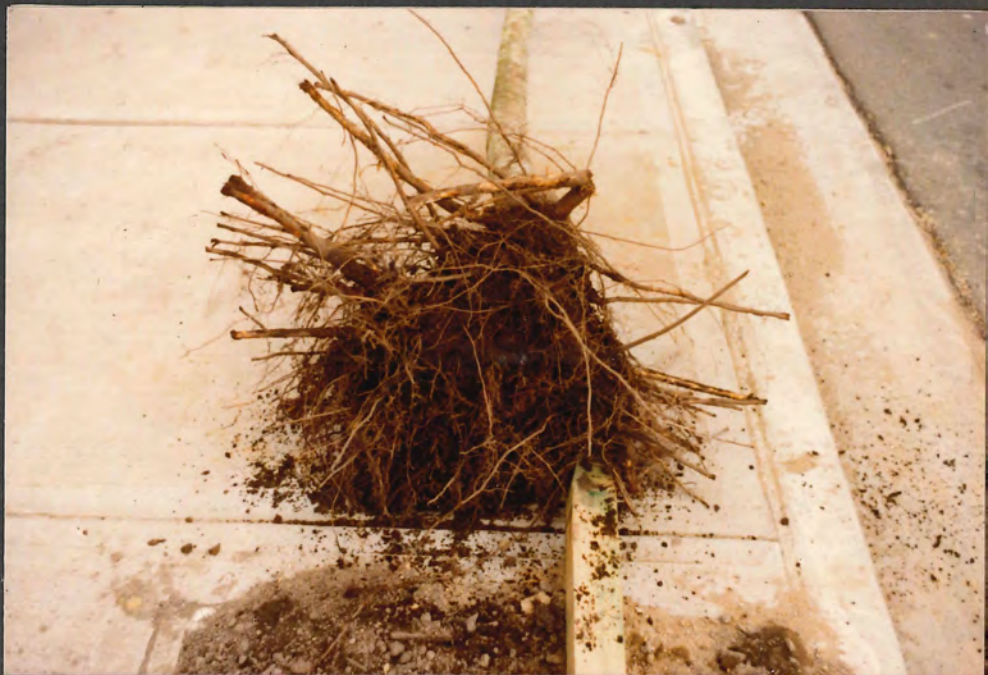
IN SOME CIRCUMSTANCES DEVELOPERS
APPEAR TO HAVE TAKEN TREE PLANT-
INTO THEIR OWN HANDS. DESPITE
THE GOOD INTENTIONS SEEN HERE,
TREE SIZE, THE SHORT STAKES, AND
CLOTH TREE TIES WILL PROBABLY
RESULT IN VANDALISM.

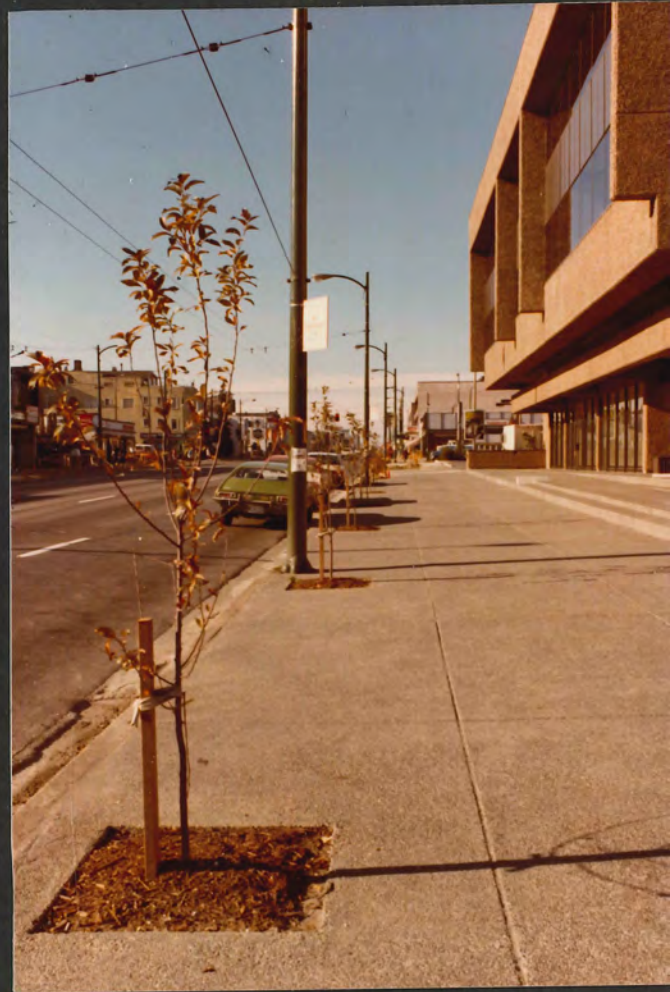
ABOVE: TO ENSURE ESTABLISHMENT
IN PAVEMENT CUTOUTS, SUMMER
WATERING IS ABSOLUTELY ESSENTIAL.

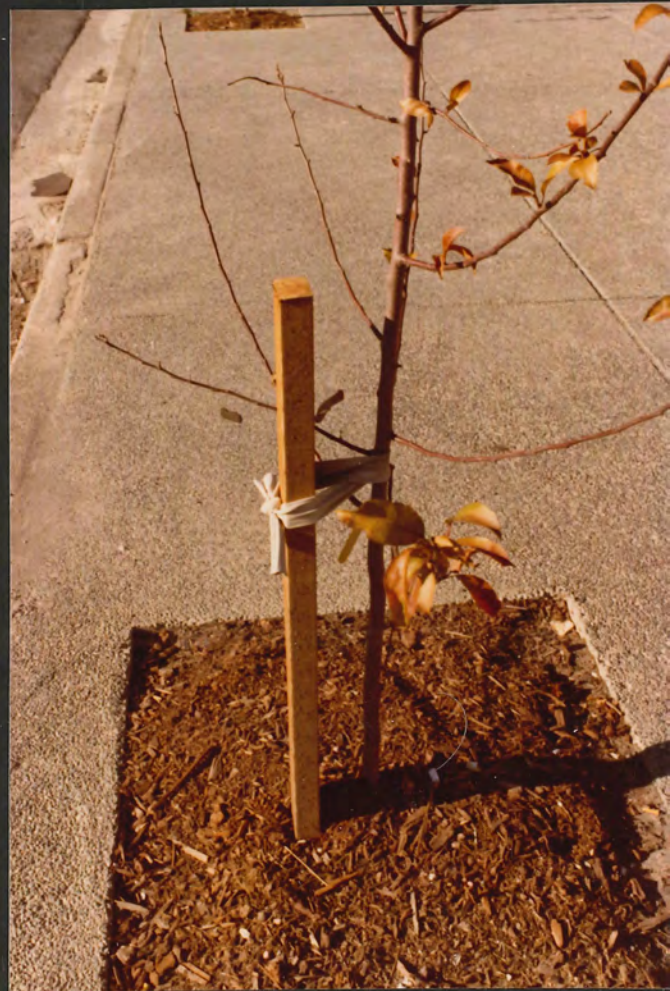
BELOW: THESE TREES PLANTED BY
A DEVELOPER WAS OBVIOUSLY NOT
INSPECTED PRIOR TO INSTALLATION.
THE HIGH BRANCHING PATTERN IN
THE TREE SHOULD NORMALLY PRELUDE
ITS USE IN A SIDEWALK SETTING.

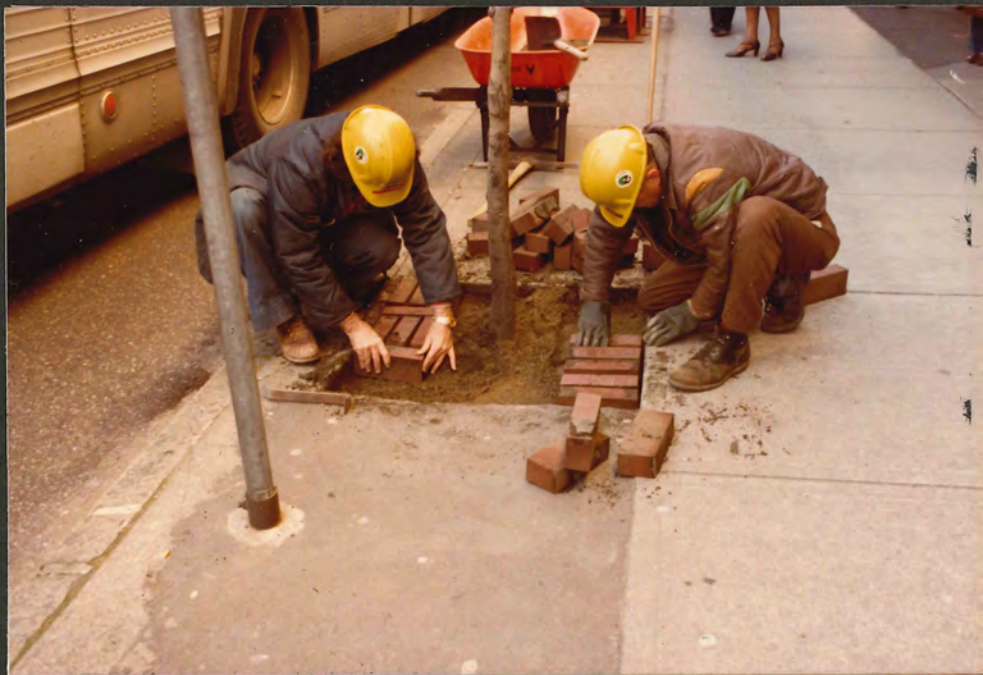
A CONSTANT SOURCE OF ON-GOING MAINTENANCE IS REQUIRED AT TREE BASES. NO GOOD SOLUTION AS TO COVER OR TREE PITS HAS BEEN DETERMINED AND IT IS RECOMMENDED THAT A SPECIAL STUDY OF THE PROBLEM IS WARRANTED.

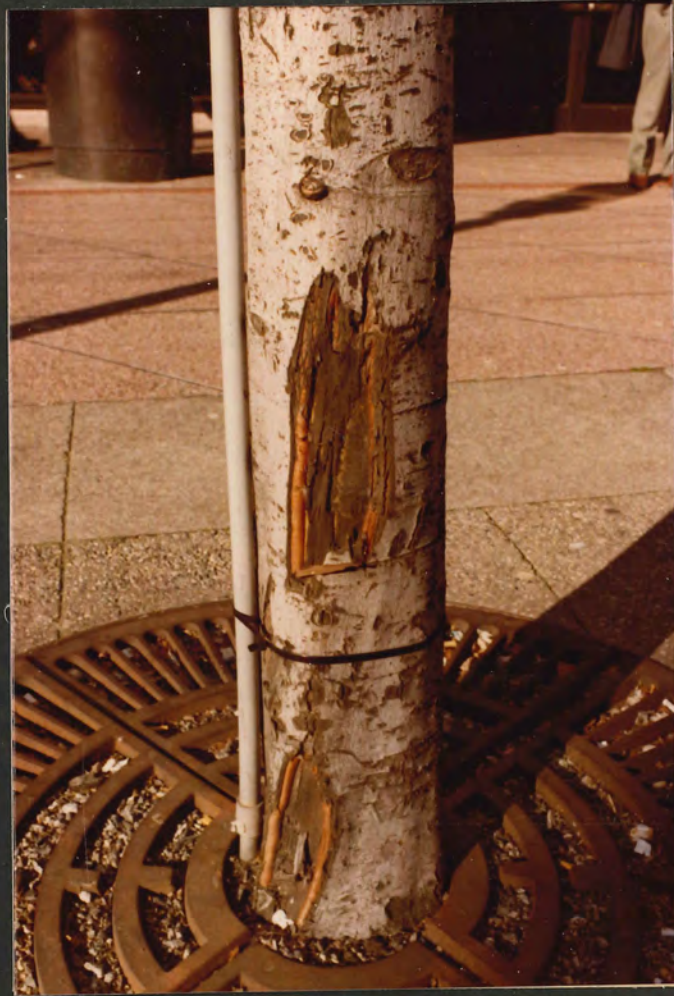
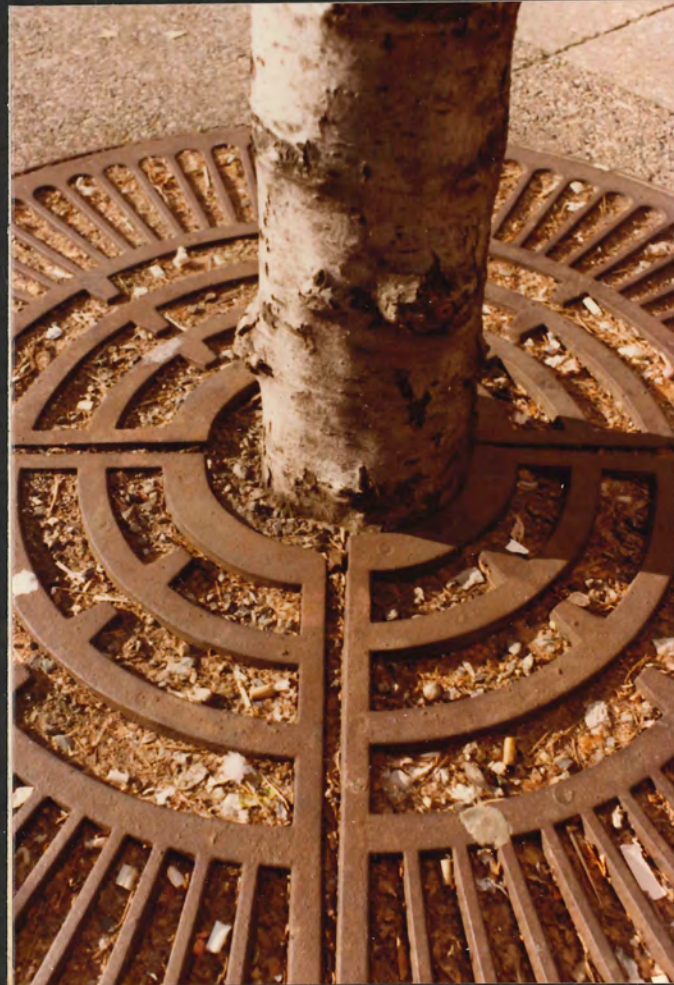
TREE GRATES ON GRANVILLE ARE IN NEED OF ATTENTION SINCE THE FIRST RING IS ALREADY BITING INTO THE STEM OF SOME TREES. DAMAGE SCARS HAVE A LICK OF TREE WOUND DRESSING BUT SHOULD HAVE BEEN PROPERLY TRACED TO PROMOTE WOUND HEALING.

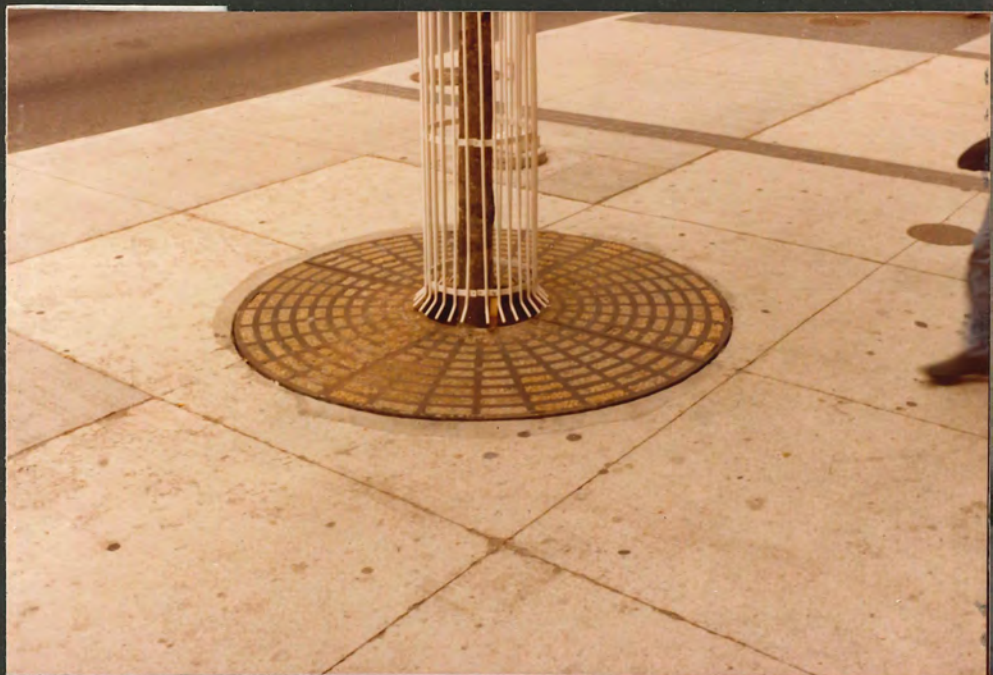
THESE STONE COVERINGS DO NOT
OFFER A SOLUTION TO THE PRO-
BLEM OF TREE PIT COVERS AND
PROBABLY ARE AN ACTUAL HAZARD
REQUIRING CONSTANT MAINTEN-
ANCE.

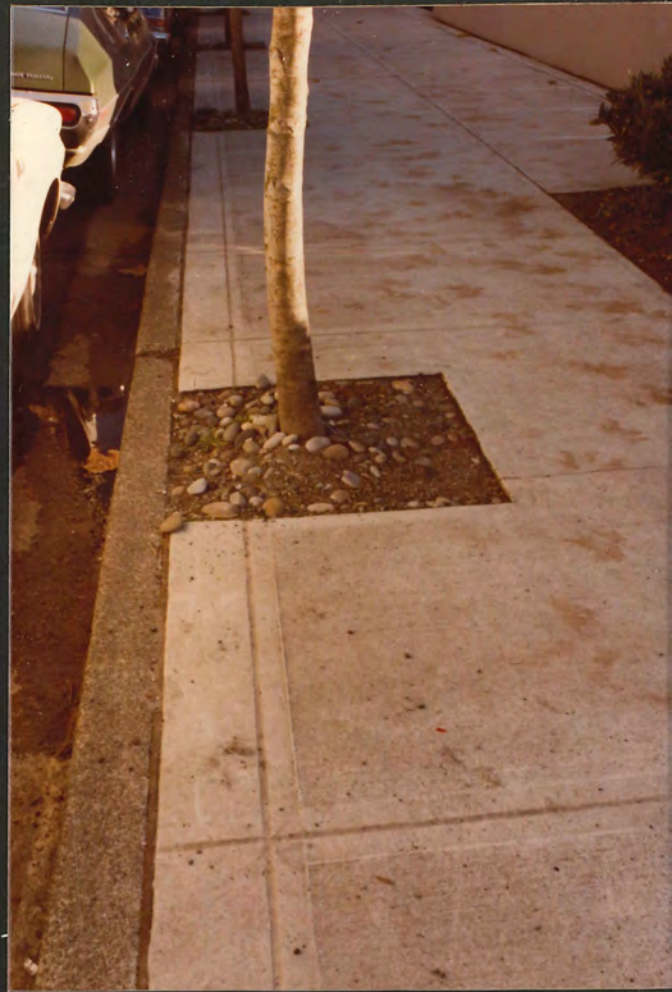
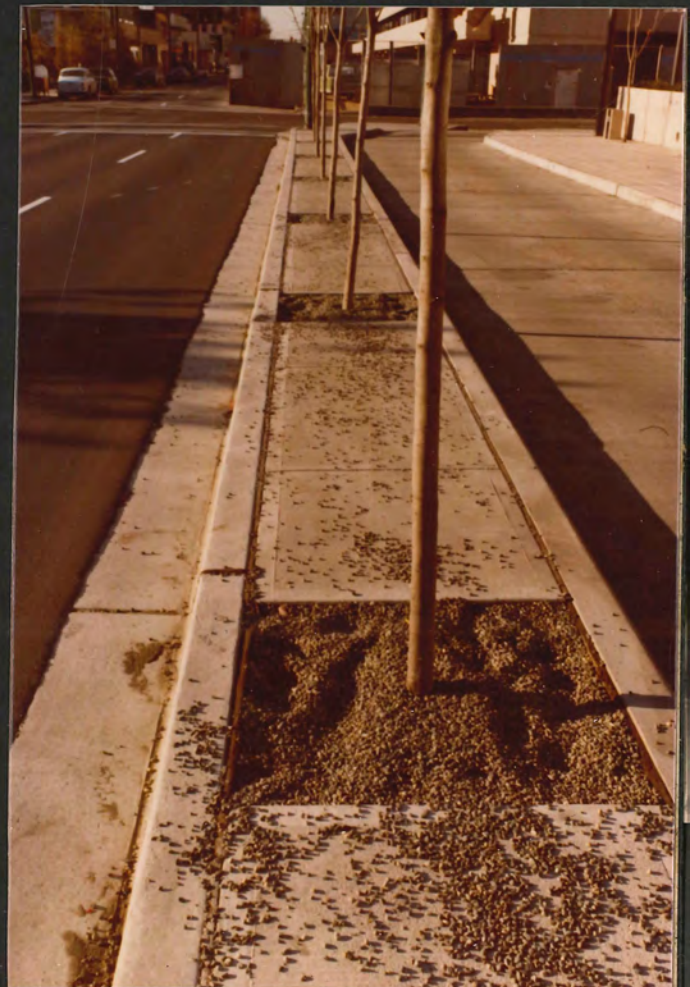
PRIVATE PLANTING ON STREETS CAN
PRODUCE PROBLEMS RANGING FROM
UNSUITABLE SHRUBS TO TREES THAT
HAVE FRUITS WHICH LITTER THE
STREETS.

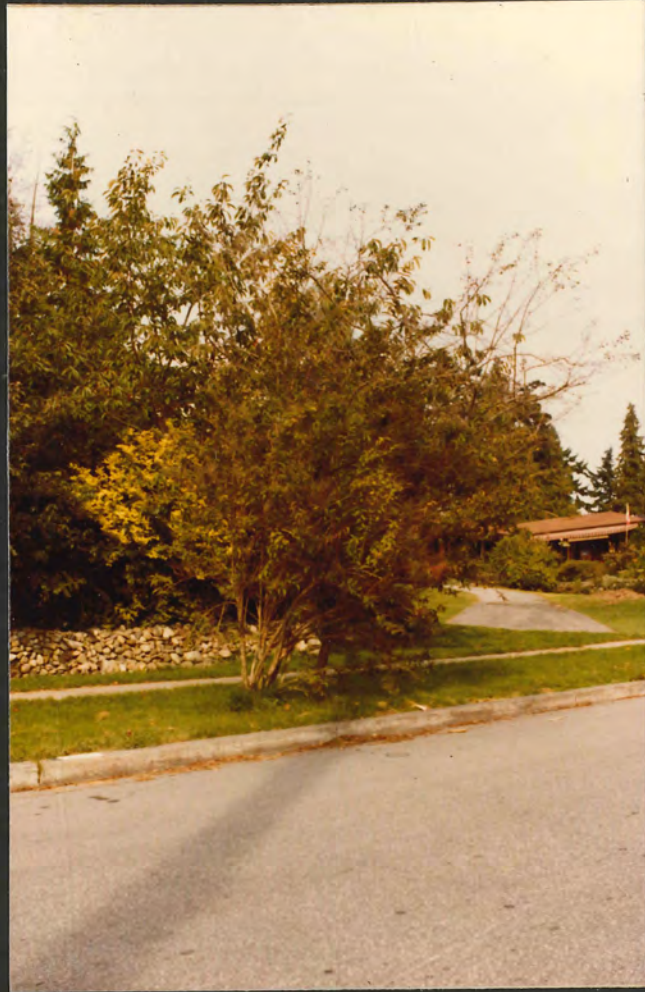
ABOVE: ADEQUATE DISTANCES MUST BE MAINTAINED FROM FIRE PLUGS, STREET SIGNS, AND SIMILAR STREET FURNITURE.

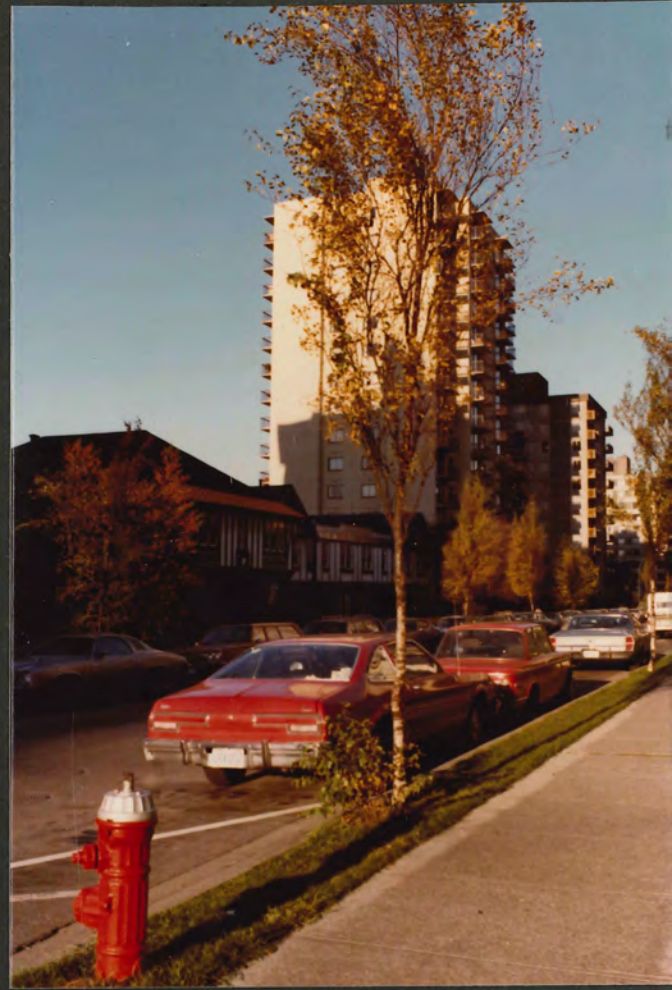
ABOVE: CONTROL OF CITIZEN ENTHUSIASM IN THE INTERESTS OF ARBO-RICULTURAL COMMON SENSE IS SOME-TIMES NECESSARY.

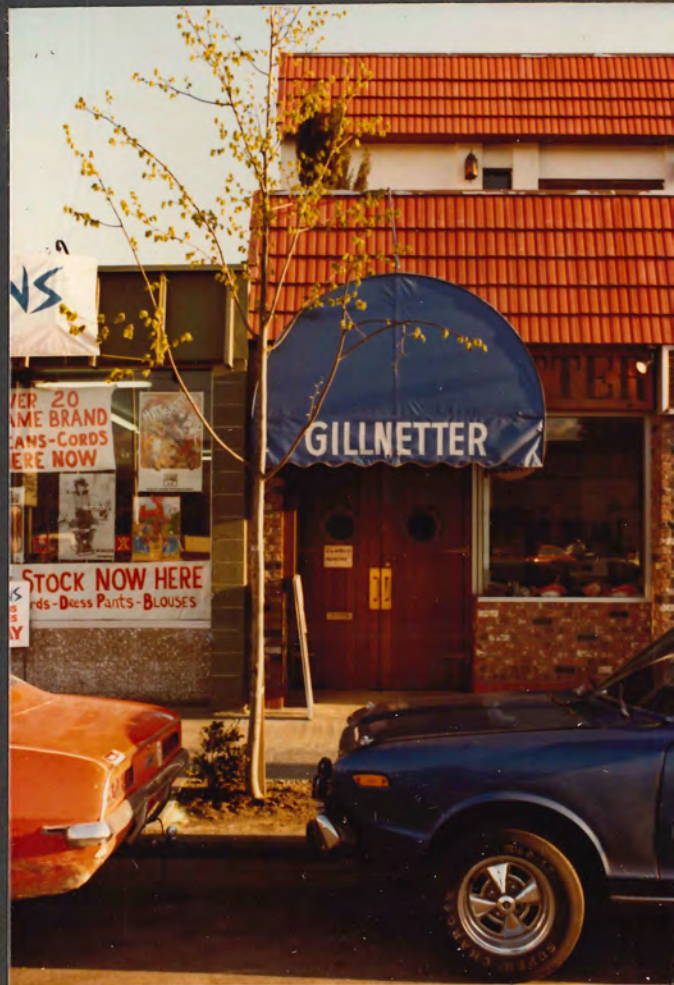
BELOW: SOME OLDER MATURE TREES HAVE NOW OUTGROWN THE CONSTRAINTS OF THEIR ORIGINAL PLANTING PLACE CAUSING EXPENSIVE AND POSSIBLY HAZARDOUS STREET CONDITIONS. TO DATE NO PROGRAM EXISTS TO LOCATE THESE SITUATIONS.

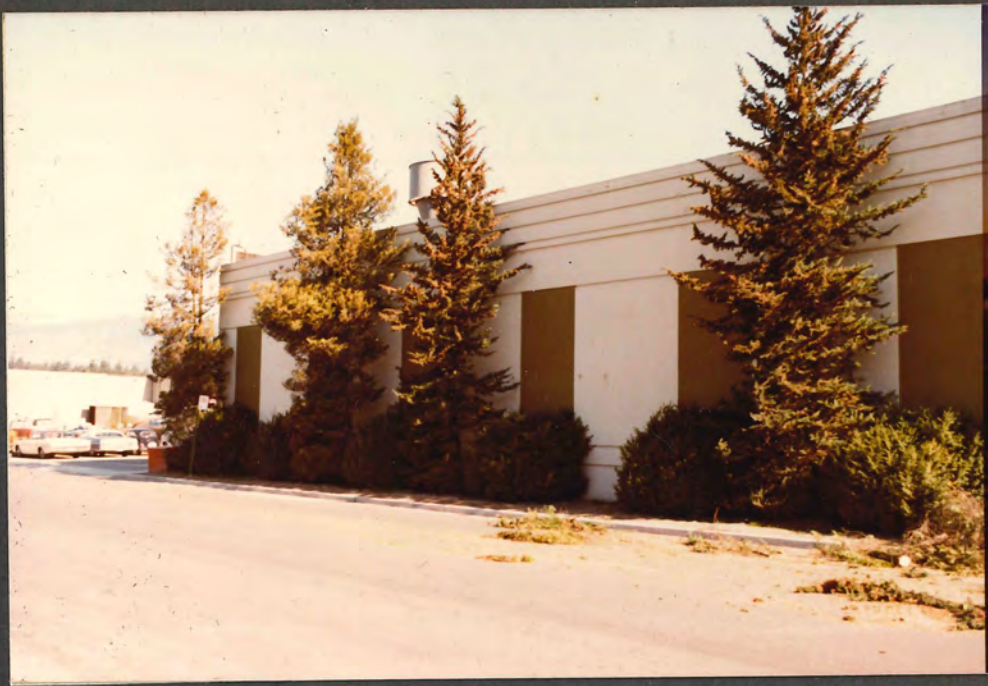
THESE CONIFERS WERE REMOVED FROM
BESIDE THE MINISTRY OF HIGHWAYS
DOWNTOWN TESTING STATION IN ORDER
TO PROVIDE ROOM FOR A UNIFORM STREET
TREE PLANTING. THIS PROPIETY OF
SUCH SACRIFICE IN ORDER TO ENSURE
DESIGN AND MANAGEMENT SIMPLICITY
IS VERY QUESTIONABLE.

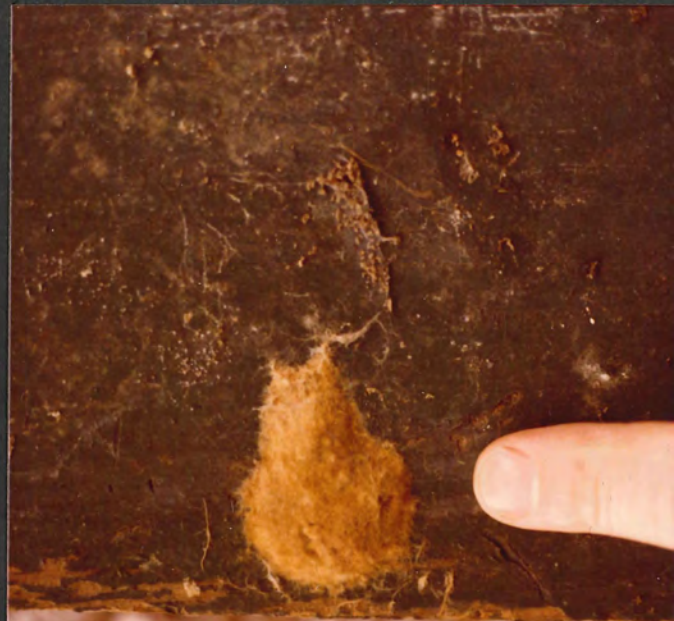
THE DISCOVERY OF THE POTENTIALLY
VERY DAMAGING GYPSY MOTH IN
VANCOUVER.

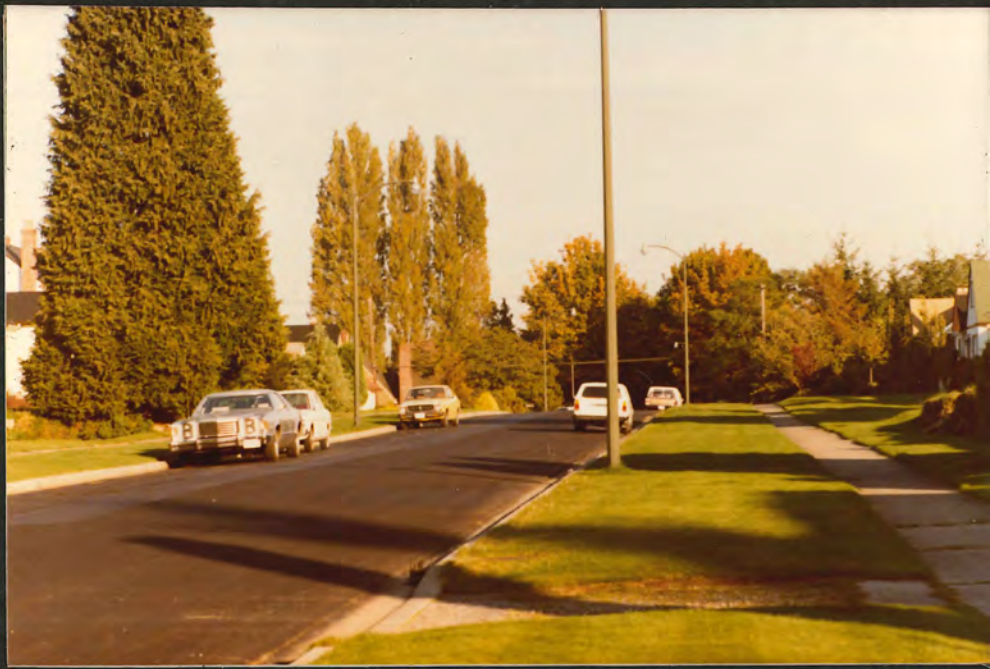
ABOVE: SOME CITY STREETS HAVE ADEQUATE PROVISION FOR BOULEVARD TREES. YET NONE HAVE BEEN PLANTED. THE NEED FOR PLANTING AND A CONSIDERATION OF APPROPRIATE DESIGNS SHOULD BE A PRIORITY IN THE PLANNING OF THE CITY BOULEVARD TREE MASTER PLAN.

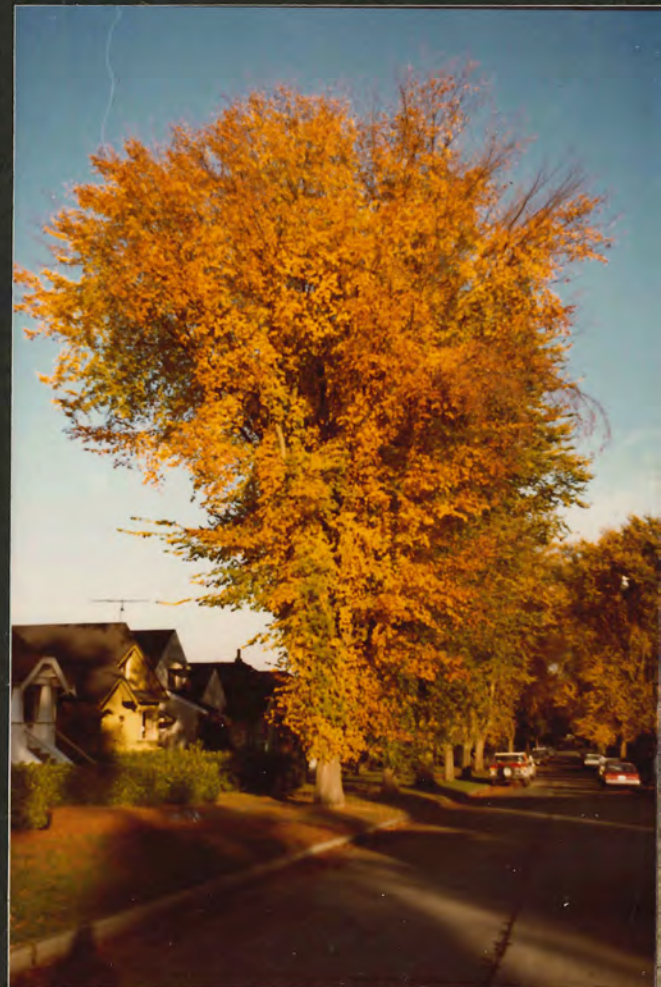
BELOW: BEAUTIFUL THOUGH THIS STATELY ELM MAY BE IN ITS FALL FOLIAGE, IT IS LIKELY THAT DUTCH ELM DISEASE WILL EVENTUALLY PENETRATE B. C. FROM WASHINGTON STATE. CAREFUL PLANNING, SANITATION, BEETLE CONTROL AND TREE REPLACEMENT MAY BECOME A MAJOR TASK FOR THE ARBORICULTURAL GROUP WITHIN THE NEXT TEN YEARS.
