**THE SILVER MAPLE
ON
UNIVERSITY BOULEVARD
VANCOUVER**

**A
STRATEGY
FOR
REVIEW AND
REPLACEMENT**

**M. R. Gardner
August 20, 1995**

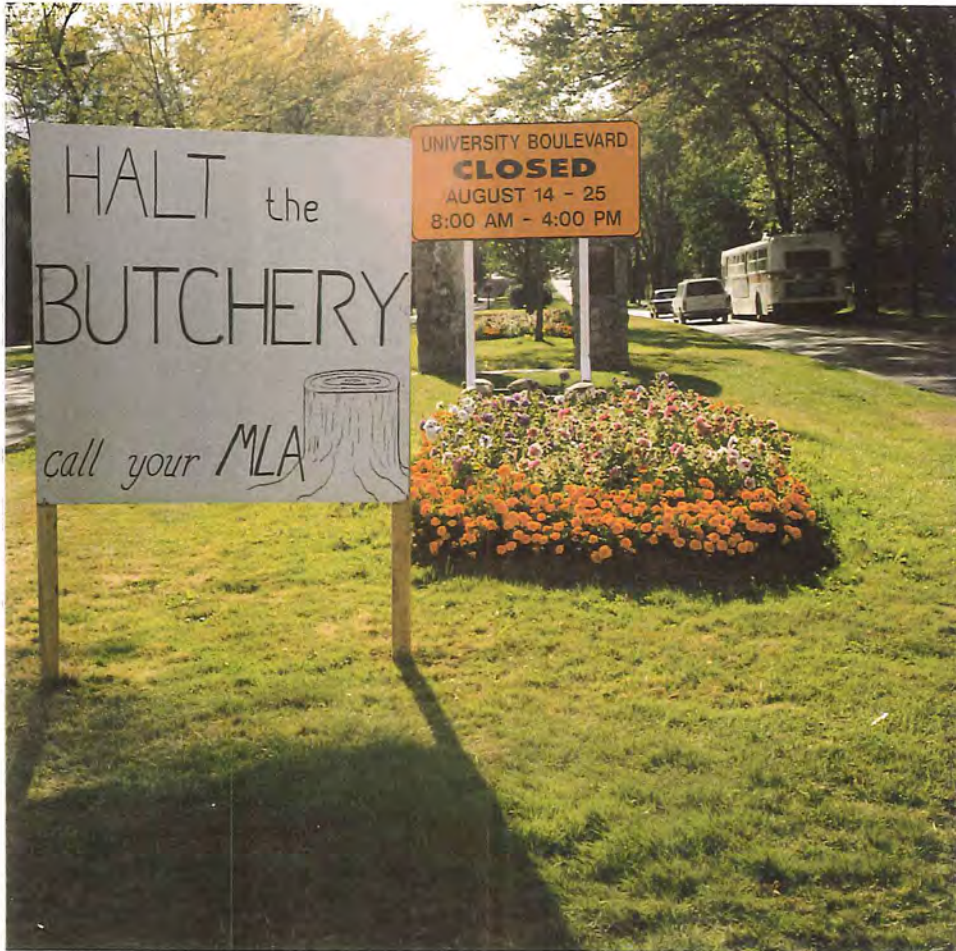
A view of University Boulevard from the east and showing trolley and van on the narrow roadway. A protest sign regarding tree removal is seen in the foreground.

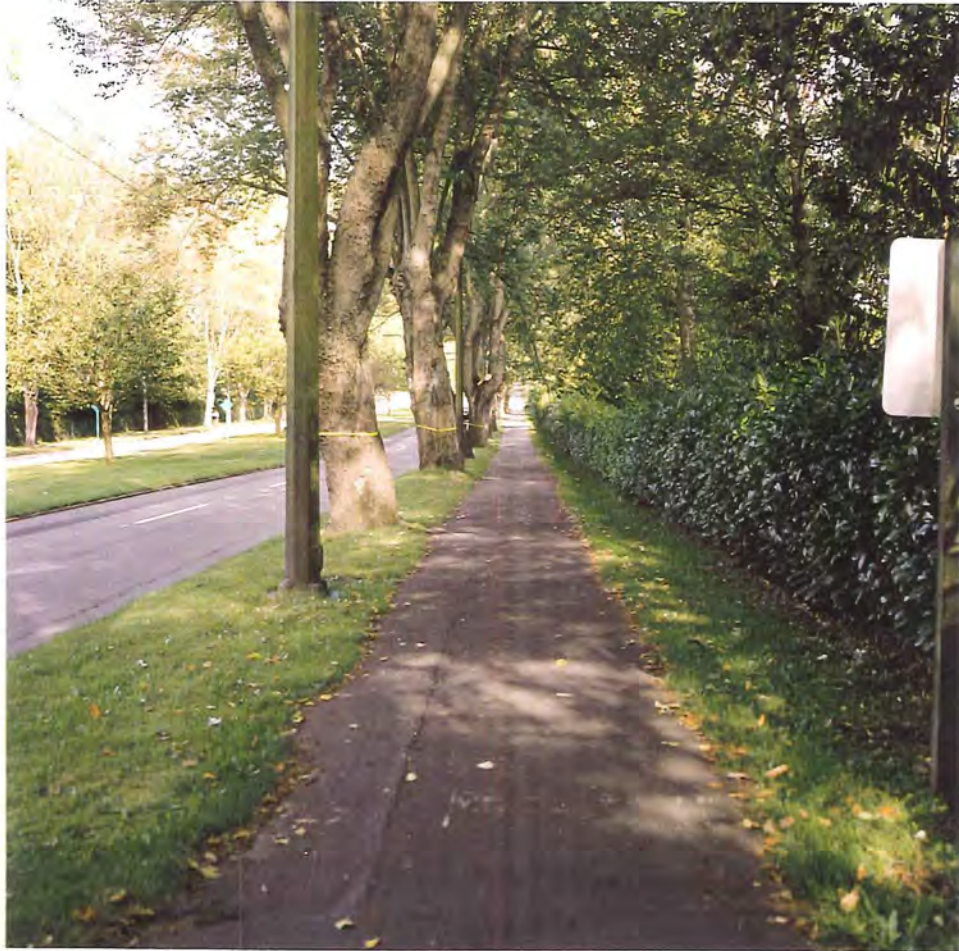
A view of University Boulevard from the south side looking east along the sidewalk showing the tree lawn, vase shape of the Silver Maple and typical trolley wire support poles.

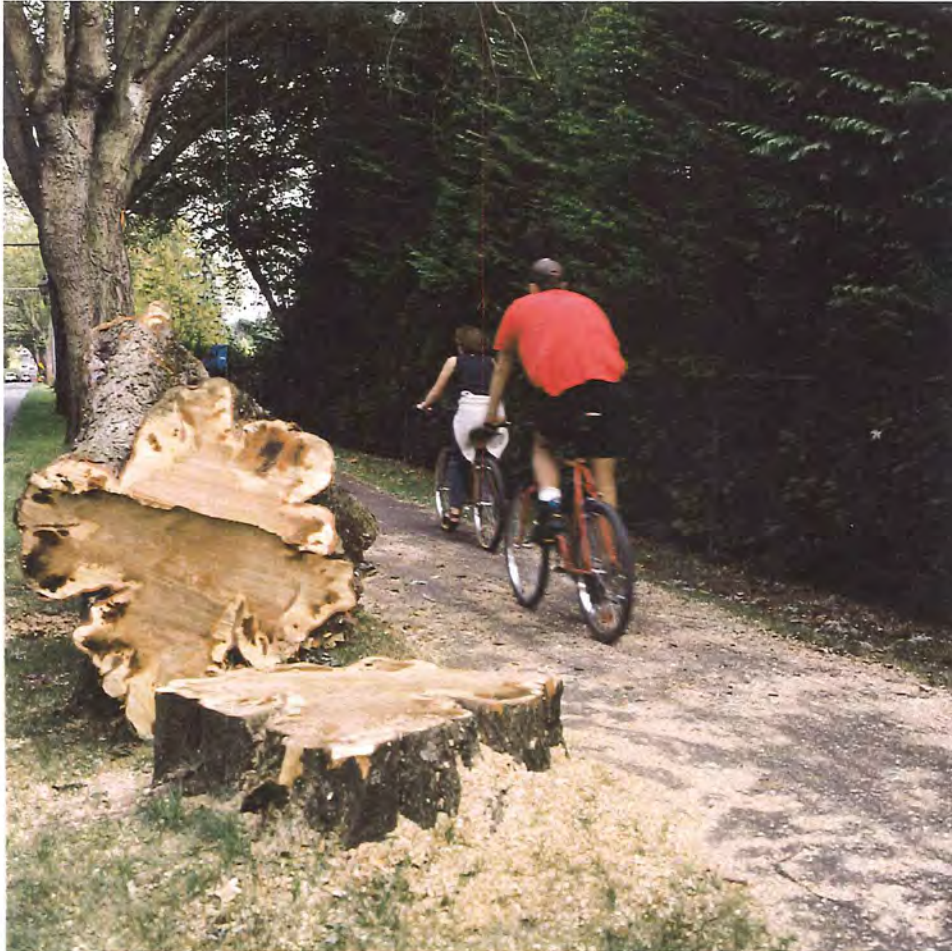
Pedestrian, jogger, and cyclist use of the edge and centre median components of the right-of-way in addition of the four blacktop lanes.
